Williamson Park Stormwater Investigation

March 2017 Storm Event Assessment

Date: 19 January 2018
Reference: 2-69195.00
Status: Draft

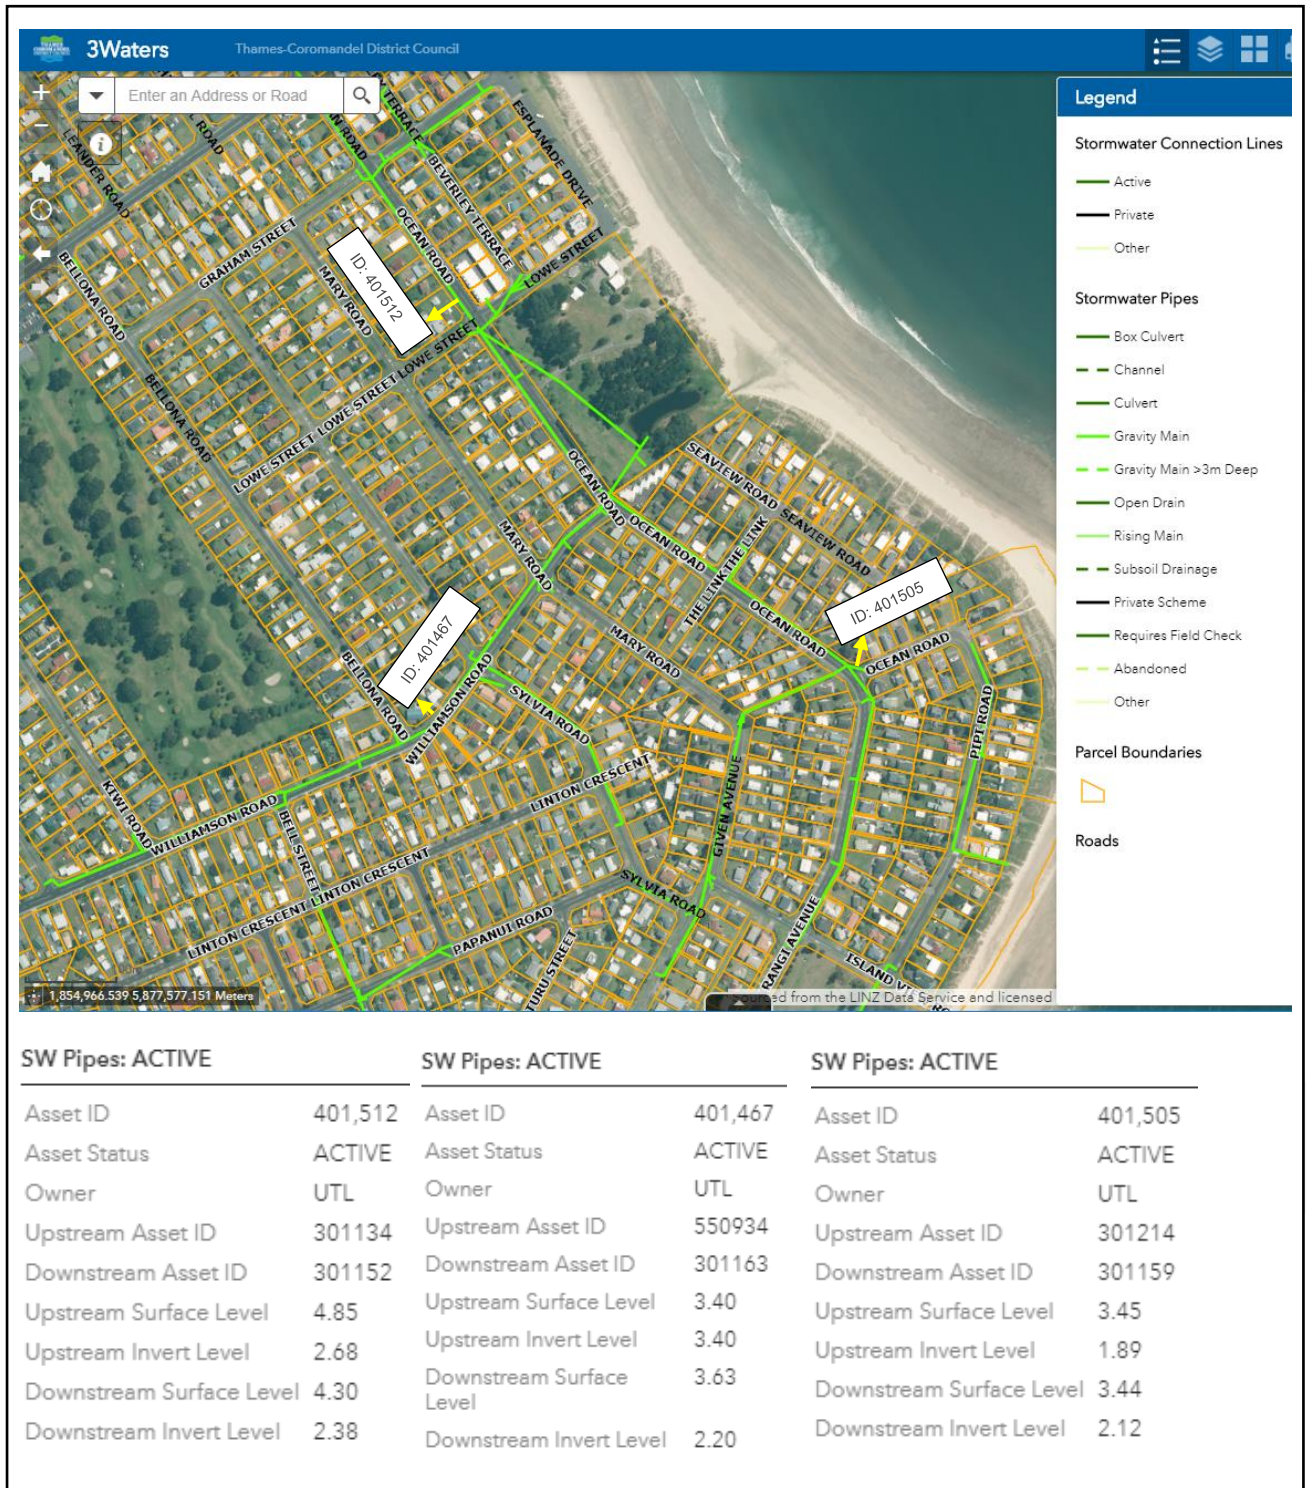
Figure 1: Pipeline information screen shot from Thames-Coromandel District Council 3Waters

The pond spillway is at 2.5mRL (Opus, 2005) and the upstream pipe outlet is at 0.79mRL (based on TCDC 3Waters Map Portal). As shown in Figure 1 below, the area bounded by Lowe Street, Bellona Road and Ocean Road have stormwater pipe invert levels lower than 2.5mRL. The capacity of this part of the network, and likely beyond, will be effected by the Williamson Park Pond.

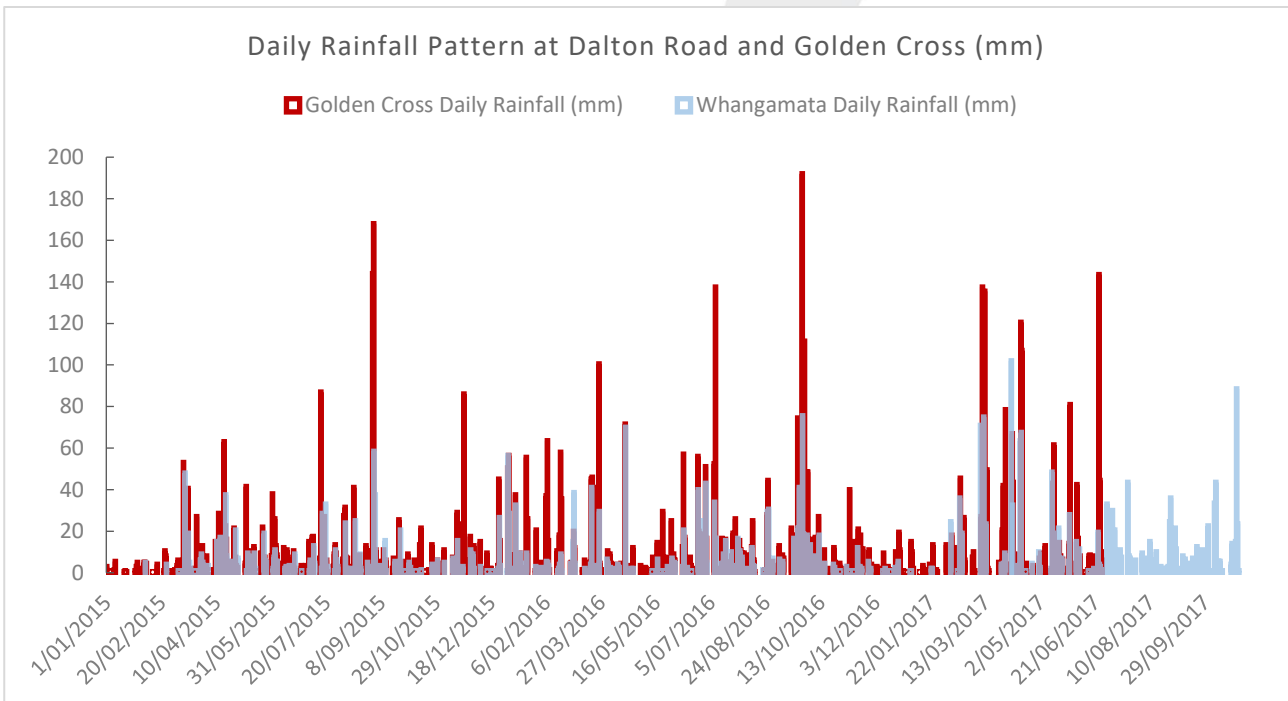
Figure 3: Daily Rainfall Pattern at Dalton Road and Golden Cross Stations

The daily rainfall for Whangamata and Golden Cross have been plotted in Figure 3 below. At both Dalton Road and Golden Cross, during March 2017 the highest rainfall events occurred between 8th and 11th of March. The rainfall event's return period on both sites have been assessed based on High Intensity Rainfall System V3 (NIWA) as shown in Table 1 below.

- Golden Cross generally records higher daily totals compared to Dalton Road.
- Frequent rainfall occurred between the 8th and 13th of March, among those time there are two large rainfall events occurred on the 8th March and 11th March 2017 at Dalton Road with 71mm and 75mm rainfall respectively.
- There was two higher daily rainfall totals at Dalton Road on the 5th April 2017 and 28th October 2017, with 102mm and 88.5 of rainfall respectively.
- **The rainfall during the March events at Golden Cross is estimated at between 5 to 10 year ARI. The Dalton Road station generally shows less rainfall comparing to Golden Cross, therefore the return periods were potentially lower in Whangamata, however it is not possible to assess on the rainfall return period as only daily rainfall totals are available.**

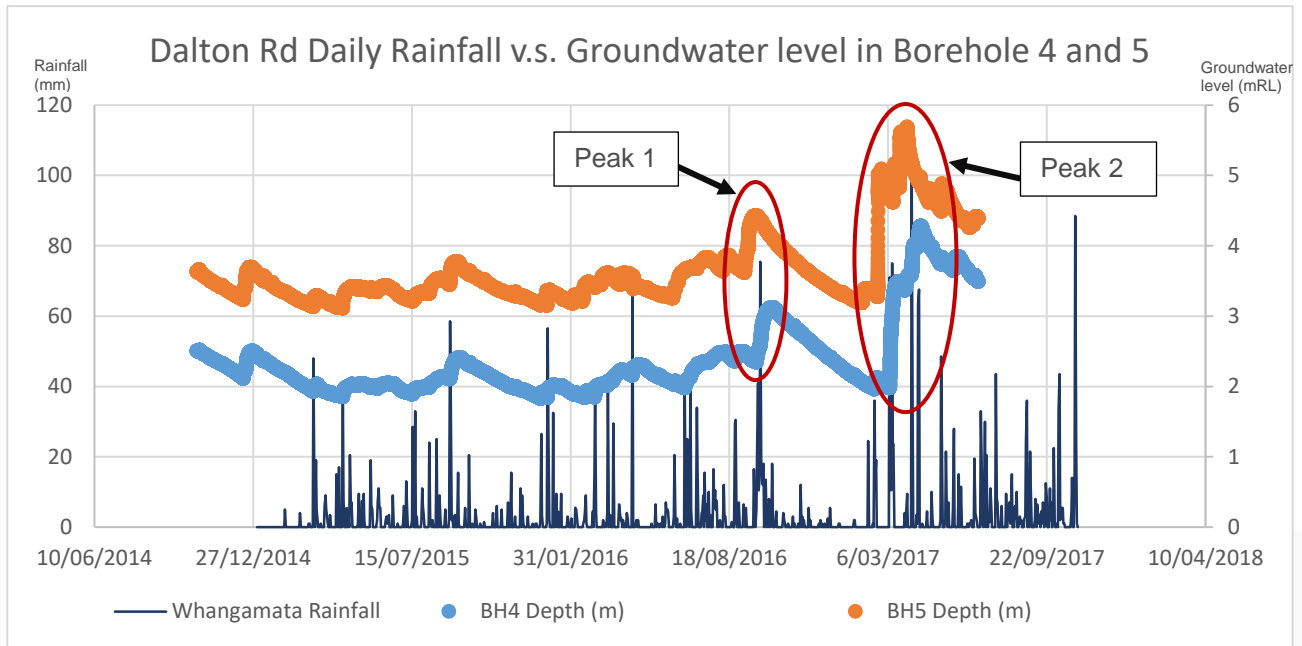
Figure 5: Trend of groundwater level with Dalton Road Rainfall

The data shows a general trend of increase in groundwater level after rainfall events - where there is a high rainfall event, the groundwater level tends to rise.

On March 2017, rainfall occurred everyday between the 8th and the 13th. Two large rainfall totals occurred on the 8th and the 11th with more than 70mm rainfall on each day. One larger rainfall event occurred on the 5th April with 102mm rainfall. This was the highest daily rainfall total during the previous two years.

Peak 1 occurred immediately after the high rainfall event in September 2016. A relatively dry summer and autumn appears to have led to the groundwater level dropping and reached a low point in February 2017.

Peak 2 was influenced by the large rainfall events that occurred in March and April 2017.

As shown in Figure 5, Peak 2 highlights the rainfall events that occurred in March and April 2017 with groundwater levels at BH04 and BH05 the highest recorded within the data period. As discussed in Section 3.2, there are many large rainfall events occurred during March and April. **The volume of rainfall that fell in this period was likely a significant factor in the rapid rise of groundwater levels**, however further investigation would be required to determine any other factors that may have influenced groundwater levels.
