Municipal Storm water Network Operation Annual Report

August 2018

Appendix A: Visual Inspection of Receiving Waters at Storm water Outlets

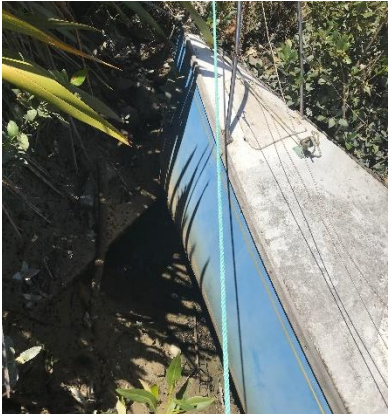
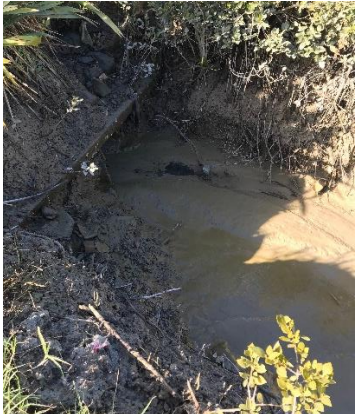
Ref	Monitoring	Observations and Actions – (Photo on left side taken February 2018, photo on right taken June 2018)
01	Thames: Thames Marina	<p>26/02/2018: Clear water, no scum, foam, oil slicks present. Aquatic life present in the mud (crabs), Presences of mangroves growing around outlet. Operation of the outlet hindered by heavy sediment build up and blocked by a boat. (Sediment removed May 2018)</p> <p>12/07/2018: Small flow from outlet, clear water, no scum, foam, oil slicks present. Mangroves present around outlet. Outlet clear of sediment build up, small amount of aquatic life present in the mud.</p> <div style="display: flex; justify-content: space-around;">

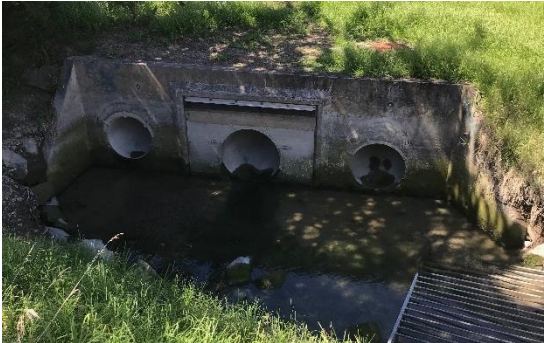
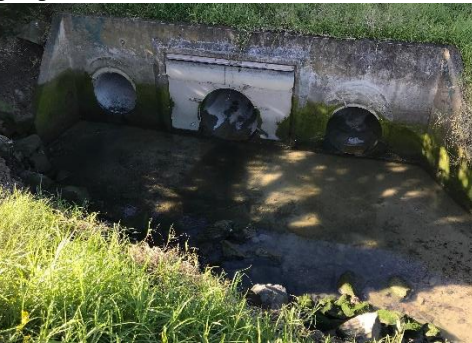
</div>
02	Thames: Sealey Street	<p>26/02/2018: Small flow from outlet, clear water, no scum, foam, oil slicks present. Presences of algae growing in water and around the outlet. Small amount of rubbish around outlet. Outlet clear of sedimentation.</p> <p>12/07/2018: Small flow from outlet, Clear water, algae present. Outlet clear of sedimentation and rubbish. No scum, foam, oil slicks present.</p> <div style="display: flex; justify-content: space-around;">

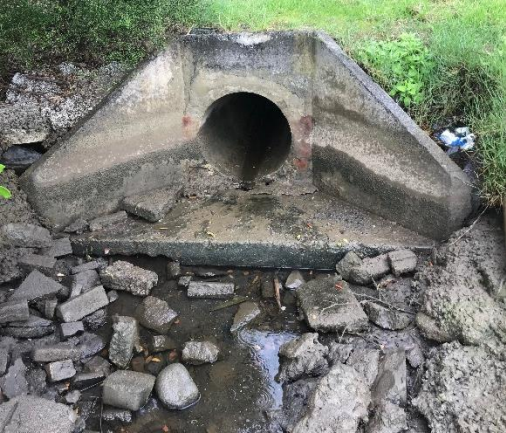
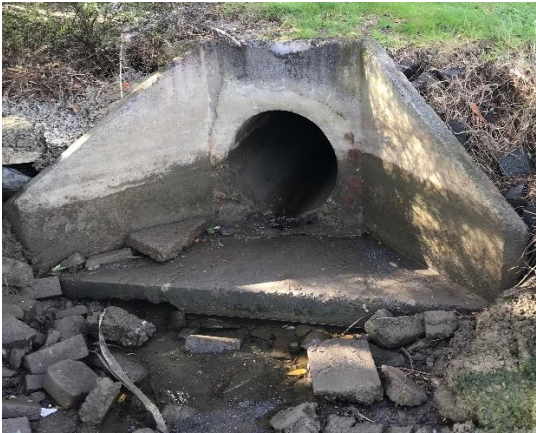
<p>07</p>	<p>Tairua: Marquet Place</p>	<p>27/02/2018: Minimal flow from outlet, clear water beyond outlet, no foam, scum, oil slicks present. Aquatic life present in mud surrounding outlet. Small presence of algae. Thin layer of mud on the base of the wing wall. 11/07/2018: Clear water, no foam, scum, oil slicks present. Small build-up of gravel in channel. Crab burrows present in mud surrounding outlet. Small amount of organic debris in channel.</p> <div style="display: flex; justify-content: space-around;">

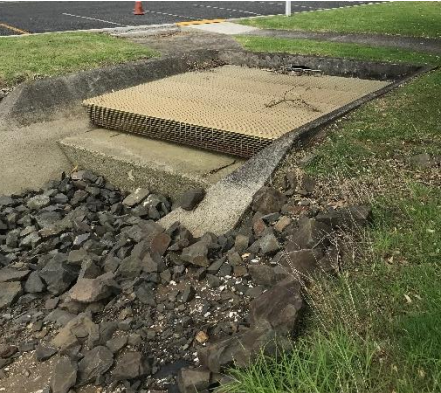
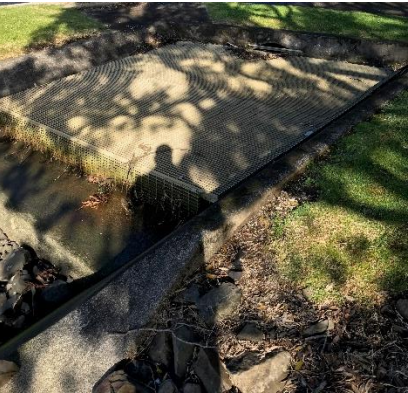
</div>
<p>08</p>	<p>Whitianga: Marina Hardstand</p>	<p>28/02/2018: No foam, scum, oil slicks present. Anti scour concrete amouring in place top prevent scouring at base of outlet. Small Amount of organic build-up on top of grill. 11/07/2018: Organic debris present on front of grill. Clear water flowing, no scum, foam, oil slicks present.</p> <div style="display: flex; justify-content: space-around;">

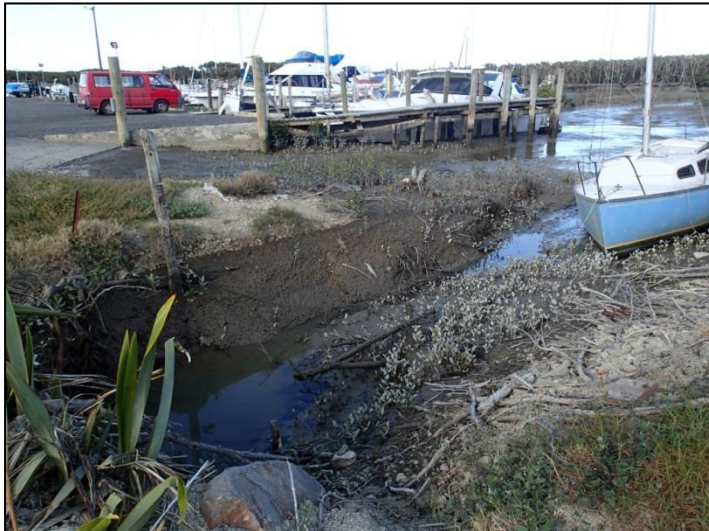
Photo 1. Site 1: Thames Marina.

This outlet flows into an area of mangroves. Several mangrove seedlings were present in the channel (coverage at high tide would be 50% of channel). A moderate amount of large woody debris was present in the channel, covering approximately 50% of the bottom. Multiple crab burrows were observed. The substrate was muddy and the anoxic layer was within a centimetre or two of the surface. Fauna present in the samples included high abundances of the Oligochaete (earthworm), mud crab *Helice crassa*, mud snail *Amphibola crenata*, true fly Tanypodinae (a freshwater species) as well as isopods and amphipods.

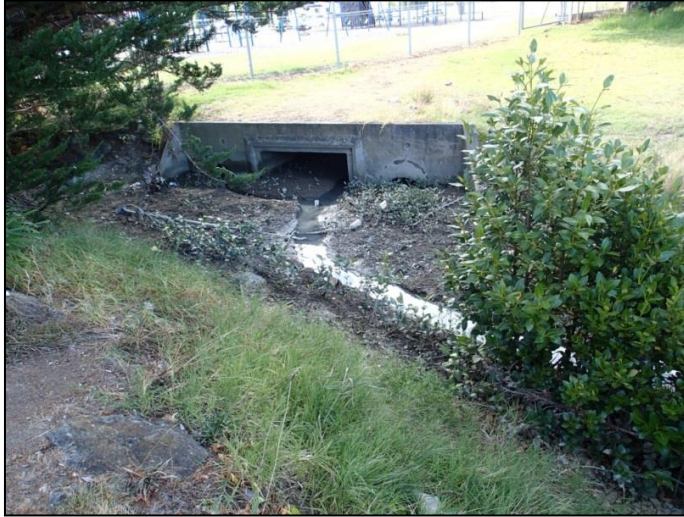
Photo 2. Site 2: Sealey St, Thames.

edge. Woody debris covered approximately 5% of the channel, with some litter also present. The flow rate was approximately 0.25 m/s, and the substrate was muddy and anoxic. Fauna present included the highly abundant mudsnail *Potamopyrgus antipodarum*, true fly *Chironomus zealandicus*, earthworms (oligochaetes), various paddleworms and an estuarine mud snail *Amphibola crenata*.

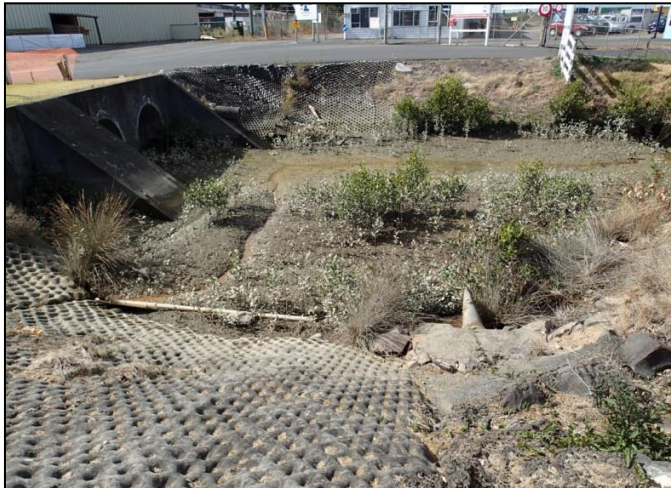
Photo 3. Site 3: Burke St outlet, Thames

Mangrove seedlings would cover 70% of the channel at high tide at this site. A very small amount of marine green algae was present. Some small woody debris was present but only covered around 1% of the stream bed. Flow was very low at 0 m/s at the time of sampling. The anoxic layer was very close to the sediment surface. A brown scummy film was present on the water's surface. Fauna present include the mud snail *Potamopyrgus antipodarum*, true fly *Chironomus zealandicus*, cockle *Austrovenus stutchburyi* and oligochaetes, paddleworms and amphipods.

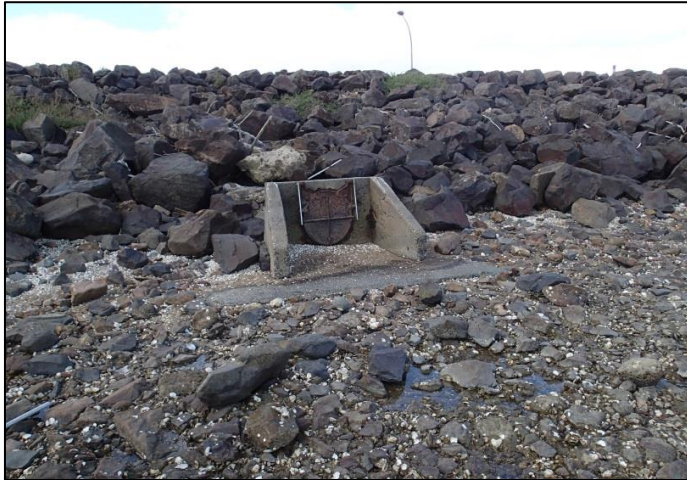
Photo 4. Site 4: Fergusson Dr, Thames

barnacle *Austrominius modestus*, cockle *Austrovenus stutchburyi*, whelk *Cominella glandiformis*, crab *Helice crassa*, pipi *Paphies australis*, little black mussel *Xenostrobus pulex*, and polychaete worms (though only the dead shells of cockles and pipis were seen). No aquatic plants were present at the site.

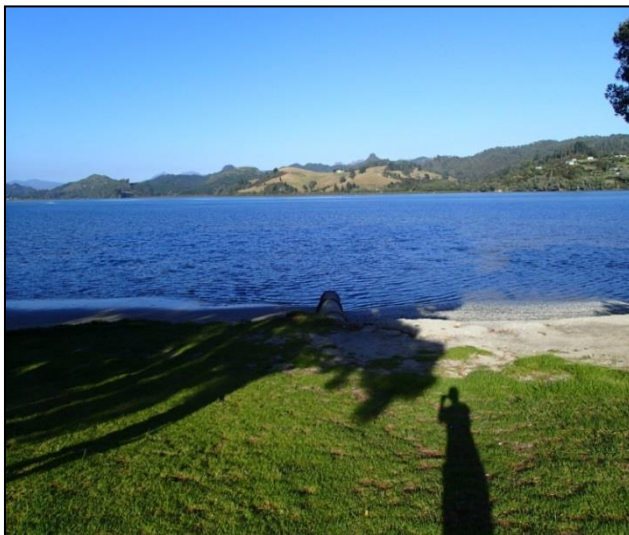
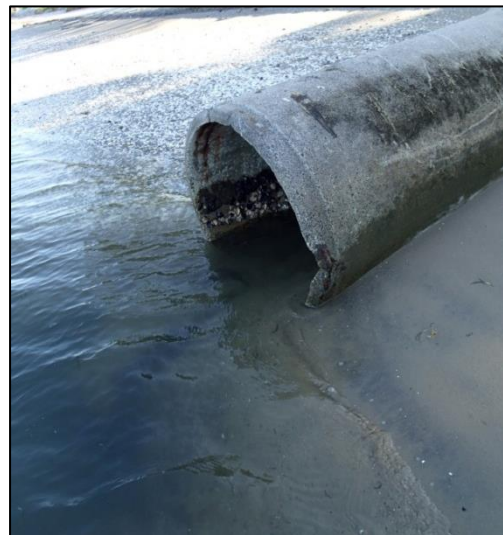
Photo 5. Site 5: Sheppard Ave, Pauanui.

The outlet near Sheppard St in Pauanui flows directly into the estuary. Fauna species noted included oyster *Crassostrea glomerata*, barnacle *Austrominius modestus*, cockle *Austrovenus stutchburyi*, whelk *Cominella glandiformis*, crab *Helice crassa*, pipi *Paphies australis*, and an amphipod. Seagrass fragments were present at the site but had likely been washed there as they were not attached to the substrate. The substrate at this site was sandy.

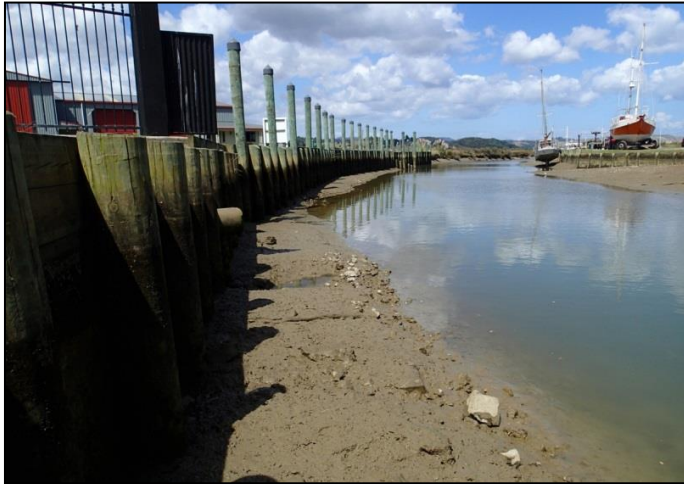
Photo 6. Site 6: Wharf Rd, Coromandel.

invertebrates. Woody debris covered approximately 1% of the stream bed. Fauna present include the mud snail *Potamopyrgus antipodarum*, cockle *Austrovenus stutchburyi*, shrimp *Paratya curvirostris* and other taxa including amphipods and oligochaetes. No aquatic plants were present at the site.

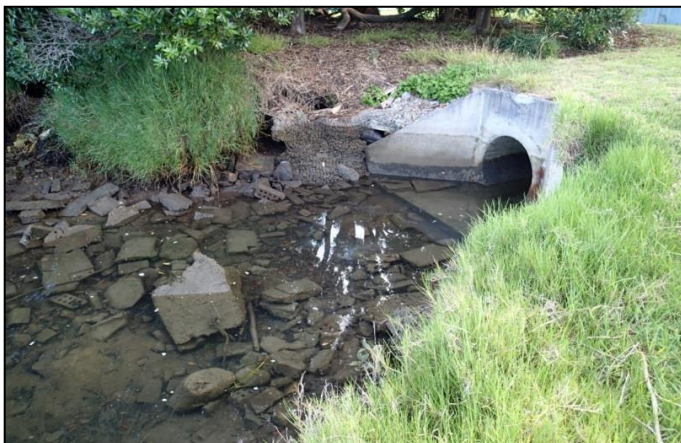
Photo 7. Site 7: Marquet Place, Tairua Harbour.

This outlet flows directly out into the harbour. Several shrimp *Paratya curvirostris* and crab burrows were observed at this site. A small number of mangrove seedlings were present. The substrate at this site was made up of concrete blocks with several *Juncus* sp. plants on the banks. The substrate was muddy sand with the anoxic layer evident very close to the surface. Several whelks *Cominella glandiformis* were seen, and a shortfin eel approximately 25 cm long was caught when collecting invertebrates. Fauna present in the sample included the shrimp *Paratya curvirostris*, mud snails *Potamopyrgus antipodarum*, *Amphibola crenata* and *Zeacumantus subcarinatus*, mud crab *Helice crassa*, true fly Orthocladiinae and periwinkle *Nodilittorina antipodum*.

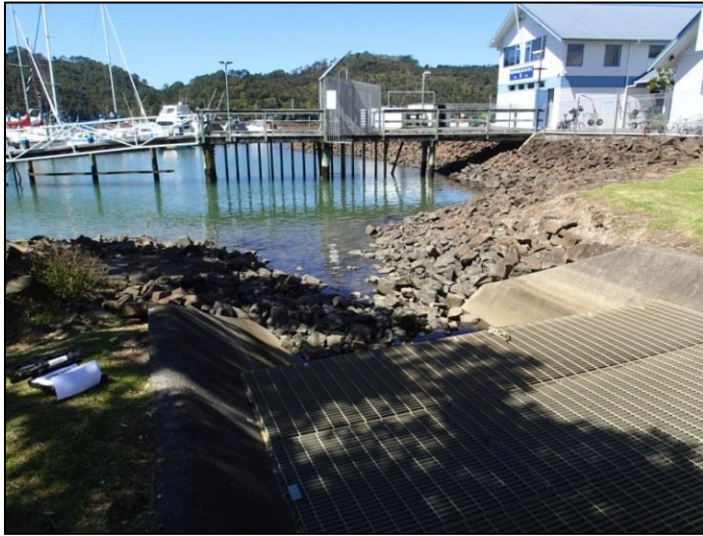
Photo 8. Site 8: Marina hardstand, Whitianga.

woody debris was present. Shrimp *Paratya curvirostris*, yellow eye mullet and cockabullies were seen at the site. Other organisms included little black mussels, topshell *Nerita melanotragus*, mudflat topshell *Diloma subrostrata*, sea slug *Onchidella nigricans*, barnacle *Austrominius modestus*, and oysters *Crassostrea glomerata*.

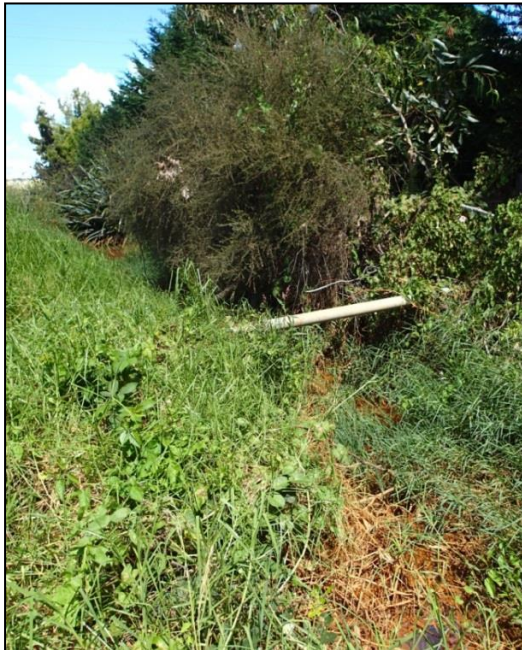
Photo 9. Site 9: Moewai Rd, Whitianga.

The outlet at Moewai Rd flows into a freshwater stream. Dense grass and *Convolvulus* covered the banks, and other plants on the riparian margins included blackberry, pine, flax, tutu and *Juncus* sp. The stream bed was completely covered in coarse woody debris and iron floc, a byproduct of iron-metabolising bacteria that is not harmful to stream fauna. Fauna present included the highly abundant mud snail *Potamopyrgus antipodarum*, cockle *Austrovenus stutchburyi*, mollusc Sphaeriidae, true fly Tanytarsini and seed shrimp Ostracoda.

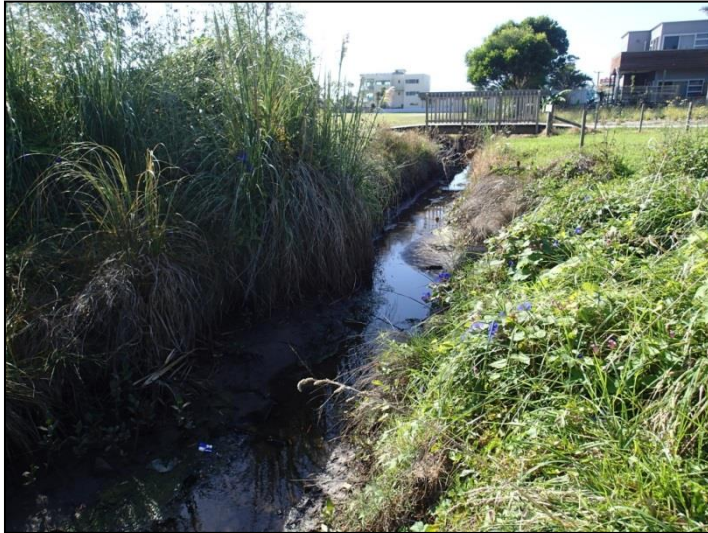
Photo 10. Site 10: Casement Rd, Whangamata.

At Casement Rd, the storm water outlet flows into a channel which then flows into the harbour. Near the harbour, the substrate was sandy and several rushes were present. No flow was present; the water in the drain was stagnant at the time of sampling. Woody debris covered approximately 30% of the substrate, and several mangrove seedlings were present. Several crab burrows and mudflat snails *Amphibola crenata* were present. Fauna present included the highly abundant mud snail *Potamopyrgus antipodarum*, true fly Muscidae, shrimp *Paratya curvirostris* and crustaceans Ostracoda and Amphipoda.

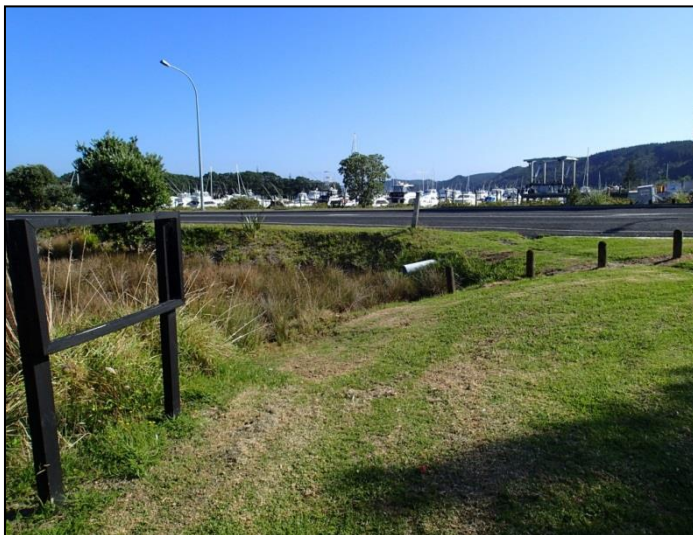
Photo 11. Site 11: Hetherington Rd, Whangamata.

The outlet at Hetherington Rd is a pipe that runs directly into the harbour. The sediment surrounding the outlet was densely vegetated with *Juncus* sp. The site was completely dry at the time of sampling with no water flowing from the storm water network. Mudflat snails *Amphibola crenata* and whelks *Cominella glandiformis* were present.

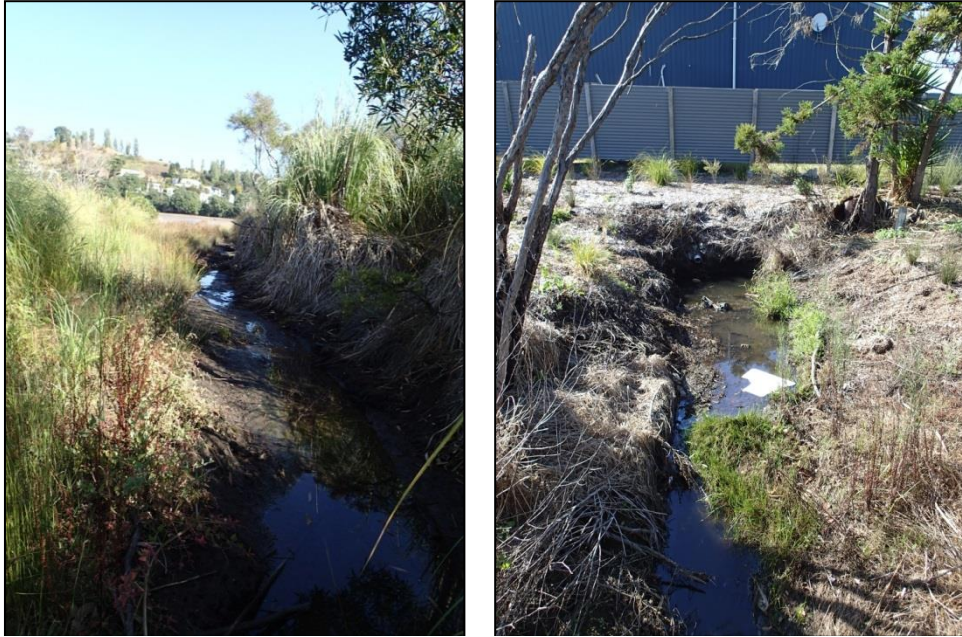
Photo 12. Site 12: Aicken Rd, Whangamata.

Similar to Site 10, the Aicken Rd storm water outlet flows into a channel which then flows into the harbour. No water was flowing at the time of sampling and an oily film was present on the water's surface. Litter was present in the drain. Leafy debris covered approximately 25% of the channel, and the substrate was soft and muddy.

Near the harbour, the channel was lined with rushes and pampas grass, with occasional manuka trees. The substrate was soft and muddy, with woody debris covering approximately 10% of the channel. Fauna present included the mud snail *Potamopyrgus antipodarum*, mud crab *Helice crassa*, true fly Ephydriidae and oligochaete worms. No aquatic plants were present within the channel.

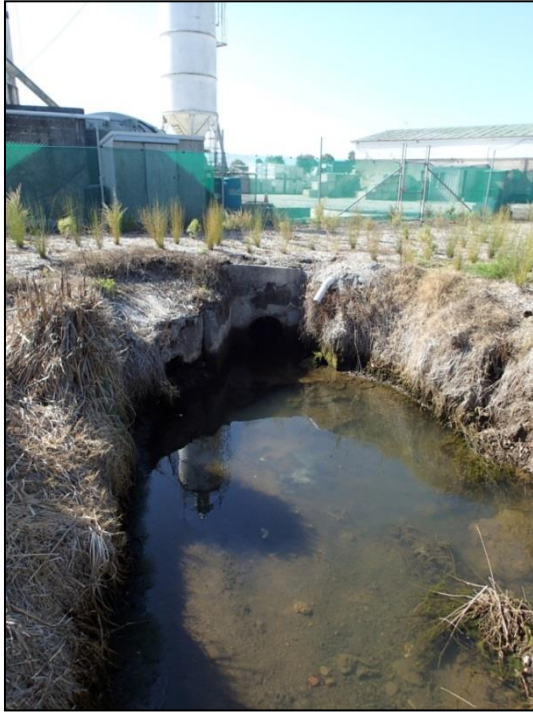
Photo 13. Site 13: Lindsay Rd, Whangamata.

Similar to Sites 10 and 12, the Lindsay Rd storm water outlet flows into a channel which then flows into the harbour. No water was flowing at the time of sampling. The outlet flows into a large pool with a maximum depth of 0.8 m at the time of sampling. The substrate was rocky with a covering of fine sediment. An oily film was present on the surface of the water. Fine filamentous green algae and shrimp *Paratya* were seen. Fauna present included the snails *Potamopyrgus antipodarum* and *Physa acuta*.

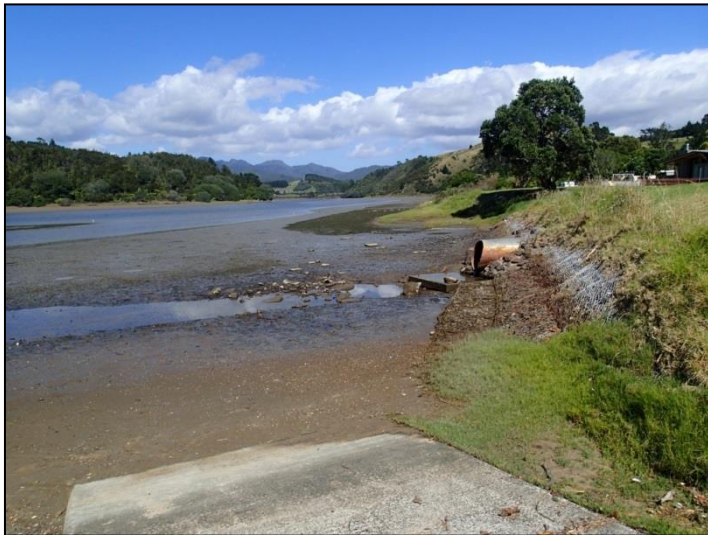
Photo 14. Site 14: Kotuku St, Whangamata.

This outlet flows into a raised concrete pond before flowing into the estuary. Flow from the outlet was very low at the time of sampling. Substrate was made up of concrete blocks covered in sand. Organisms included topshell *Nerita melanotragus*, mudflat topshell *Diloma subrostrata*, barnacle *Austrominius modestus*, oysters *Crassostrea glomerata*, cockle *Austrovenus stutchburyi*, whelk *Cominella glandiformis*, amphipod, pipi *Paphies australis*, limpet and shrimp *Paratya*. No aquatic plants or algae were present at the outlet.

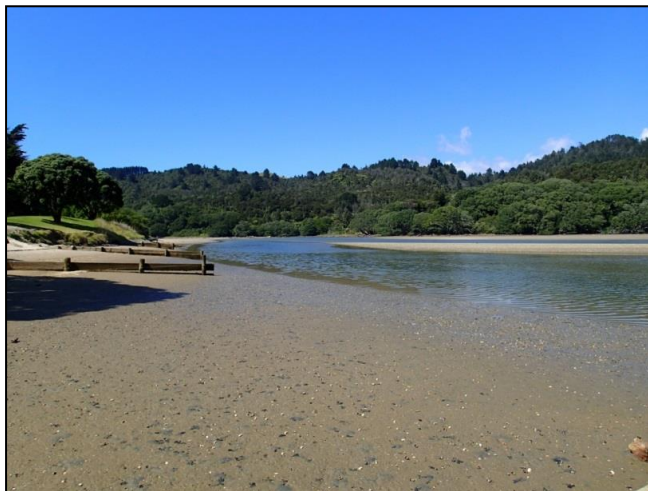
Photo 15. Site 15: Otahu Estuary, Whangamata.

Site 15 is the estuary control site, with no storm water outlet present. The substrate at this site was sandy. Fauna present included cockle *Austrovenus stutchburyi*, whelk *Cominella glandiformis*, amphipod, pipi *Paphies australis*, mudflat topshell *Diloma subrostrata* and shrimp *Paratya*. No aquatic plants or algae were present.
