Folder [Drybasin progress report 20240701]

Report on first rain event during construction of Drybasin

This is an initial report following the first reasonable rainfall event after the weir pipe has been installed at Williamson.

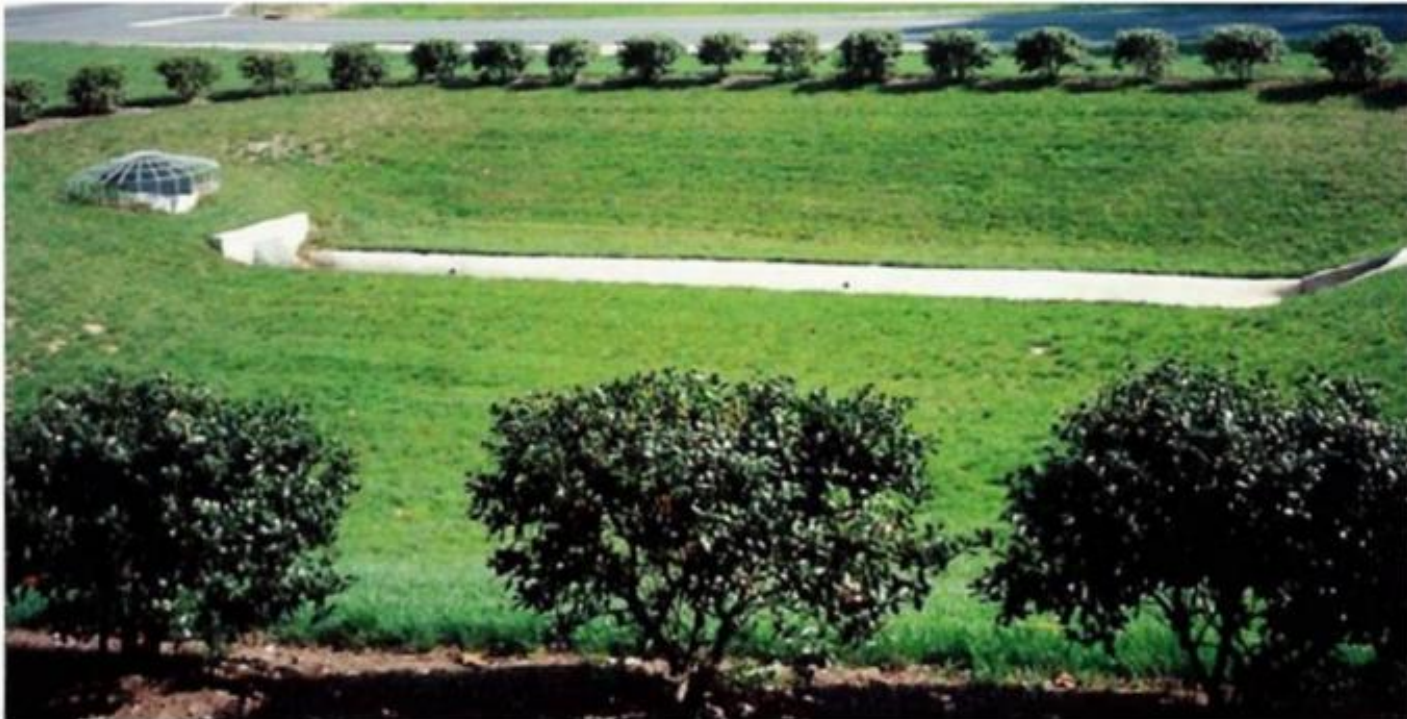
[010 drybasin example.jpg](#)

Example of clean, neat and easily accessible to maintain dry basin. Mowers can reach down to the spillway.

When fall between discharge and outlet is less than 1:20 gradient the ground will turn to mush so concrete is required.

At Williamson it has a lot of bikes and walkers so the spillway needs to be shallow formation as kids will want to ride through it.

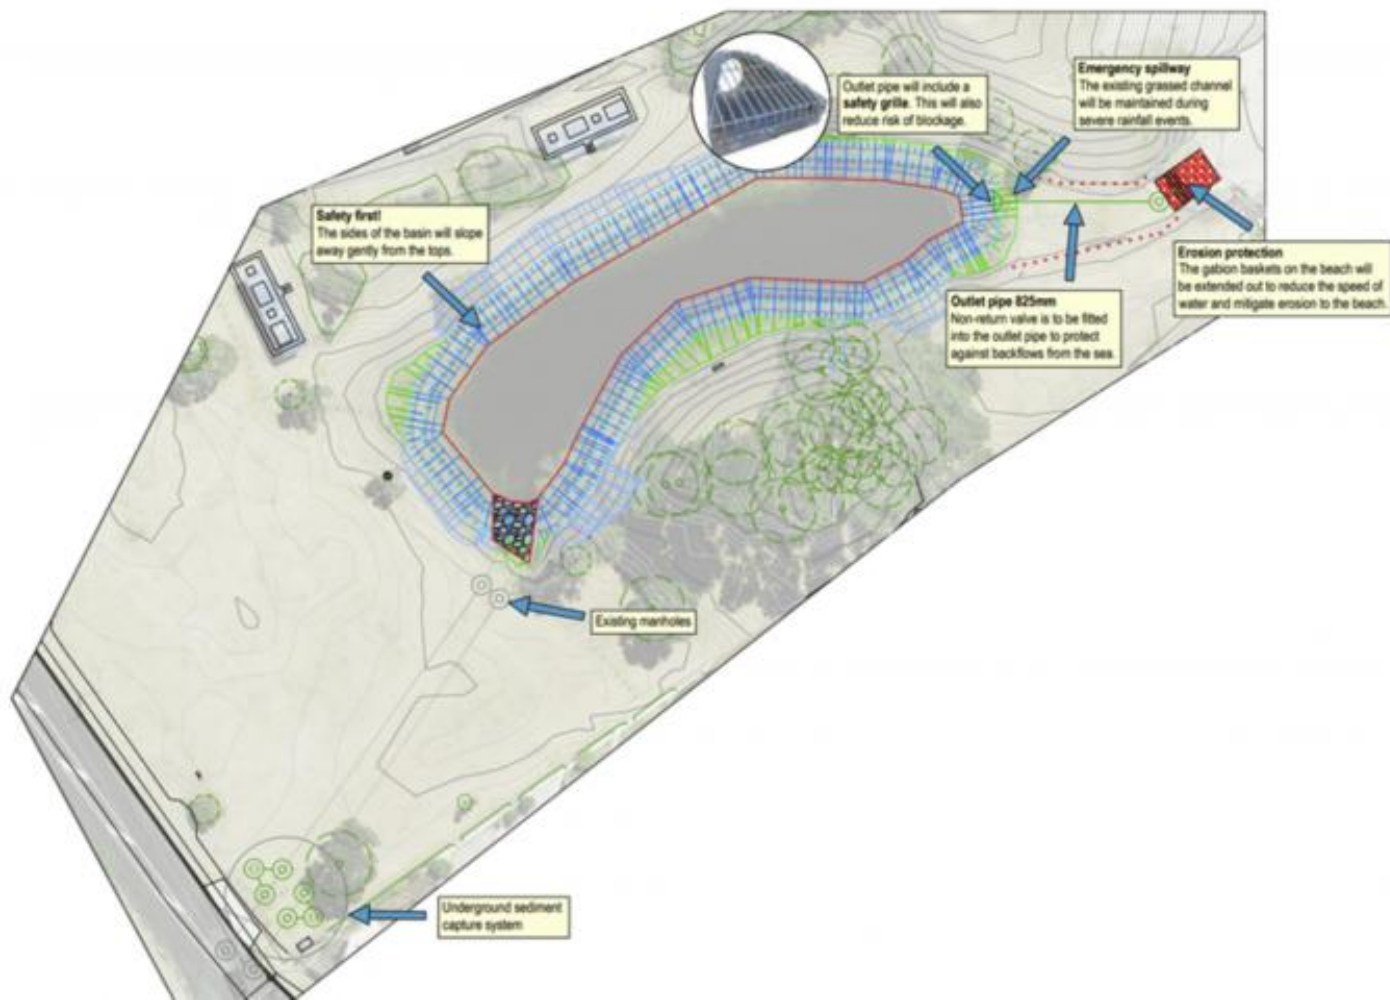
020 Existing plan of proposed drybasin.jpg

Plan as provided.

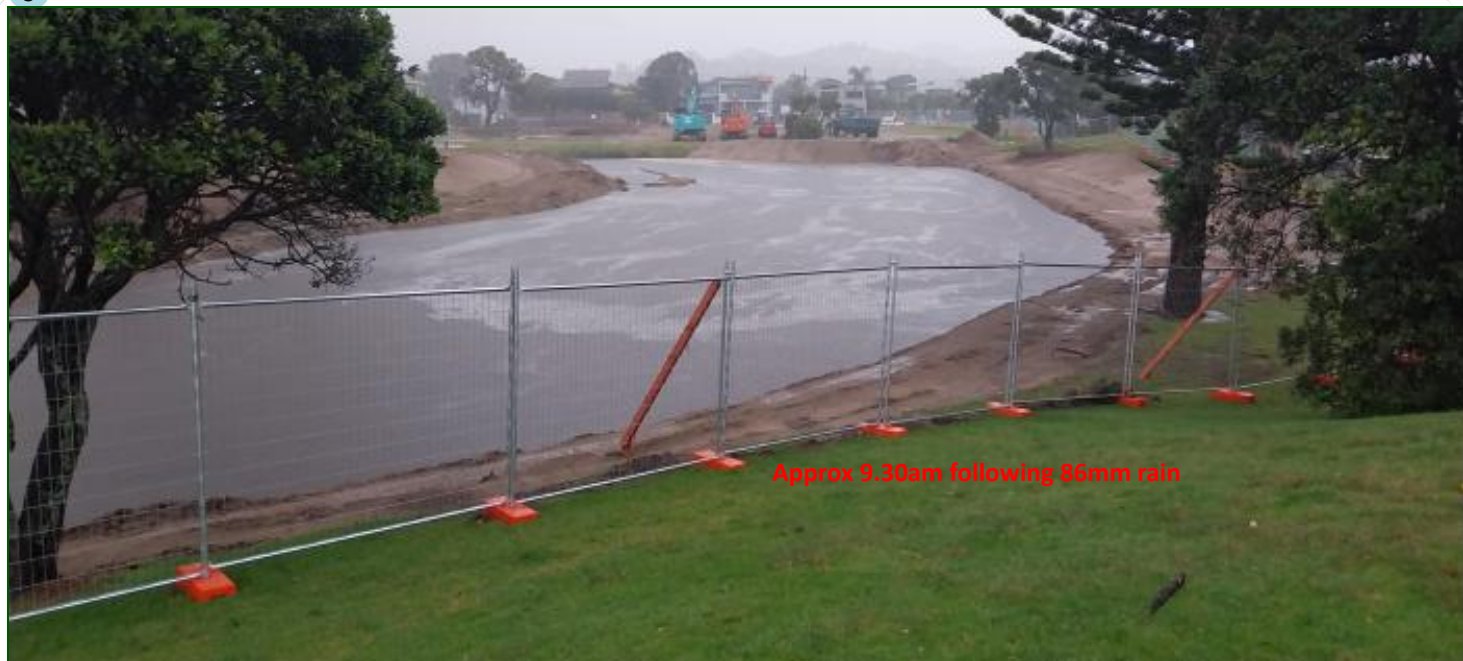
20240623_082922.jpg

Sunday 23 June 2024 rain event showing basin up to soffit of discharge pipe in background.

The water level was slightly higher earlier in the morning see wet sand level around the sides.

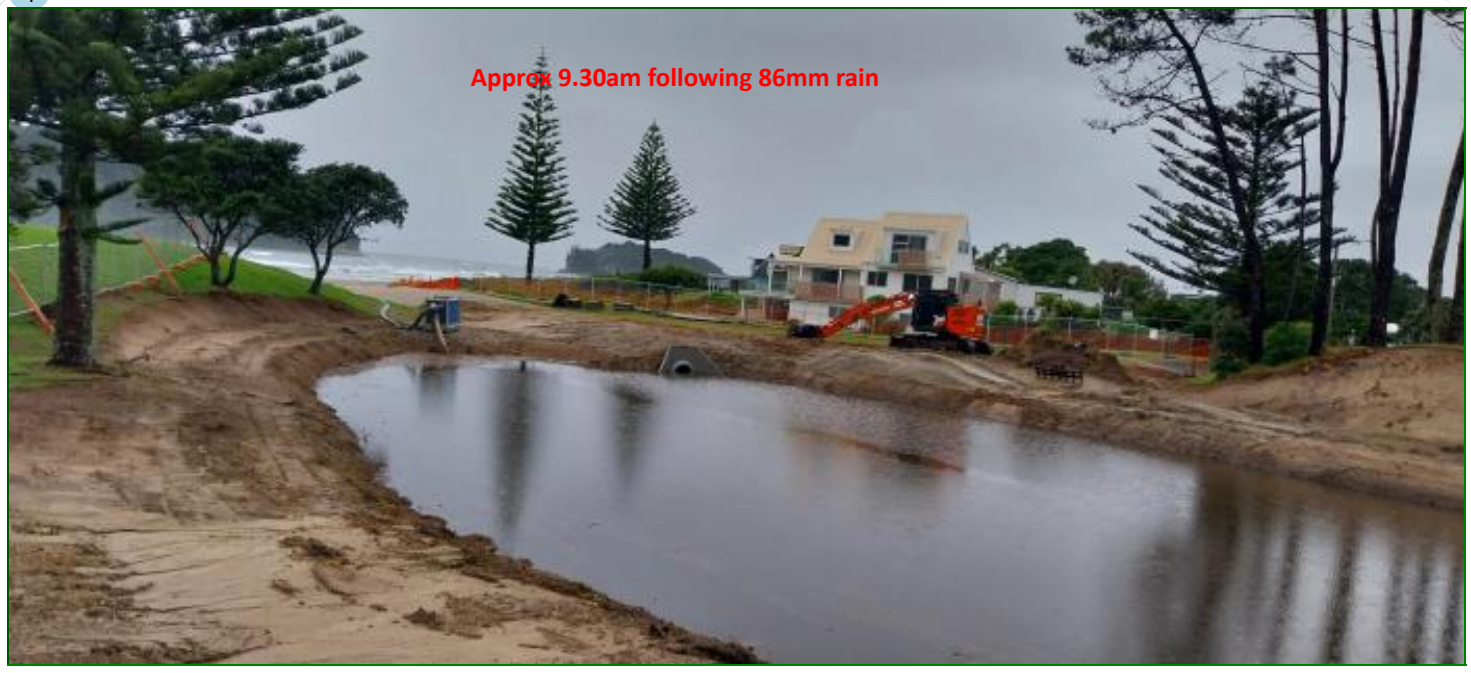
20240623_092923.jpg

Water level at outlet to weir. Water level did reach higher and had started running into the sand swale but did not appear to have over topped the weir.

This would confirm the discharge pipe is correctly sized - and it would not matter if water did rise and over top the weir. The surrounding properties are above the weir Rml

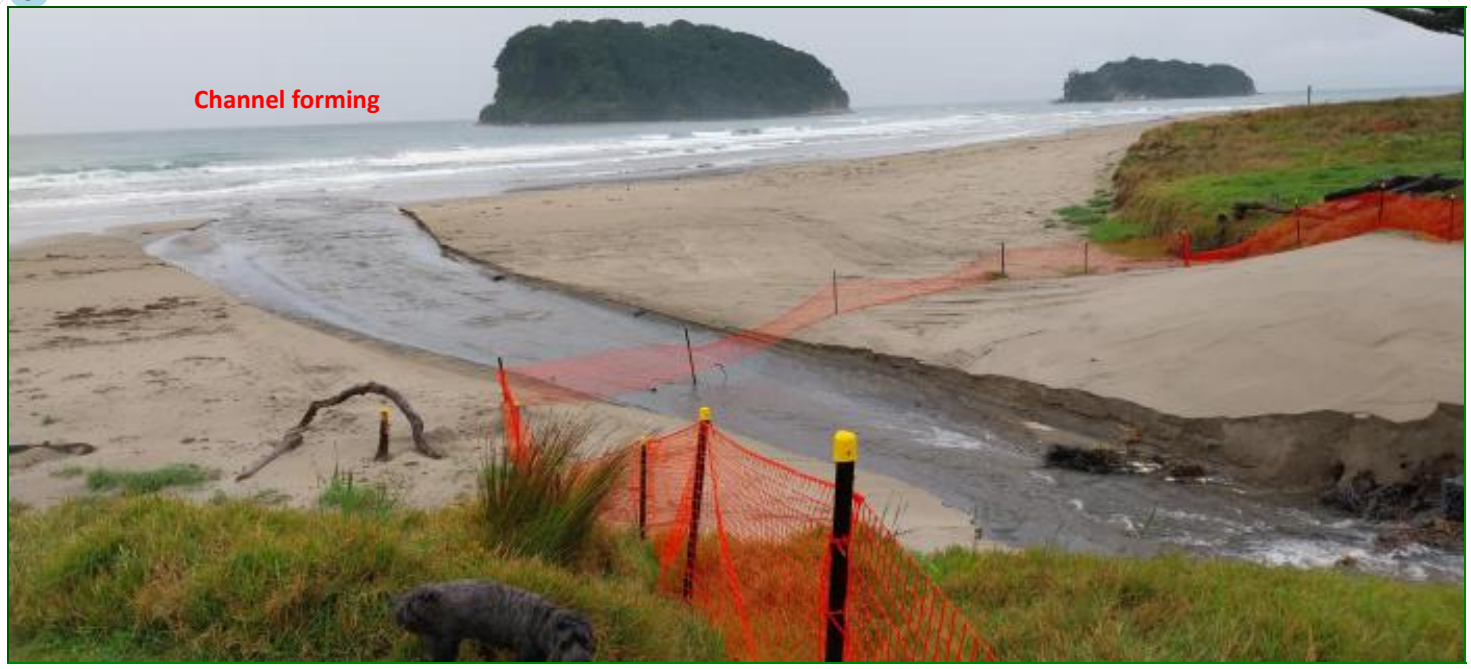
20240623_093023.jpg

23 June 2024 channel formed in sand.

Had washed away sides of swale - now has some rocks at the end of the new baskets.

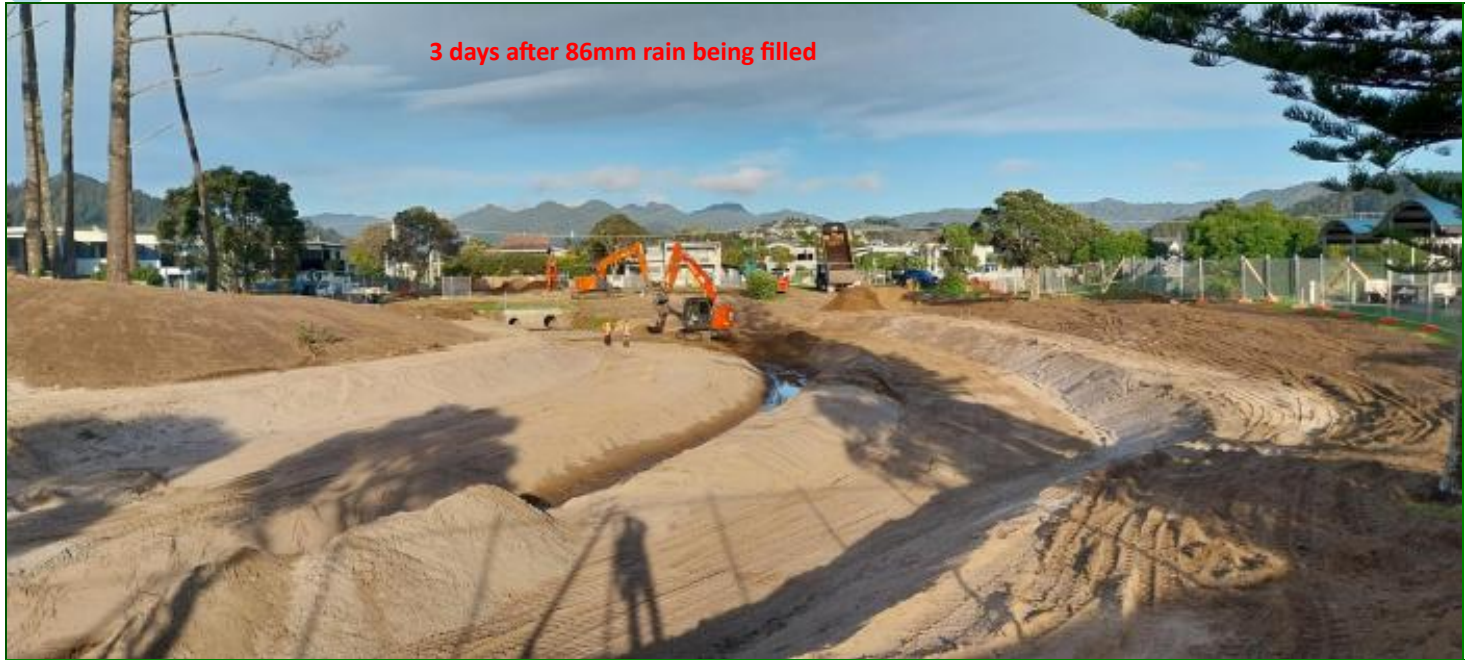
20240626_085431.jpg

On 26 June 2024 3 days after the rain the central basin now being filled.

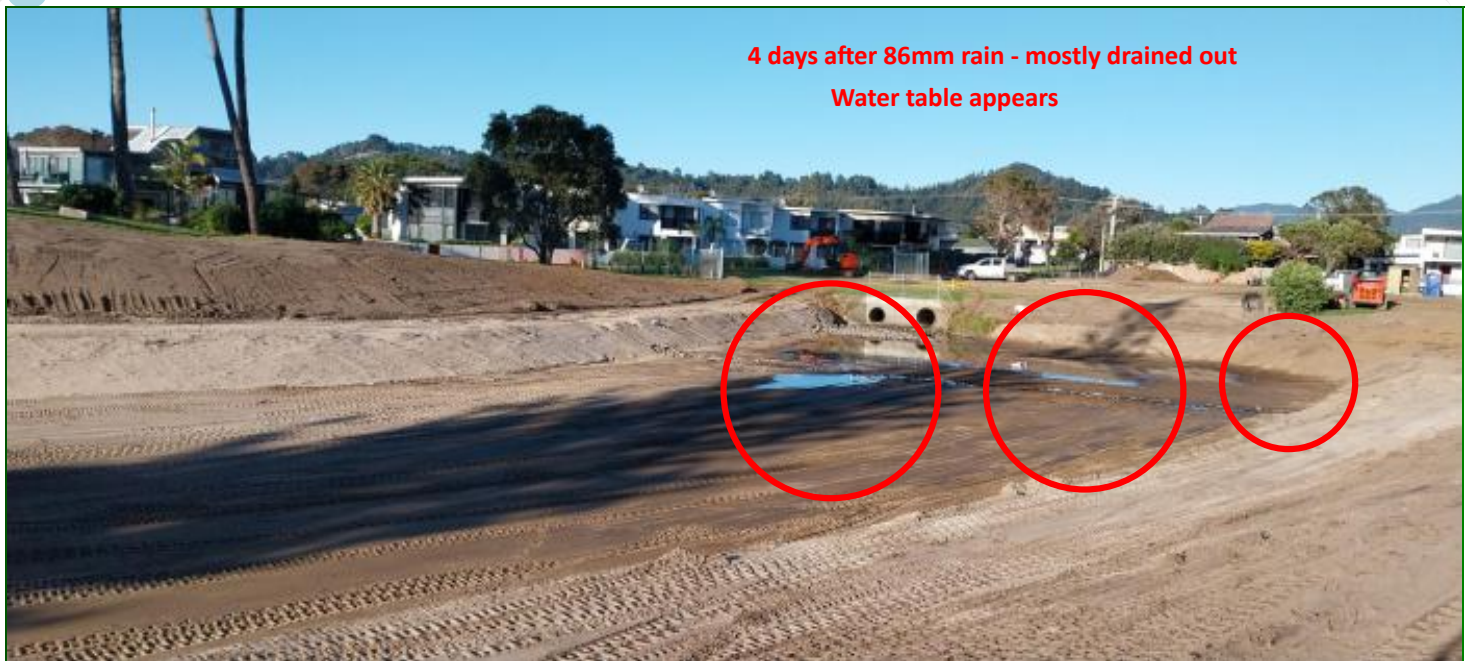
20240627_091127.jpg

27 June 2024 basin filled about level from discharge pipe to weir outlet.

Water table now breaching the fill in places.

NB: Water table would have risen as a result of the 86mm rainfall - but initially rain is absorbed by the surface sand and eventually after a day or so by gravity descends into the water table thus rising it.

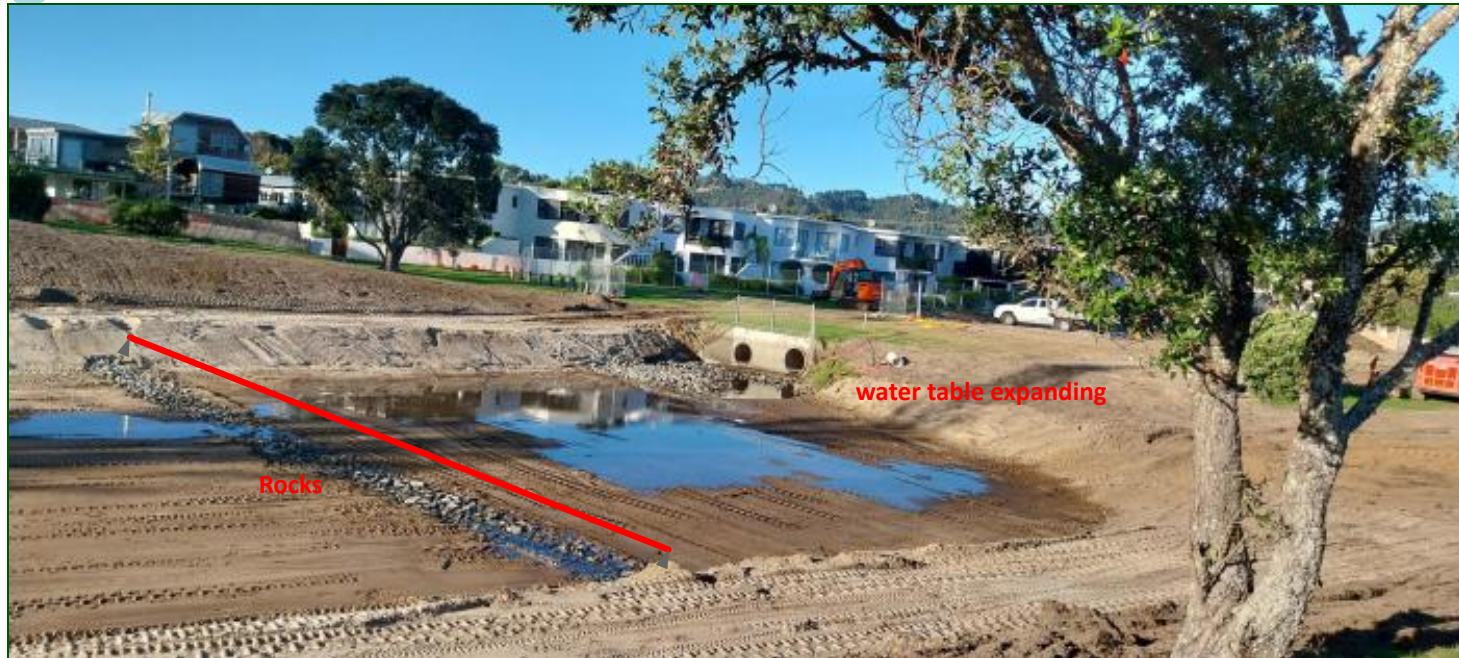
20240627_091304.jpg

A row of rocks has been laid across the basin.

What is the purpose of this - the sand will still be compacting as the water table fully wets it so more sand will be needed to lift the basin - so are these rocks part of a method to drain the surrounding water table. If so they will be below the concrete spillway so too deep to work.

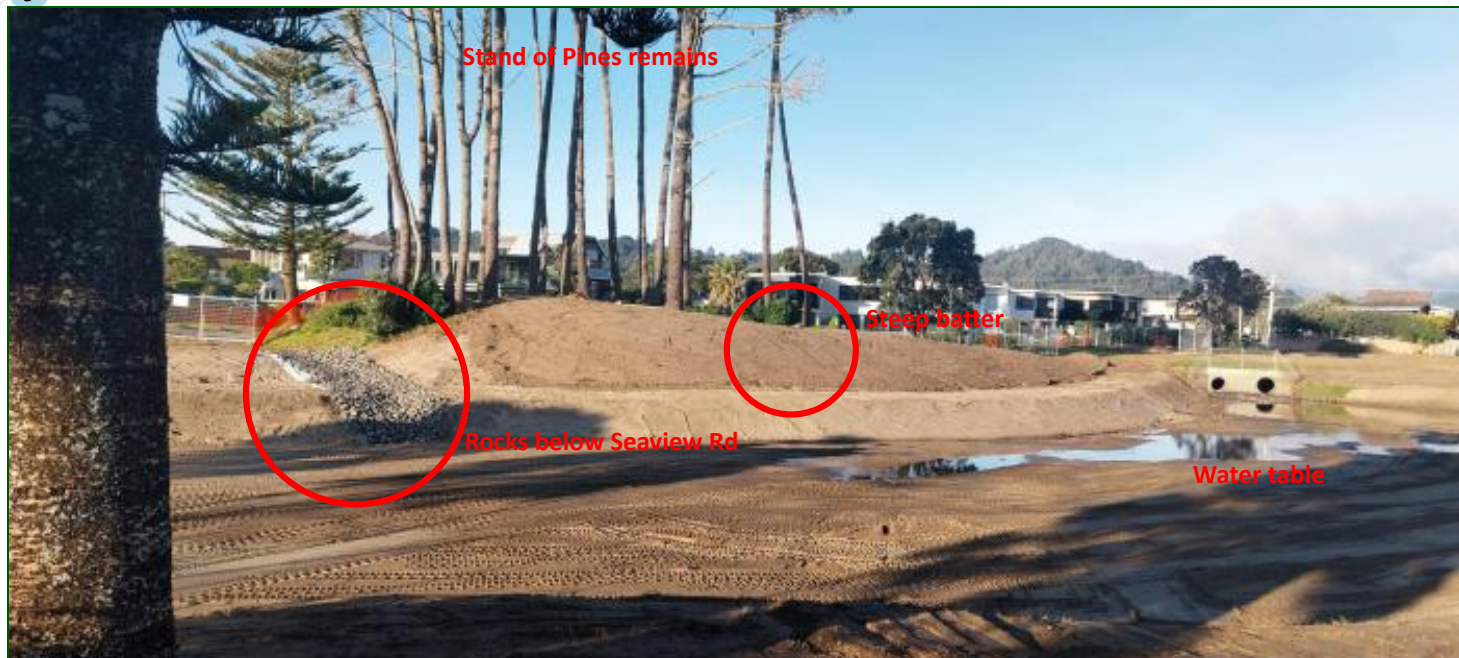
20240630_084922.jpg

Rocks have been laid to the bank down from the swale at the end of Seaview. What is the purpose of this? Seaview rarely has the overland flow path and rocks will be difficult to maintain and mow around. The swale was cut after Gabrielle and has not eroded since then.

The stand of Pines remains - these were to be removed whilst the big machinery was on site and whilst the grass was being damaged.

A steep batter has been formed. This will be difficult to mow.

The water table continues to breach as at 30 June 2024 now quite extensive.

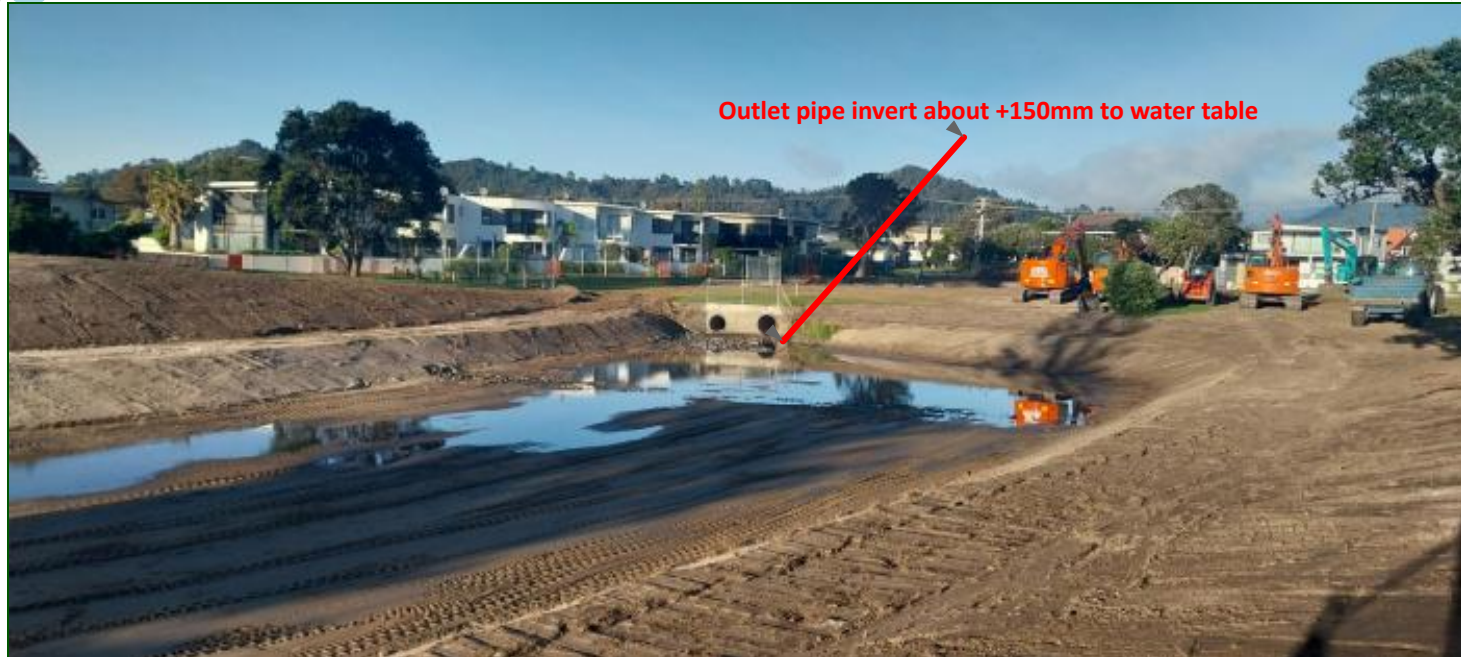
20240630_085017.jpg

Water table extending 30 June 2024.

NB: seepage through the batter around the edges.

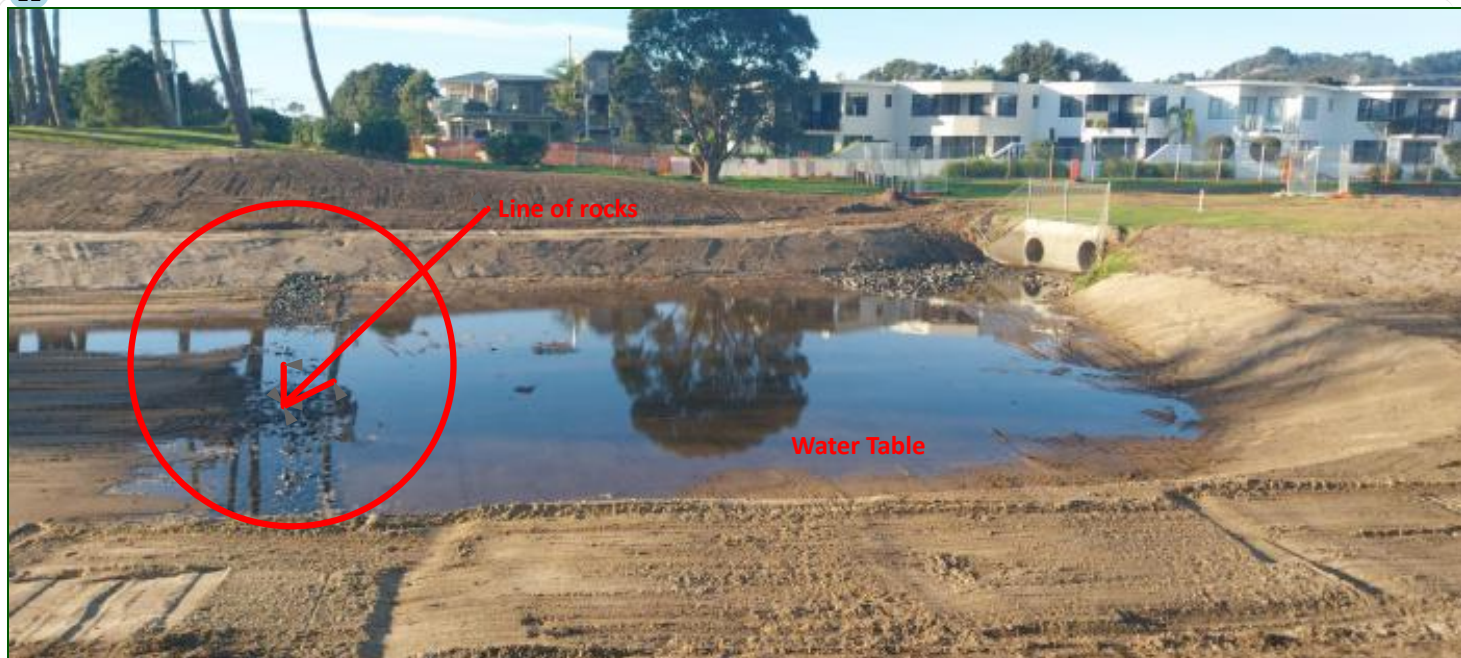
20240630_085241_001.jpg

Water table now above the line of rocks.

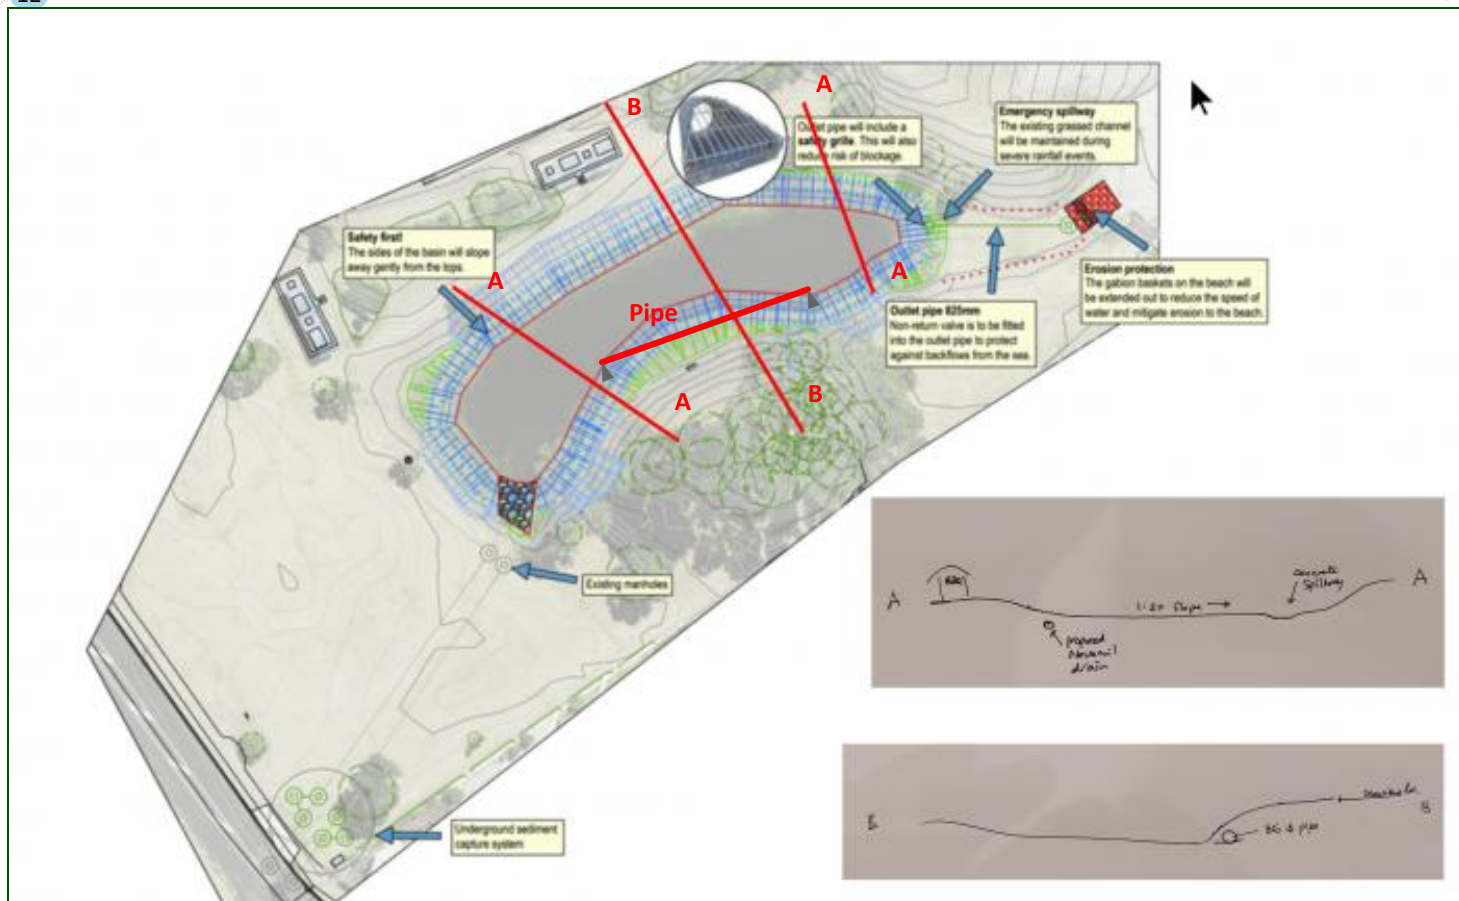
20240630_088000.jpg

Original drawing of proposed Drybasin.

It would be my preference to:

1. Lay a pipe along the line through the mound by the Pines. See cross section B-B. This pipe could be minimal fall to allow more fall on the concrete spillway.
2. Lay an open concrete spillway between the discharge pipe to the pipe and from the pipe to the outlet pipe. This to have minor shaped sides so kids could bike through it when dry.

Noted: the discharge of road storm water ceases within a few hours of rain stopping - so the concrete spillway would predominantly be dry.

This will allow access across from Seaview and reduce the extent of the open spillway.

Removal of Pines will reduce further cleaning up as these fall over

Clearing the mound will allow room to plant Natives.

In flood the central pipe won't cope so water will fill the basin by bypassing the pipe - the basin would be sloped 1:20 across so after rain stops water would drain away either to the weir end or the Ocean Rd end - doesn't matter.
