## Folder [110 Kiwi Road flooding - problem and solutions]

### Interim Review of 110 Kiwi Rd Flooding

Ian Holyoake. 23 November 2023

This report is focusing on flooding at 110 Kiwi Rd. Thee problem and some solutions. It is an interim report because I am waiting on LGOIMA responses, responses to the Kiwi Rd petition, response to the letter to the Mayor and our stakeholders workshop debate.

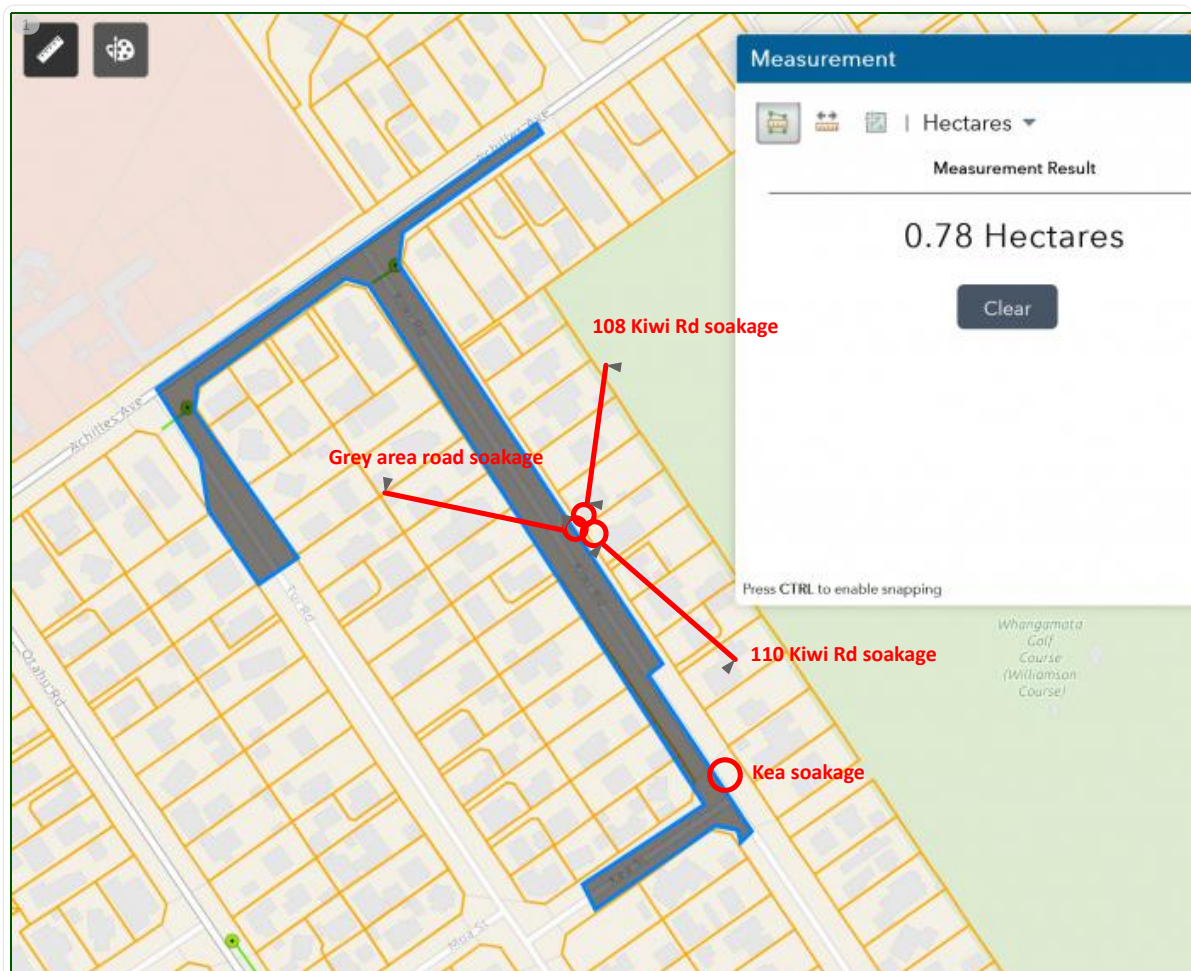
100 Catchment area and soakage device locations..jpg

What was witnessed on 19 November 2023 in the light rains was rainwater from all the grey catchment area was flowing to Kiwi Rd to be dealt with by the 108 Kiwi Rd soakage device and as it became overwhelmed down to Kea Street soakage device.

This could equate to 7800sqm catchment. I accept verges get calculated at lower rates. The catchment area does not include driveway run off to the roads. The catchment area does not take into account greater flooding or the Achilles pedestrian crossings getting blocked by the swimming pool.

The 7800sqm catchment is possible because the road has been formed almost level with little fall. Kea Street appears to be slightly lower than 108 Kiwi Rd. Tui is higher than Achilles and Kiwi. Water feeds in from higher ground which is difficult to test until 100-200mm of water is ponding and running to the lowest point.

A temporary solution is to add at least 6 more soakage devices enroute from Tui to the Kiwi Rd soakage devices between 108 and 110 Kiwi Rd and from Tui back to Kea Street to break up the catchment area into smaller areas that soakage devices can manage. Note: This only assists when the water table remains low and the rainfall is below 746mm over a 4 month period.

To reduce the likelihood of floors flooding an above ground stormwater pipe could be installed from the Kiwi RD road cesspit outside 108 Kiwi Rd to discharge onto the Golf Course land. This would act as a temporary overland flow path at peak load.

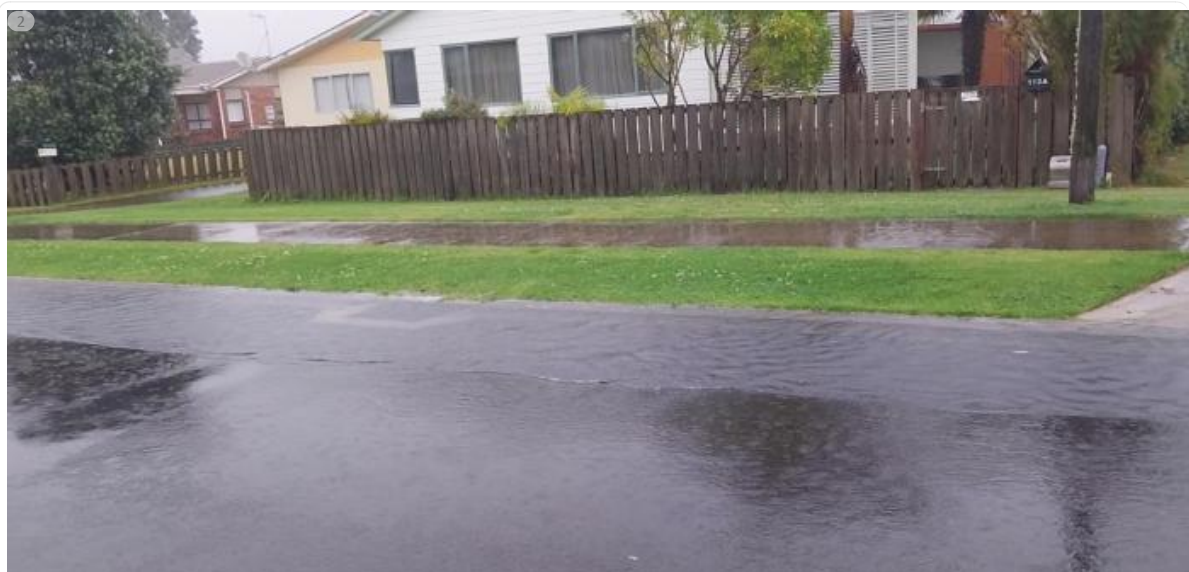
105 20231119.jpg

Cesspit opposite 108 and 110 Kiwi Rd overwhelmed on 19 November 2023 then flows to the Kea Street cesspit. Some of the water originates from Tui Rd. The Kea Street soakage devices were immediately overwhelmed which causes stormwater to back up, rise and trespass.

Noted the other side of the road kerb and channel was not as full with water as the crown at this stage is preventing water breaching across.

The cesspit outside 108 Kiwi Rd was full - this will be because of the pipe connection from the flooded cesspit.

No solution will be found for Kiwi without dealing with Tui and repositioning the soakage device away from low lying land.

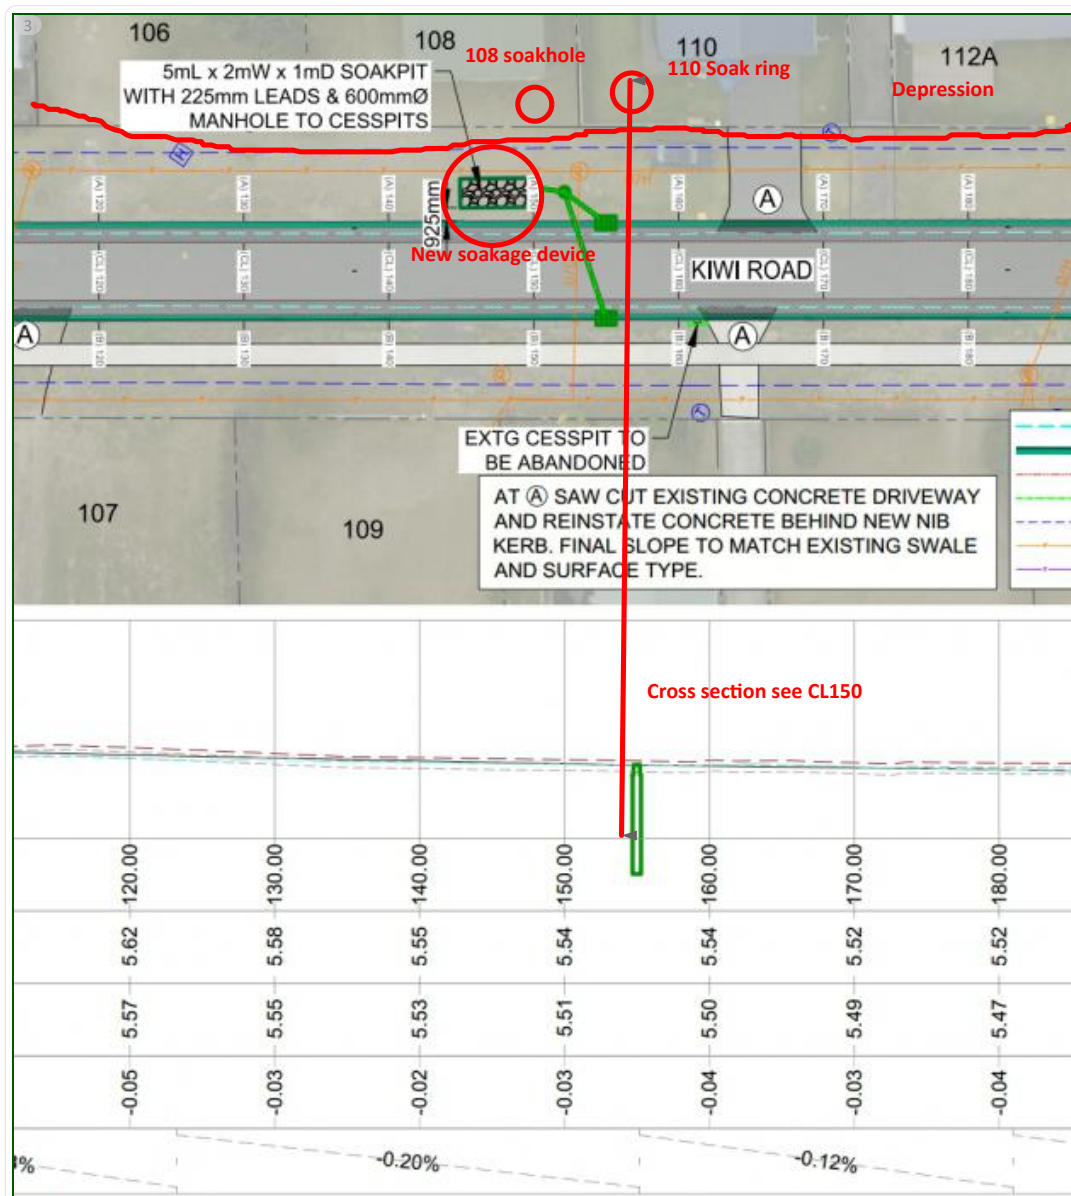
200 Plan at 110 Kiwi Rd.jpg

Pinnacle Plan detail at 110 Kiwi Rd between CL140 and CL150

Soakpit is in front of 108 Kiwi Rd

Plan does not have LIDAR contours - freehand line is approx edge of depression - noted 110 Kiwi Rd is below 108 Kiwi Rd.

There was an existing cesspit on opposite side of road which was abandoned. This will be the original low ground.

Looking at levels it seems the ground is pretty level making drainage to single points means water becomes deep and can breach the nib kerb and flood properties enroute to the soakage device.

No inspection hatch for maintenance found

No reason why Kiwi Rd soakage device was constructed at this particular location.

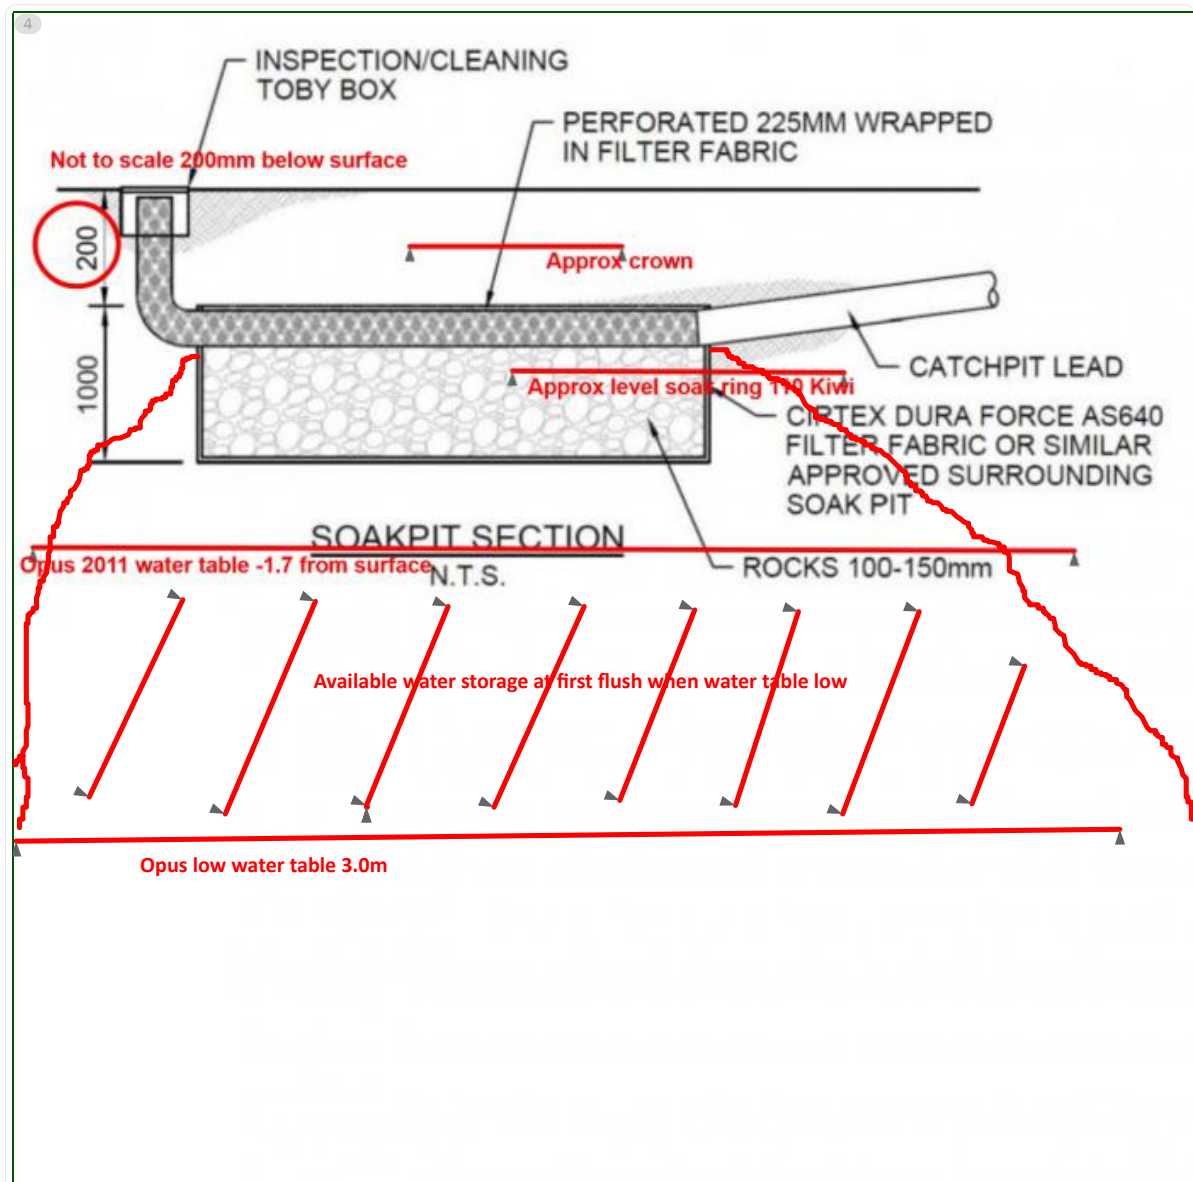
20231120\_213743\_SC\_.jpg

On the lead up to Hale we had a dry end of year so the water table could have been 3.0M below the surface (Opus Bore 3).

At Cyclone Hale first flush the area below the soakage device was capable of storing surface water entering the system. Denoted by area below the soakage device.

As the rain persisted the water table would rise - eg to Opus 1.7M below the surface.

At cyclone Gabrielle the next first flush only has the area above the 1.7M line available for storing surface water.

Whilst lateral filtration/absorption will be occurring, together with hydraulic pressure from the weight of the saturated sand, the water table will crest up below the soakage device.

The top of the Kiwi Rd soakage device is about 300mm above the ground level of 110 Kiwi Rd.

'Breakout' will then occur through the sloping ground onto the surface of the depression within 110 Kiwi Rd.

What compounds the issue is as the soakage devices becomes overwhelmed the stormwater collects as surface water which then drain backs into the cesspit and feeds the breakout onto 110

Kiwi Rd depression.

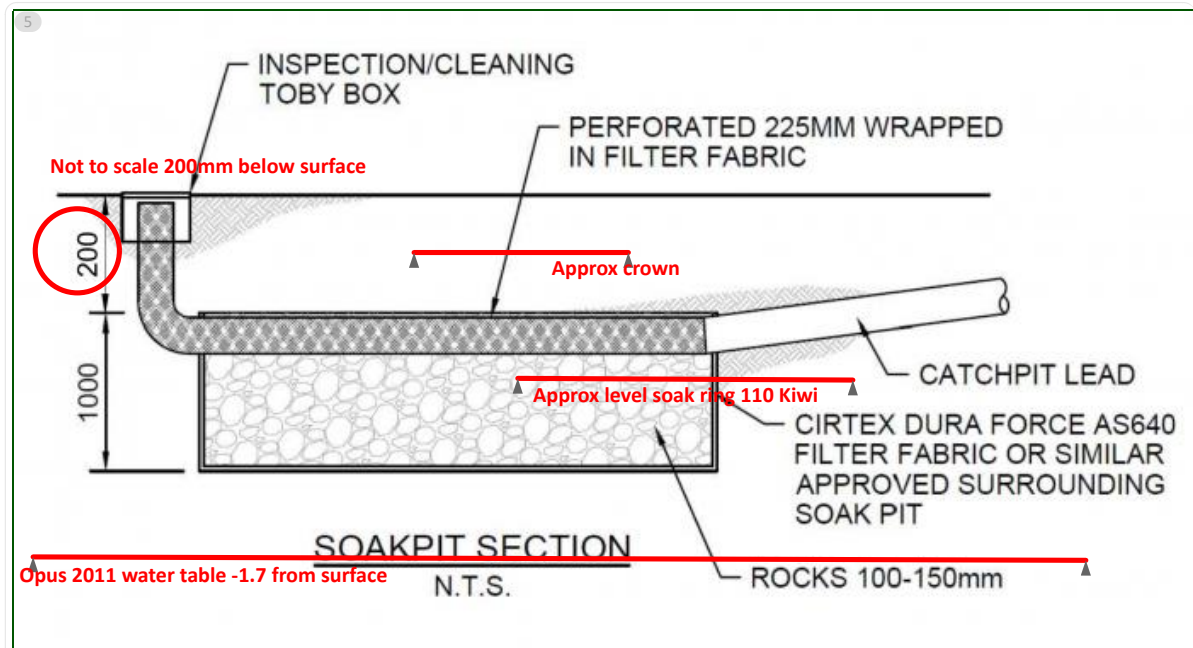
220 Soakage pit Kiwi Rd at CL 150.jpg

#### Cross section of soakpit design

Note shows top of soakpit to be 200mm below ground level - states not to scale as 1000mm deep is out of proportion to the 200mm

Note shows rocks 100-150mm. We believe this is incorrect and substituted to Cirtex plastic crates.

We found a second cesspit along the catchpit lead but not yet found the inspection/cleaning toby box.

The top red line is about the line (to scale of the 200mm) which is above the grate height of the catchpit

The lower red line is the approximate ground level of 110 Kiwi Rd which means the soakage device stores water to above the level of the depression on 110 Kiwi Rd.

That leaves 500mm of sand to store flood water below the soakage device. This is not enough.

110 Kiwi Rd depression is about 500mm below the verge so it would have only 200mm storage. This is not enough for roof discharge.

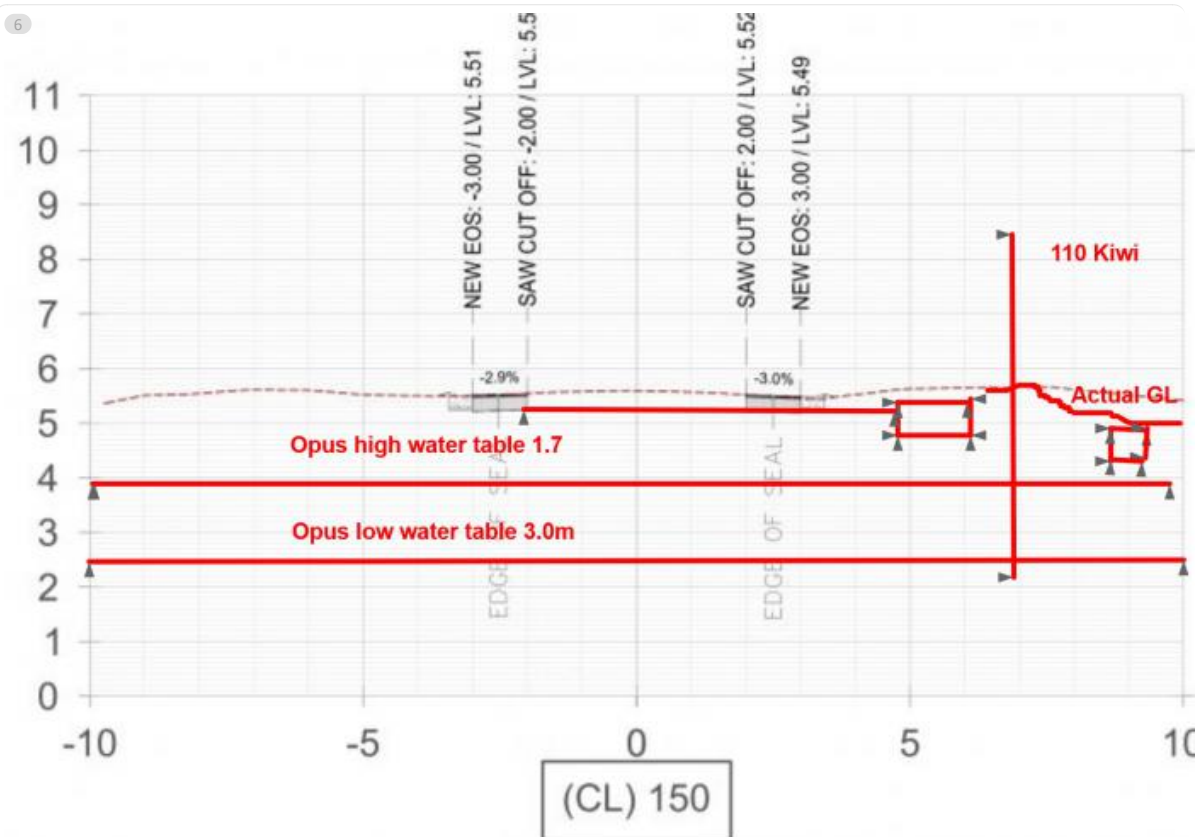
240 Cross section showing water tables and soakage devices.jpg

The road soakage pit design does not meet the TCDC soakage pit design requirements of 500mm above winter water table levels.

Neither does 108 or 110 Kiwi Rd meet this criteria.

There are no soakage test results for any of these 3 soakage devices.

The dotted grey line is NOT correct. The dotted grey line does not follow the actual ground contour of the low lying land along Kiwi Rd starting at 100 Kiwi Rd (and back to Achilles) right down to about 118 Kiwi Rd.

What was viewed on 19 November 2023 is rainwater is marshaled along the nib/channel and into the cesspits as shown. The rainwater almost immediately overwhelmed the soakage device at 108 Kiwi Rd, the rainwater level rises until it banks up back to Achilles and along to the cesspit at Kea St. It took about 10 mins to then overwhelm the Kea St soakage devices. Then water banks up and overflows into the low lying properties along Kiwi Rd.

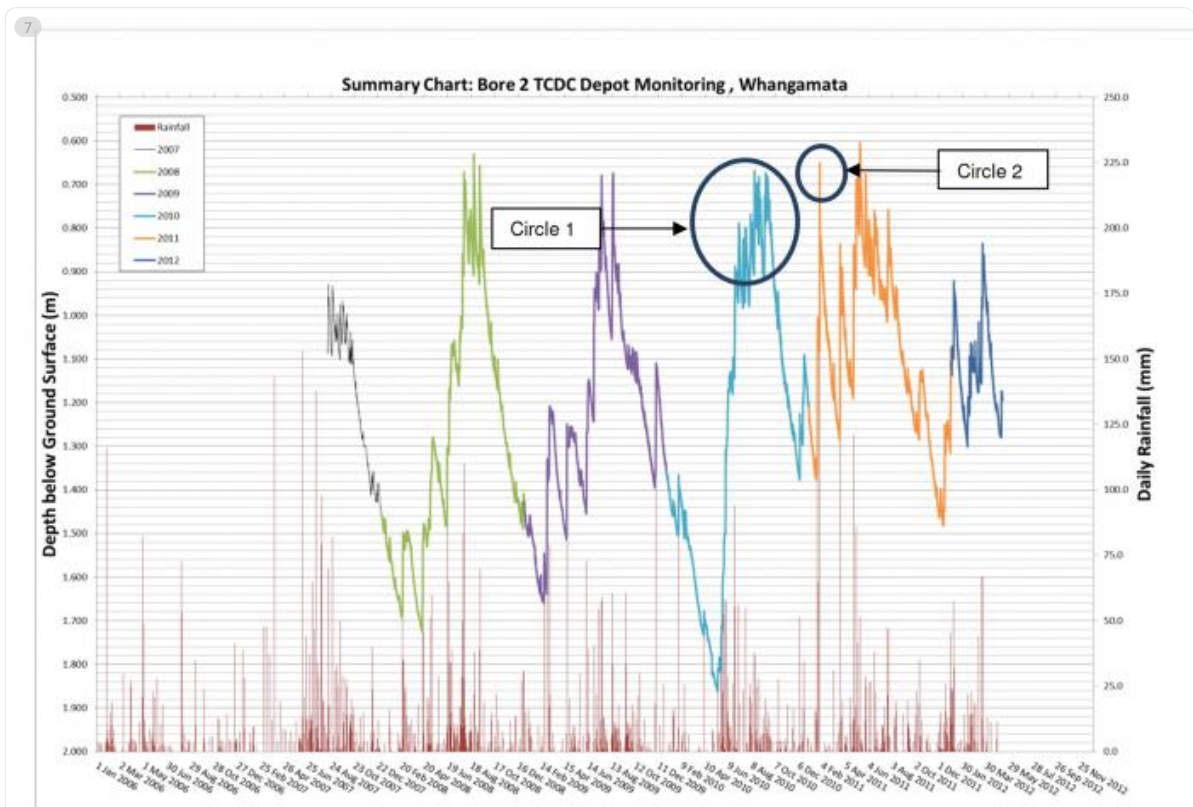
300 Opus charting of rainfall vs water table monitoring 2008-2012.jpg

**Figure 12: An example of a large increase in groundwater level, sustained over 4 months.**

The peak groundwater level highlighted by Circle 2 was influenced by two events occurring in a short period of time with measurements approximately 100 mm and 170mm respectively. While the increase in groundwater level is significant, the corresponding time sustained does not compare with the Circle 1 period which contained significantly smaller, but more, daily rainfall events.

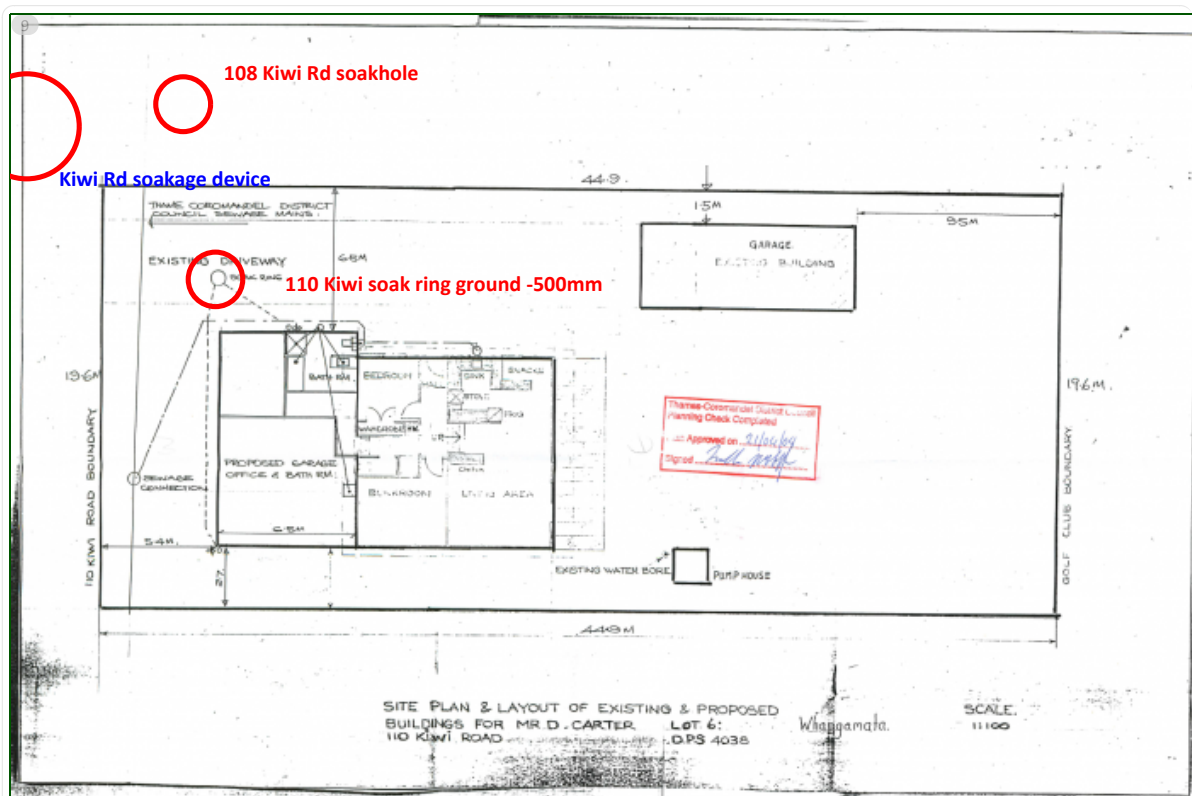
400 showing soakage device location 110 Kiwi Rd domestic dwelling.png

110 Kiwi Rd plans 2004 showing soak ring in front left of property. This is in the 'low' point of the section.

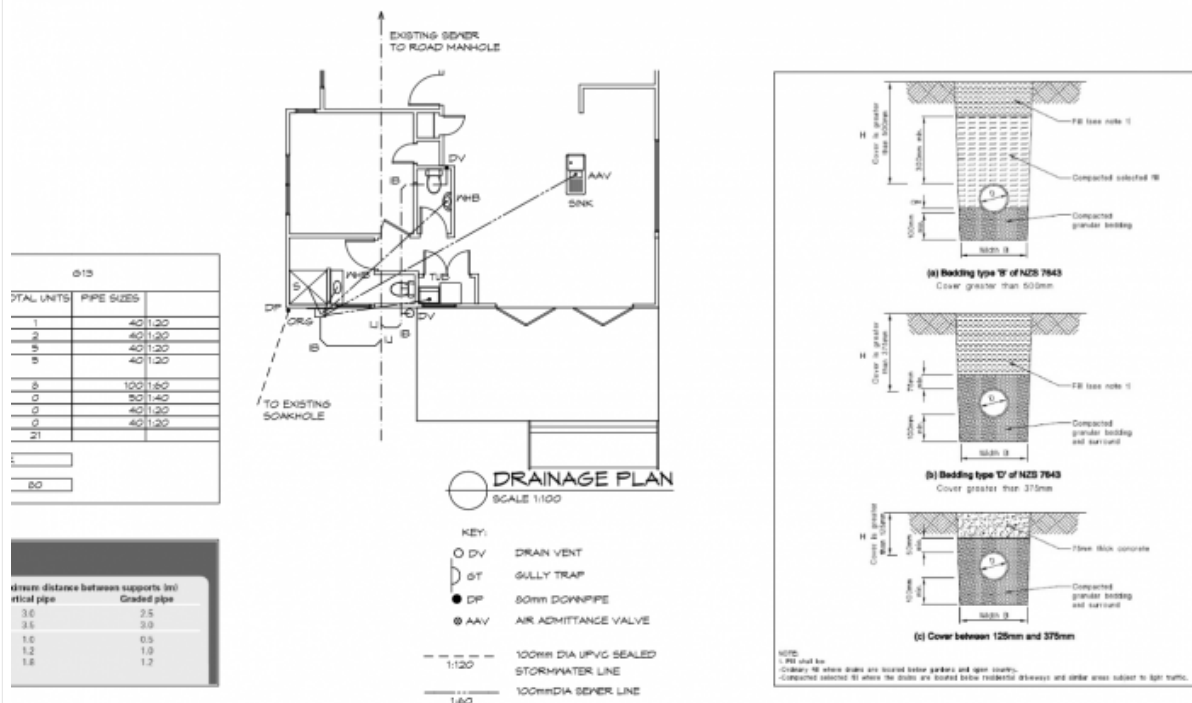
410 Showing 108 Kiwi Rd drainage plan and soakhole.png

108 Kiwi Rd last drawing on property file shows 'existing' soakhole.

It is understood that the owners undertook maintenance about when Kiwi Rd was being upgraded and installed a larger soakage device toward the front right corner of the property.

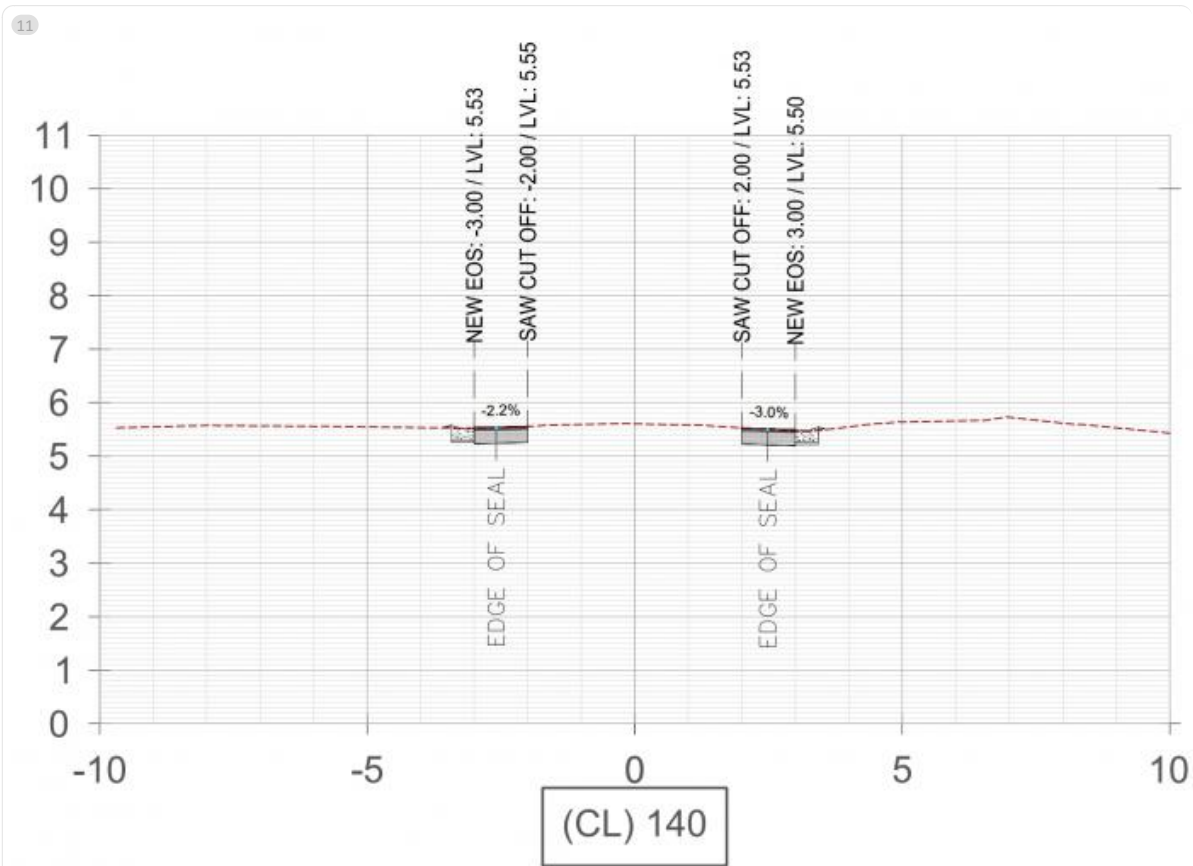
600 CL 140 Kiwi Rd.jpg

Cross section of purported ground line to LVL at CL 140 which is at 108 Kiwi Rd far edge of soakpit.

Note LVL varies 5.53 to 5.55M ie 200mm with the dotted line not falling below the edge of seal and new EOS

Portions of 108 Kiwi Rd property is below the road crown. This cross section is not correct.

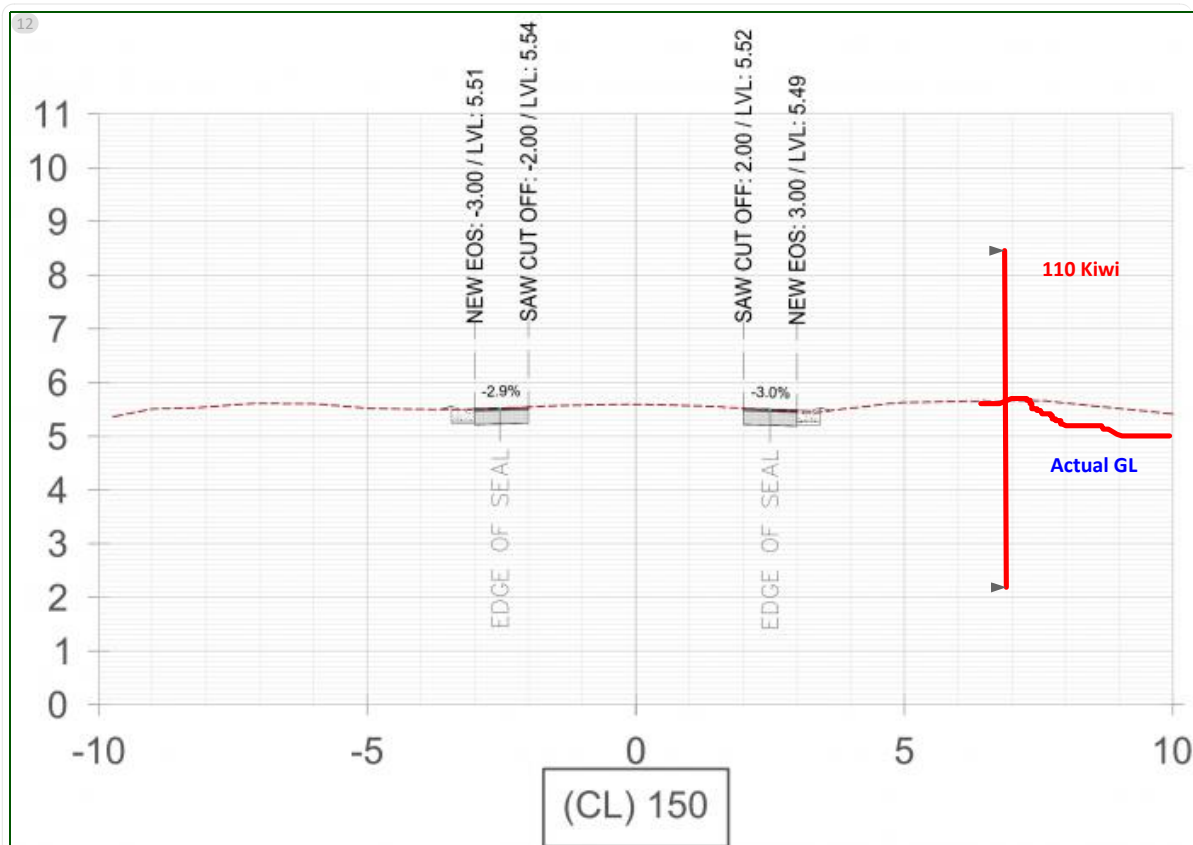
610 CL 150 Kiwi Rd.jpg

Cross section ground level at CL 150 to right of soakpit and near boundary between 108 and 110 Kiwi Rd.

LVL now 5.51 to 5.54M with low point around 100mm at -10M left and dropping - on both sides.

The actual ground level in 110 Kiwi Rd is much lower than the cross section shows.

The box is the new road soakage device

BUT the fact it did will be because of lateral absorption from the road soakage device. As the water table rises the soakage device does not work so water breaks out through into the depression.

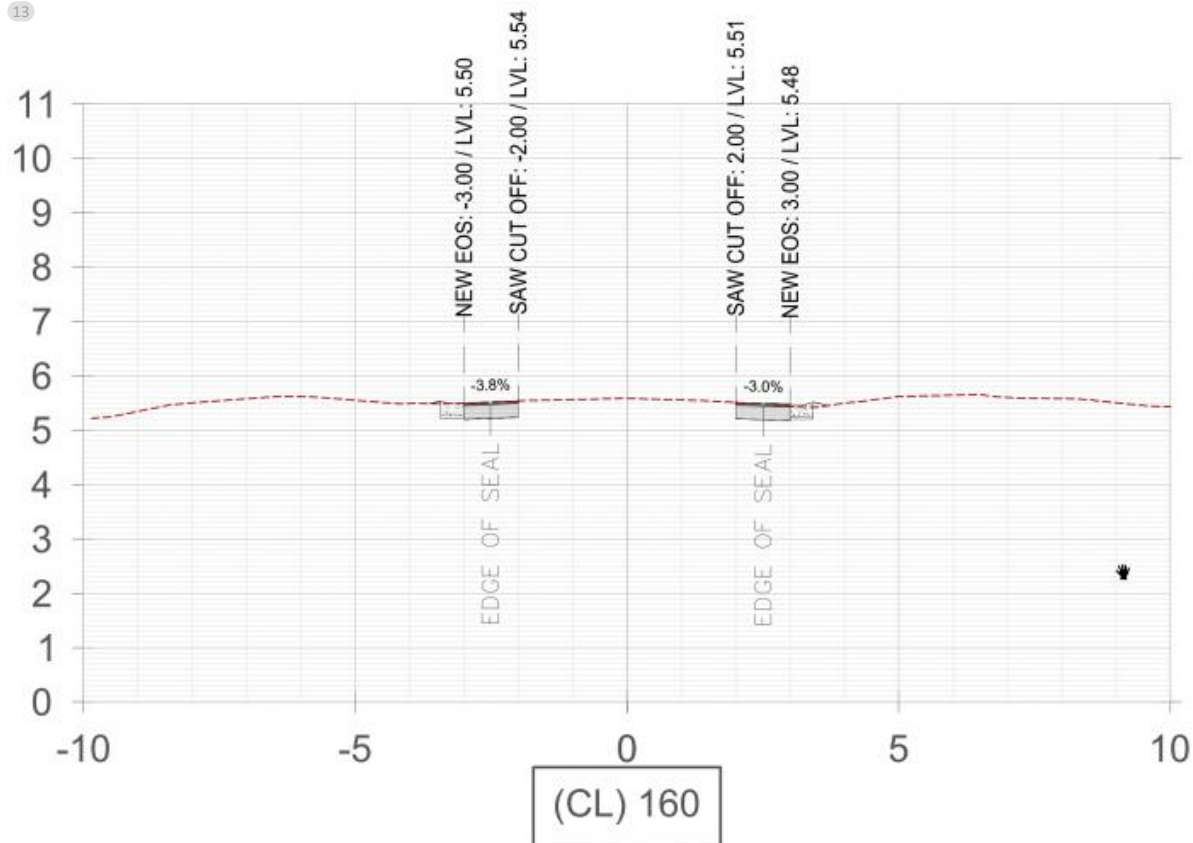
620 CL 160 Kiwi Rd.jpg

Cross section at CL 160 beside driveway into 110 Kiwi Rd.

Noted 110 Kiwi has a depression basin at about -500 to -600mm below crown of road.

The road EOS was overloaded which means the soakpit is full (-200mm) so water soakage into the sand is cresting and flowing through the sand verge and draining into the basin 300-400mm below.

This is likely to mean the overall Whangamata water table may not be the influencer of surface water within 110 Kiwi Rd - because the source is the cresting flow coming from the soakpit which is loaded to +400mm above the basin so drains in.

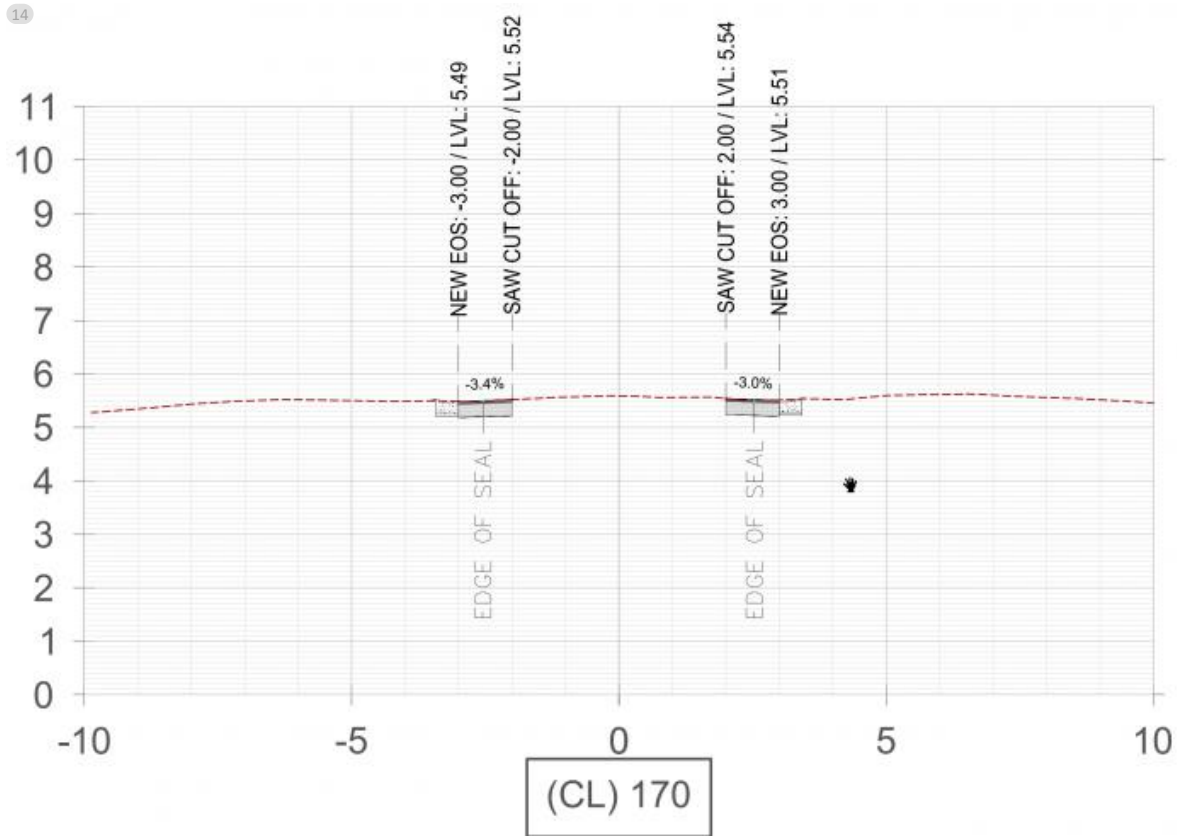
640 CL 170 Kiwi Rd.jpg

Cross section to right of 110 Kiwi Rd driveway shows LVL at 5.49-5.54M
