Folder [Compiled street addresses flooding Whangamata SmartMAPS, images and notes including Opus]

WRA Whangamata Rate Payers Association >

Folder [2003 to 2005 Opus Flood report]

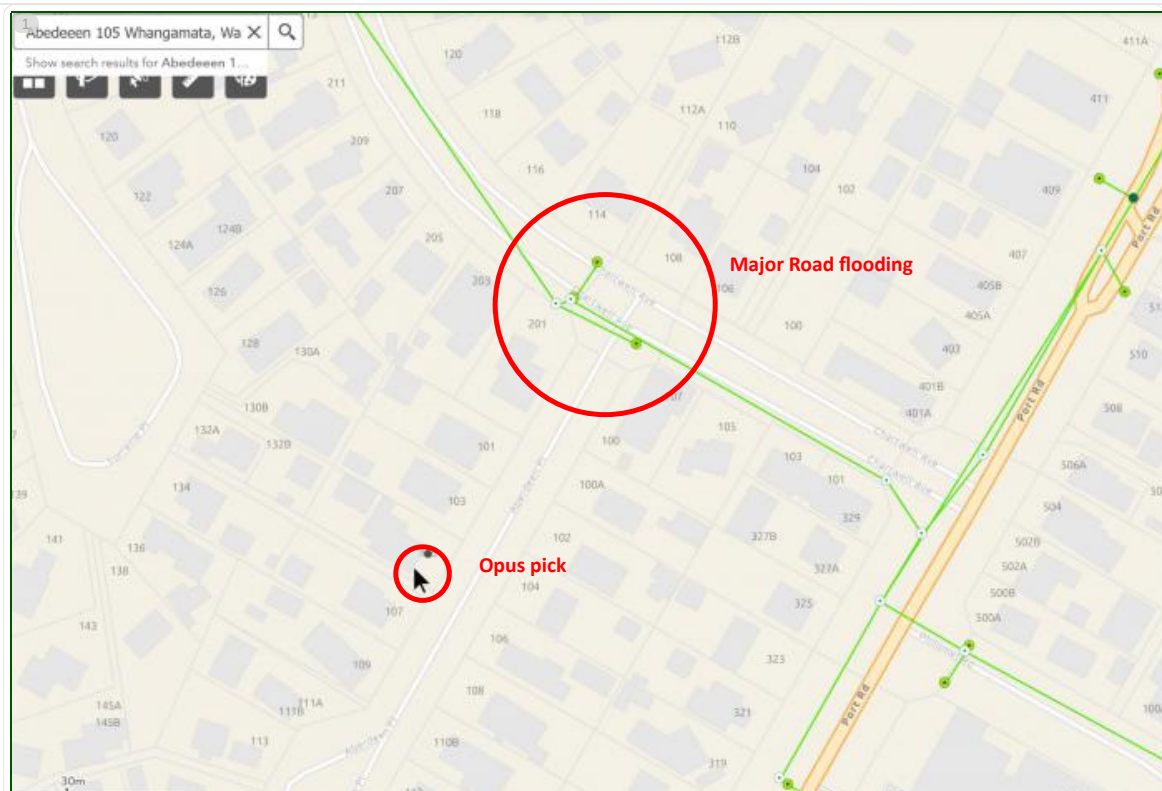
Aberdeen Place 105 001SM.jpg

Aberdeen 105, Flooding due to blocked cesspits Existing cesspits at intersection of Aberdeen/Chartwell are to be retrofitted with back entry blocks, along with upgrade of pipe in Chartwell Avenue (between Aberdeen and Charleston – see pipe upgrade table) \$90k \$108k \$119k

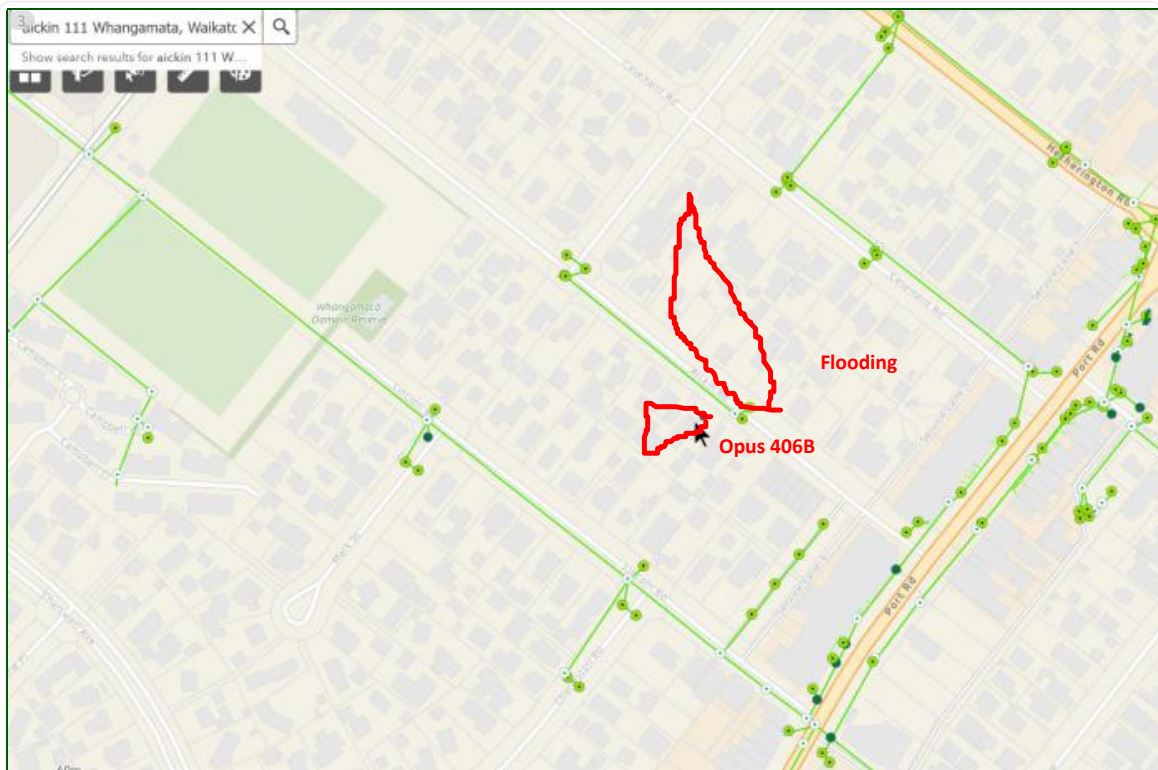
Aickin Road 111 001SM.jpg

Aickin Rd 111 Flooding in private property and garage due to lack of kerbing and stormwater system in road Install stormwater pipes and cesspits in road \$14k \$17k \$19k

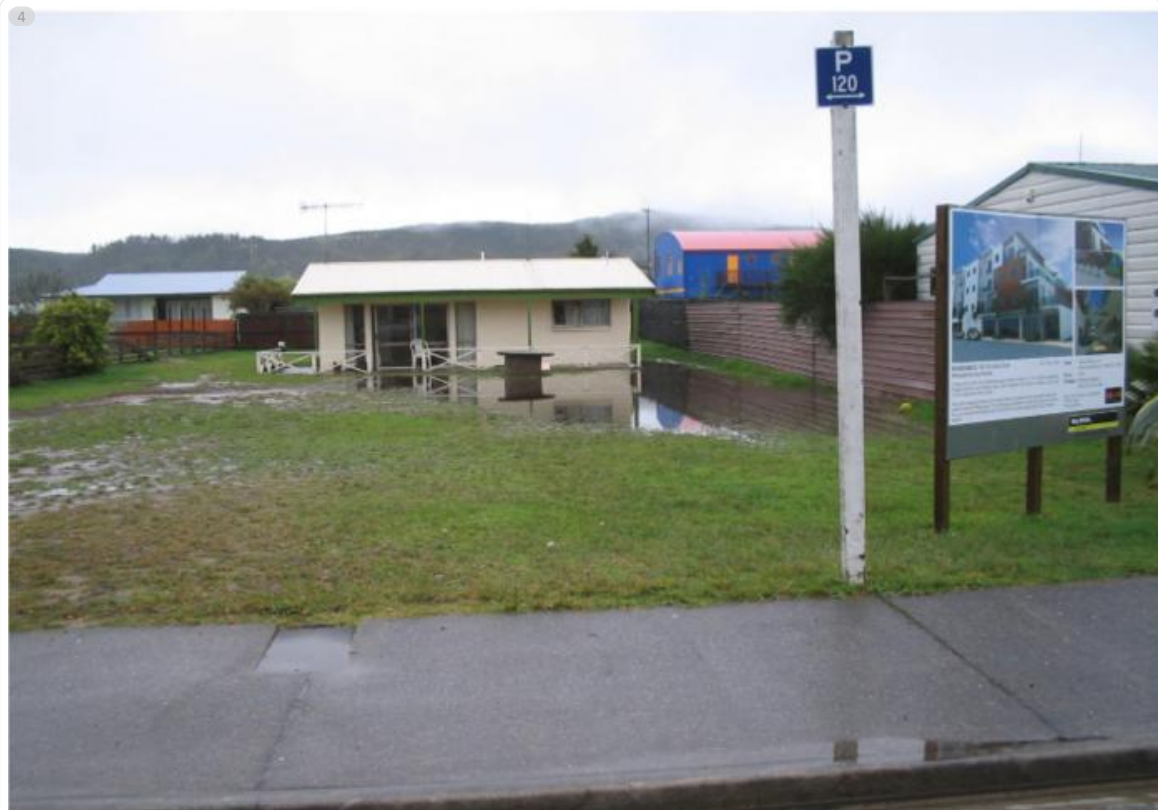
Aickin Road apartments 2005 Opus.jpg

Aickin Rd 102, Flooding in private property due to contour of property forming local low point
Construction of apartments is planned for this site. Detailed stormwater management options have been outlined in separate letter by Opus to TCDC dated 25th May 2005 n/a n/a n/a

Surface ponding West side - to neighbours fence

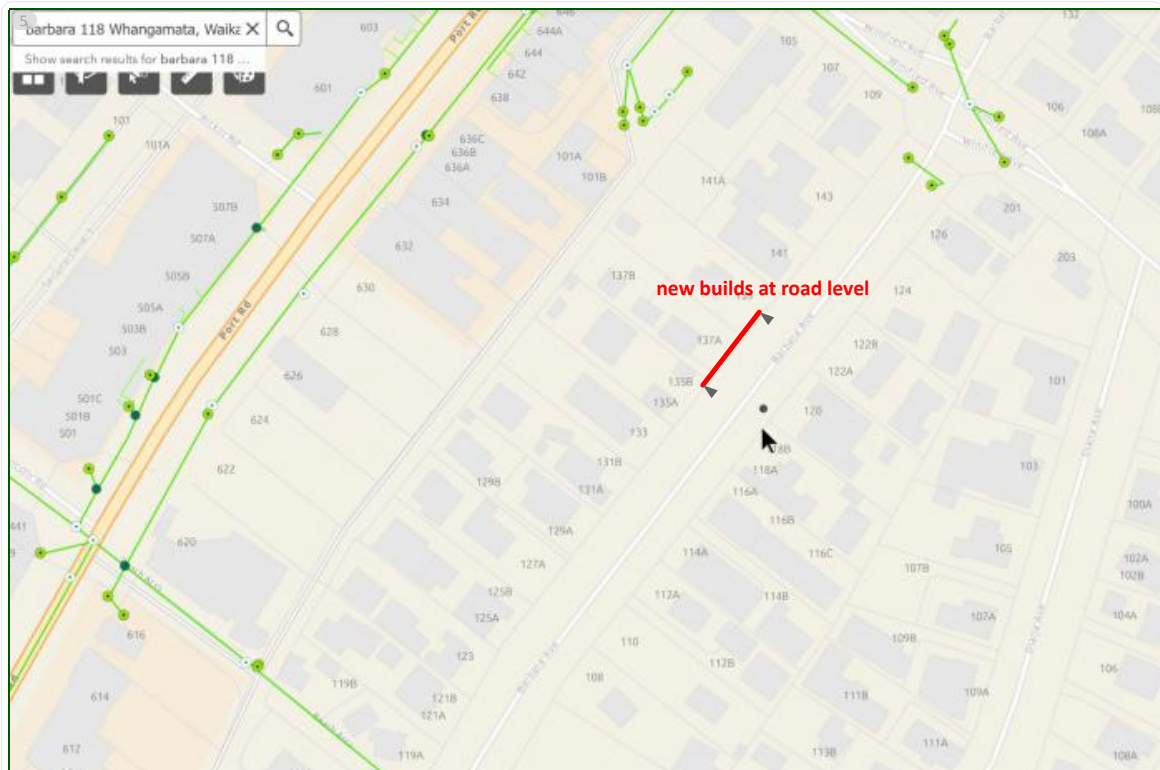
Barbara Avenue 118 001SM.jpg

Barbara Ave 118, 120, 121A, 123, 125A, and 125B,

Barbara Ave reported flooding issues. It appears that this area may receive run-off from the service lane behind the shops, which is not well serviced in terms of stormwater reticulation.

Provide local stormwater reticulation in the service lane connected to the existing reticulation in Lincoln Rd. Catchpits should be installed to capture surface water. The adequacy of individual on-site soakage disposal of runoff from roof and paved areas should be investigated.

Similar but less severe stormwater problems are reported adjacent to the service lane on the other side of Lincoln Rd. It would be sensible to extend the stormwater reticulation in this direction also.

Investigate adequacy of on-site disposal systems. Confirm levels and adequacy of downstream reticulation.

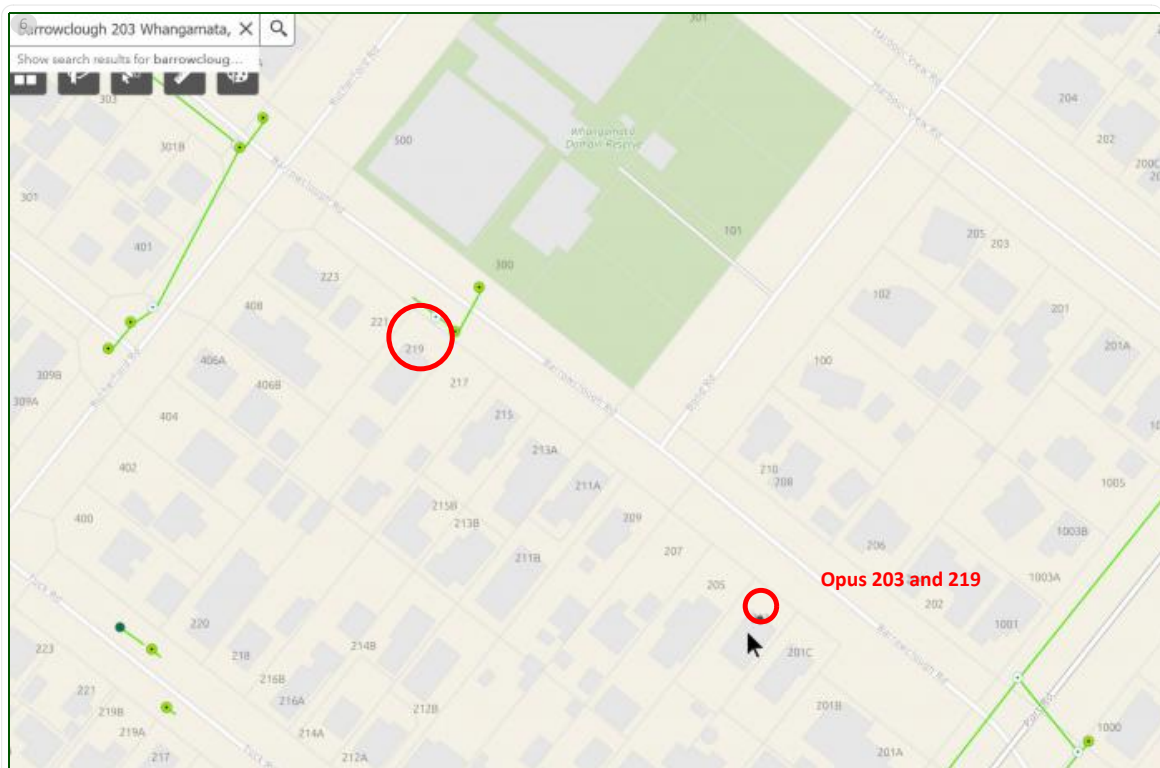
Barrowclough Road 203 001SM.jpg

Barrowclough Rd 203 & 219, Flooding into private property and garage caused by undersized cesspit lead

Replace existing cesspit with double and increase connection size from 150mm to 300mm

diameter \$28k \$34k \$38k

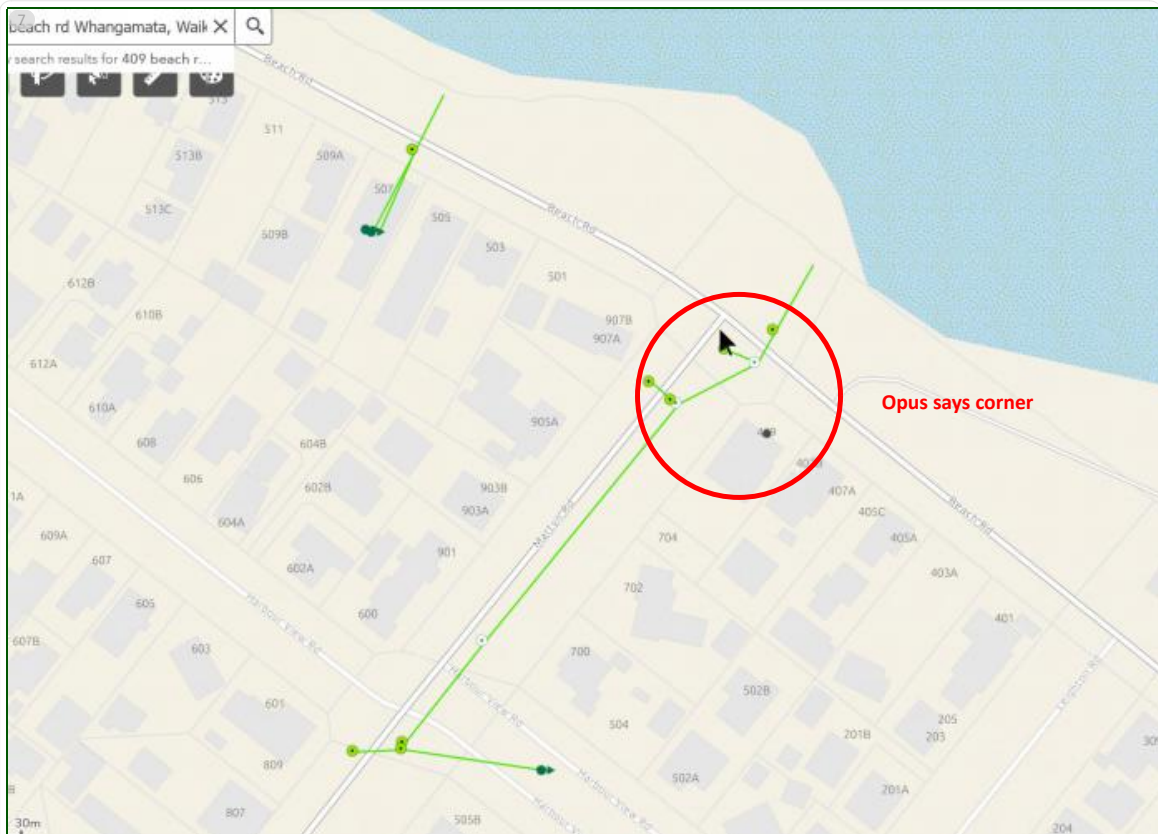
Beach Road corner Martyn 001SM.jpg

Beach Road/Martyn Road

Flooding into private property and garage due to undersized outfall pipe work. Outfall pipe size needs to be increased \$118k \$142k \$156k

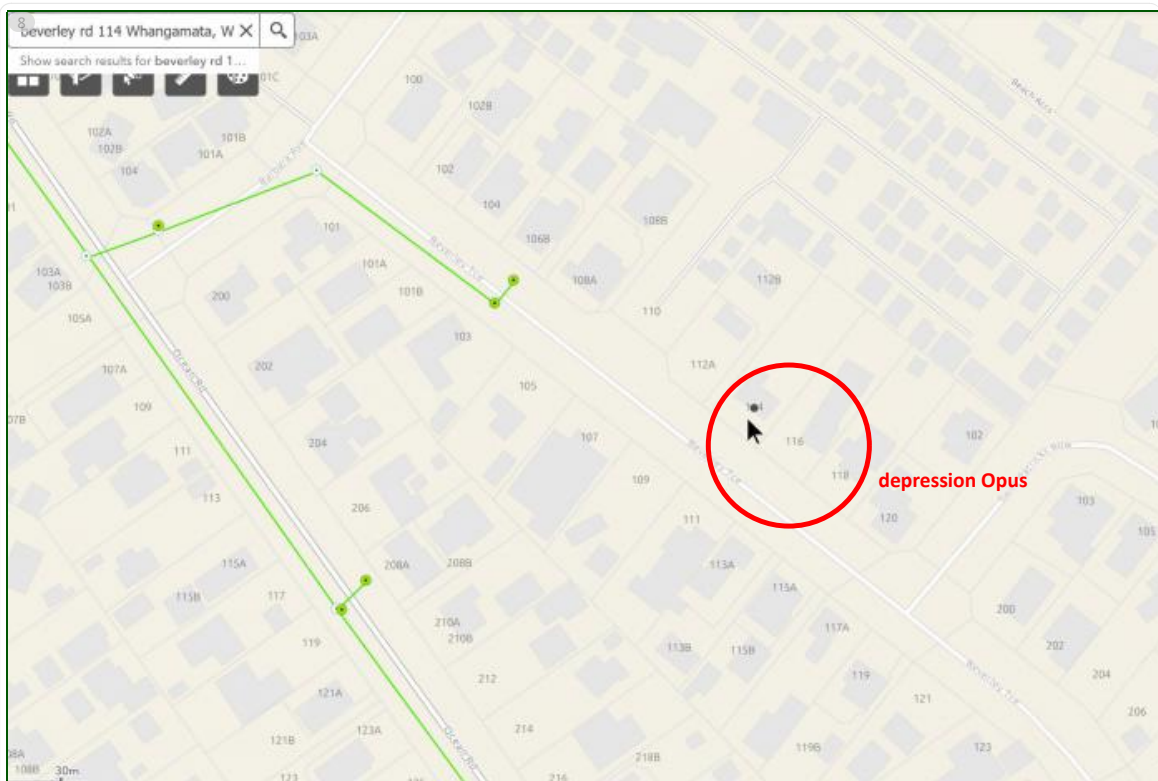
Beverley Road 114 001SM.jpg

Beverley Rd 114 & 116, Flooding to private property and houses due to house being constructed in local low point and runoff from road

Install kerb & channel, cesspits and pipework in road \$37k \$44k \$49

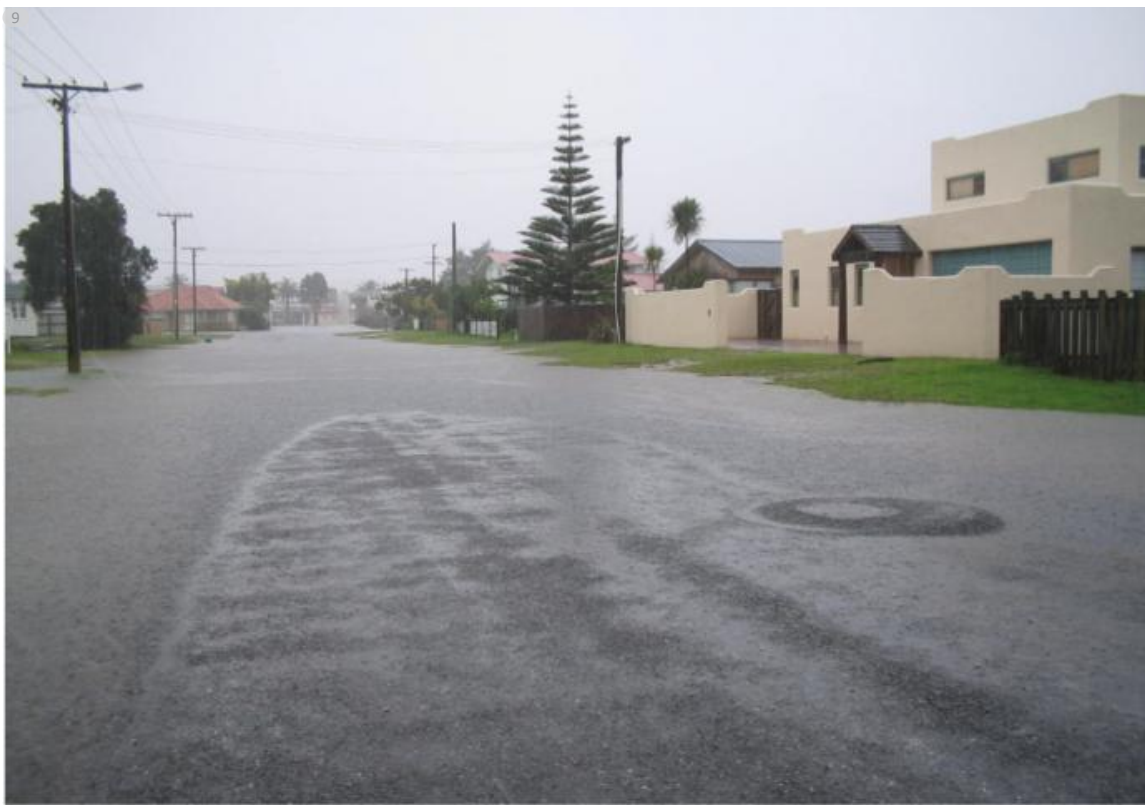
Beverley Road 114 and 107 2005 Opus.jpg

Opus 2005. Beverley Rd 114 & 116, Flooding to private property and houses due to house being constructed in local low point and runoff from road.

Surface water on road entering properties

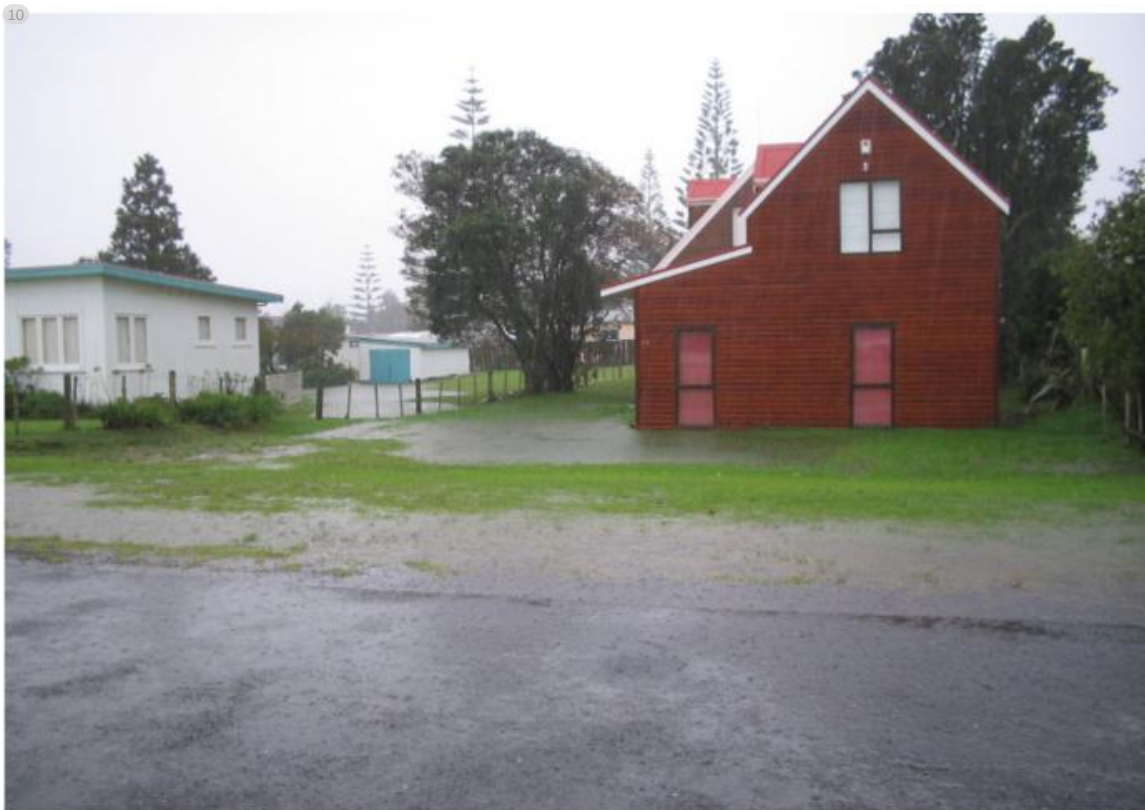
Beverley Road 116 2005 Opus.jpg

Property flooded that is in depression. Comes off road and from Whangamata Campground behind back fence and garage

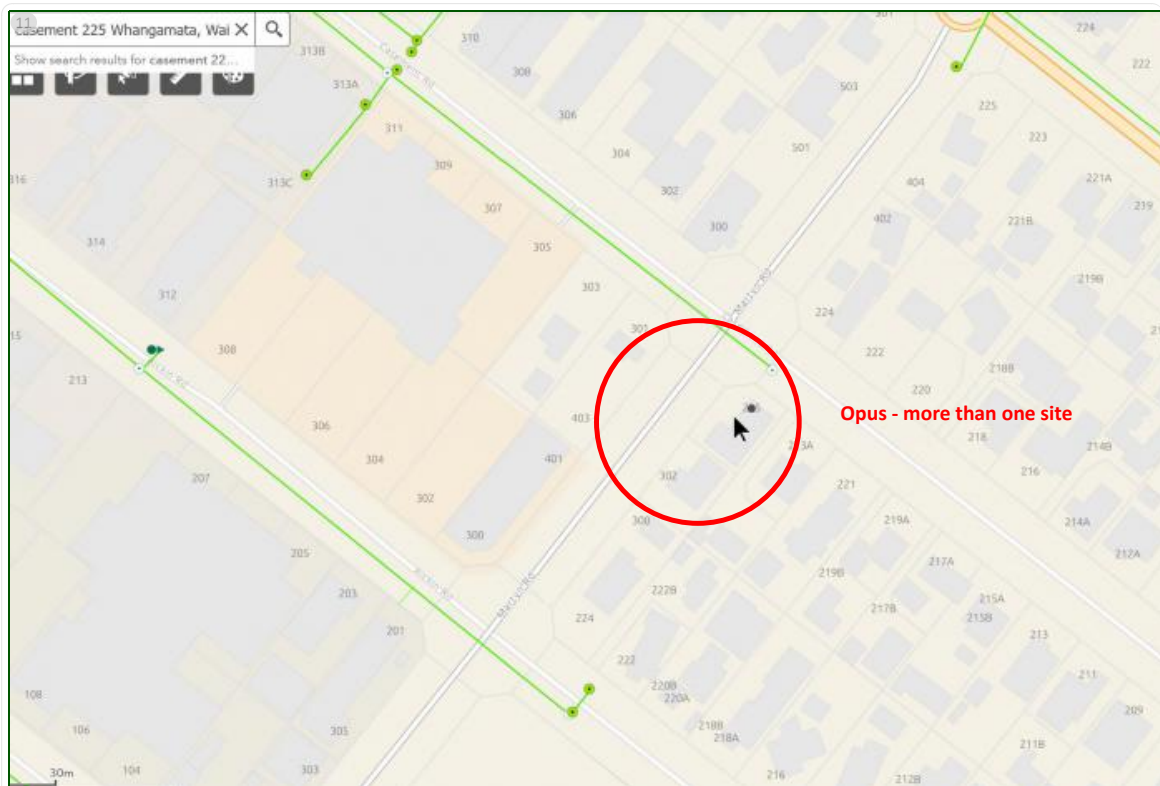
Casement Road 225 001SM.jpg

Casement Road 225, Corner of Casement and Martyn

A number of properties along Casement Road have either been flooded or have reported stormwater problems. These properties tend to be low-lying and receive run-off from the road.

Flooding on-road in vicinity of industrial area impedes access and disrupts work.

Option 1: Lower Martyn Road to allow Overland Flow Path to direct water away from property

Option 2: Install back entry cesspits to replace existing cesspits

Install a road drainage swale along at least one side of Casement Rd. If practicable, consider extending the stormwater reticulation from Casement Rd into this area to drain the swale.

Ideally swale drains should be installed both sides of Casement Rd, however the accompanying cost estimate is for the one-side-only minimum option

Install channel for water to flow from Casement Road to estuary and reduce flooding in road

Carry out a topographic survey to ensure that it is practicable to drain Casement Rd basin into the existing reticulation

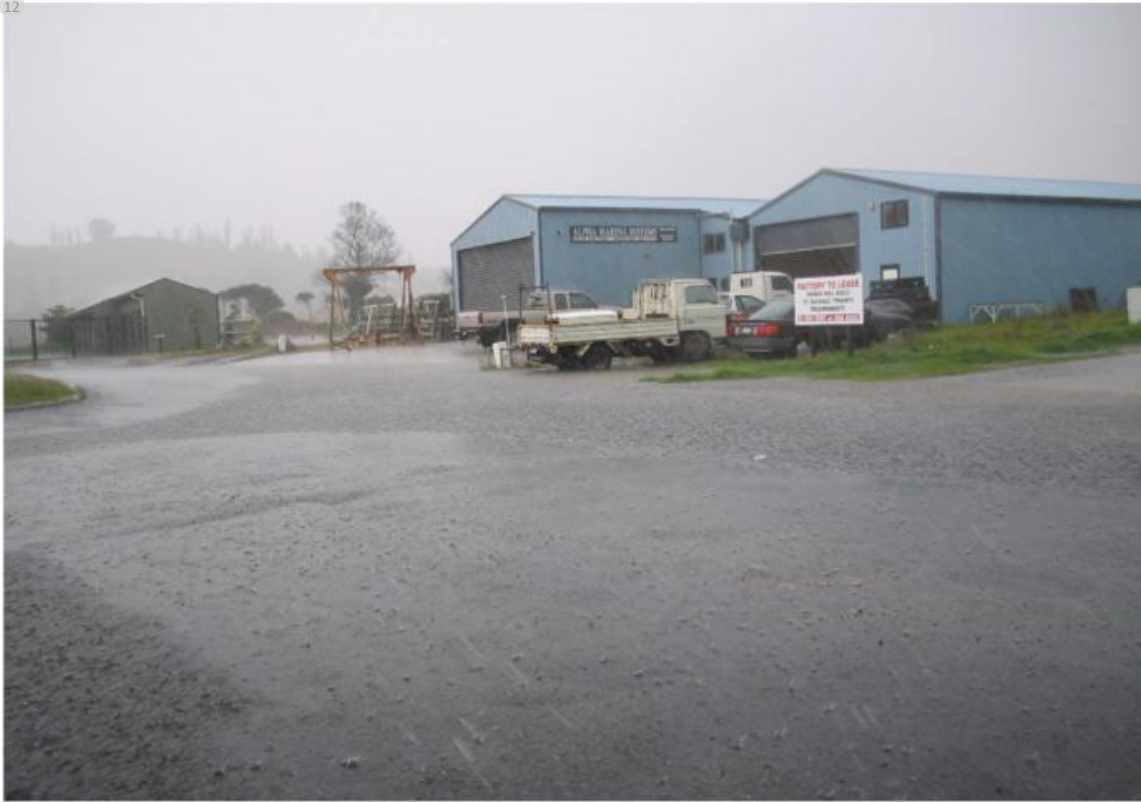
Casement Road Opus 2005 (2).jpg

Casement Road 225, Corner of Casement and Martyn

A number of properties along Casement Road have either been flooded or have reported stormwater problems. These properties tend to be low-lying and receive run-off from the road.

Flooding on-road in vicinity of industrial area impedes access and disrupts work.

Option 1: Lower Martyn Road to allow Overland Flow Path to direct water away from property

Option 2: Install back entry cesspits to replace existing cesspits

Install a road drainage swale along at least one side of Casement Rd. If practicable, consider extending the stormwater reticulation from Casement Rd into this area to drain the swale.

Ideally swale drains should be installed both sides of Casement Rd, however the accompanying cost estimate is for the one-side-only minimum option

Install channel for water to flow from Casement Road to estuary and reduce flooding in road

Carry out a topographic survey to ensure that it is practicable to drain Casement Rd basin into the existing reticulation

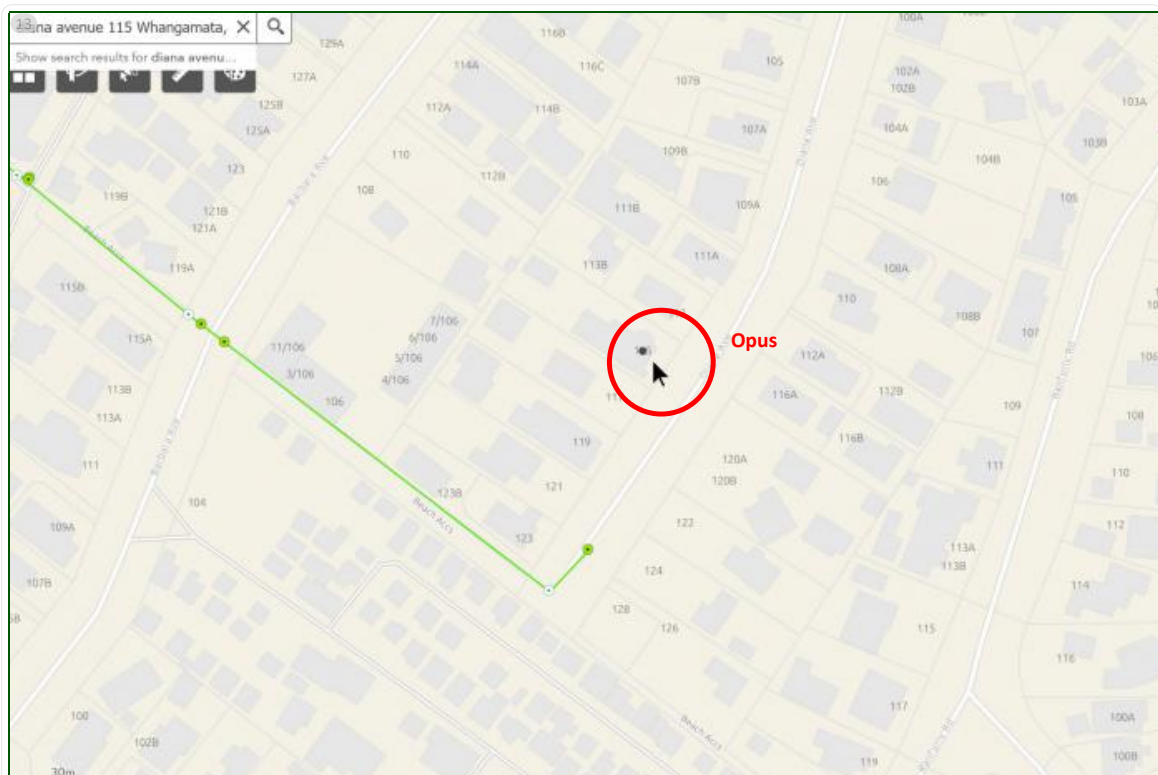
Diana Drive 115 001SM.jpg

Diana Ave 115, Flooding of properties and garages caused by lack of kerbing or stormwater system

Requires additional cesspits and pipework \$38k \$46k \$51k

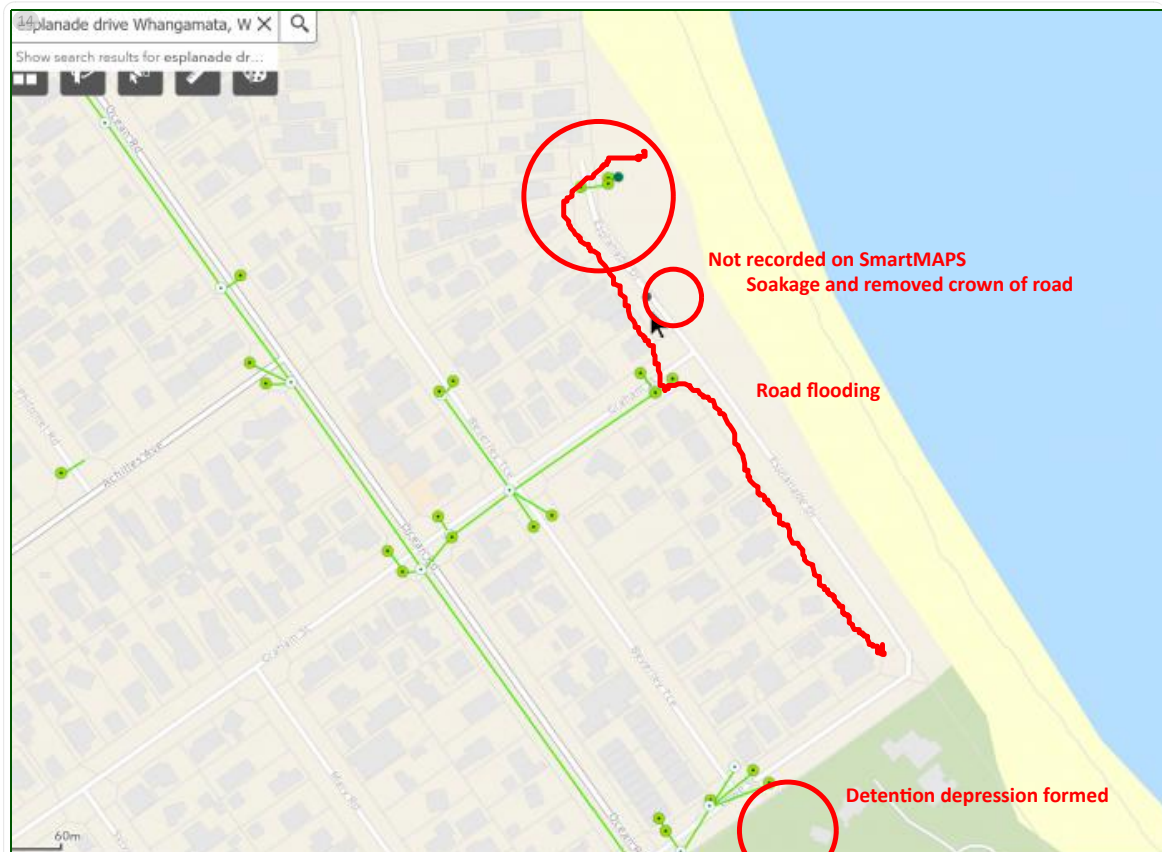
Esplanade Drive 001SM.jpg

2005 Opus:**Esplanade Drive:**

A number of houses at the northern end of Esplanade Drive have been flooded. These houses are in natural depressions and run-off from the

carpark opposite may exacerbate the problem.

Opus considered an open swale alongside the car park in Esplanade Drive (both sides of Graham St), together with a piped stormwater drain connecting with the existing reticulation in Graham St. Unfortunately, this may not be practicable. Further survey is needed to confirm.

Without such drainage works there is little that can be done other than enforcing appropriate floor levels for new buildings.

Carry out topo survey of the low-lying area and confirm whether it is practical to drain \$19k \$22k \$25k

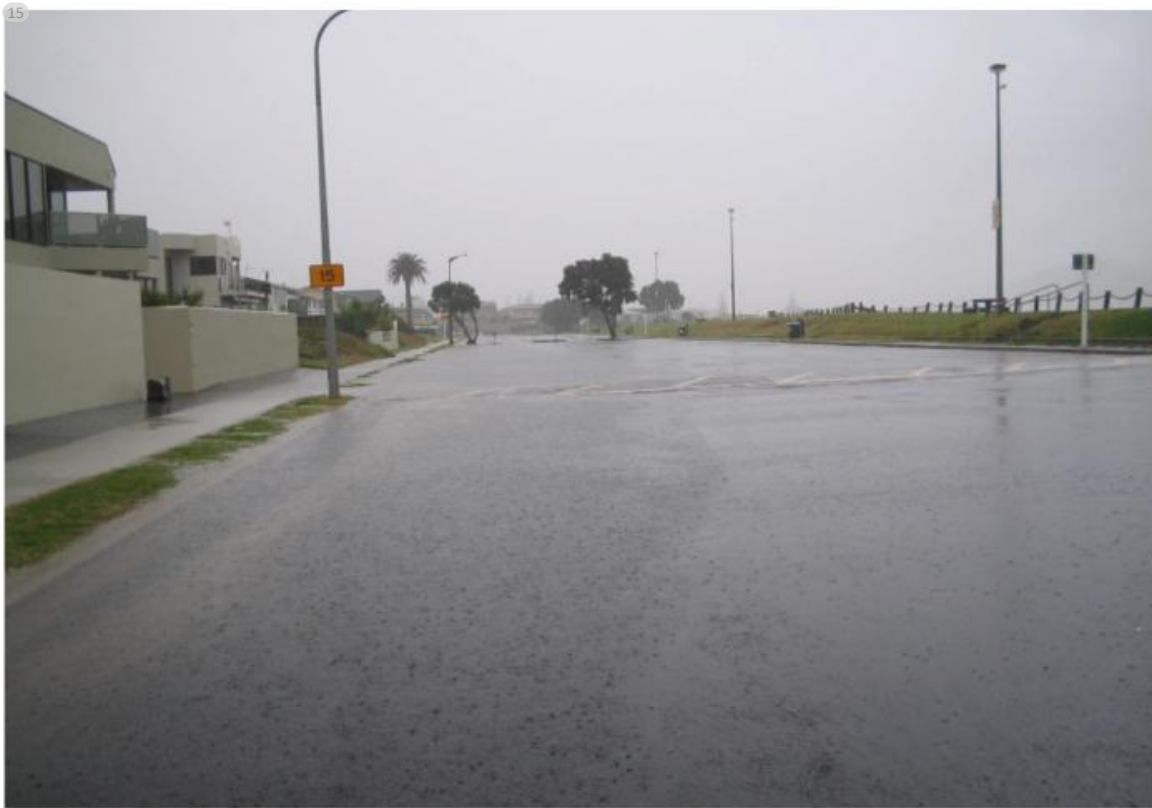
Esplanade Drive 115 2005 Opus.jpg

Esplanade Drive:

A number of houses at the northern end of Esplanade Drive have been flooded. These houses are in natural depressions and run-off from the

carpark opposite may exacerbate the problem.

Opus considered an open swale alongside the car park in Esplanade Drive (both sides of Graham St), together with a piped stormwater drain connecting with the existing reticulation in Graham St. Unfortunately, this may not be practicable. Further survey is needed to confirm.

Without such drainage works there is little that can be done other than enforcing appropriate floor levels for new buildings.

Carry out topo survey of the low-lying area and confirm whether it is practical to drain \$19k \$22k \$25k

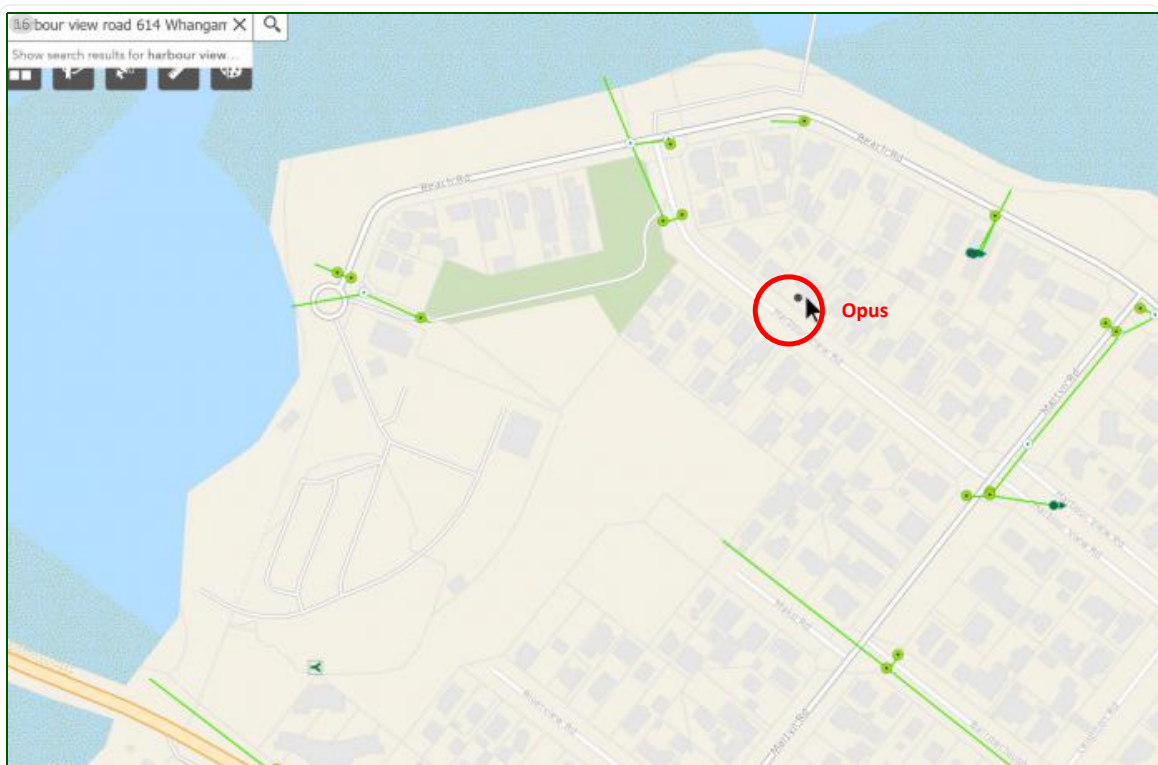
Harbour View Road 614 001SM.jpg

Harbour View Road 614, Flooding into private property due to lack of kerbing or stormwater system

Requires additional cesspits and pipework \$67k \$80k \$89k

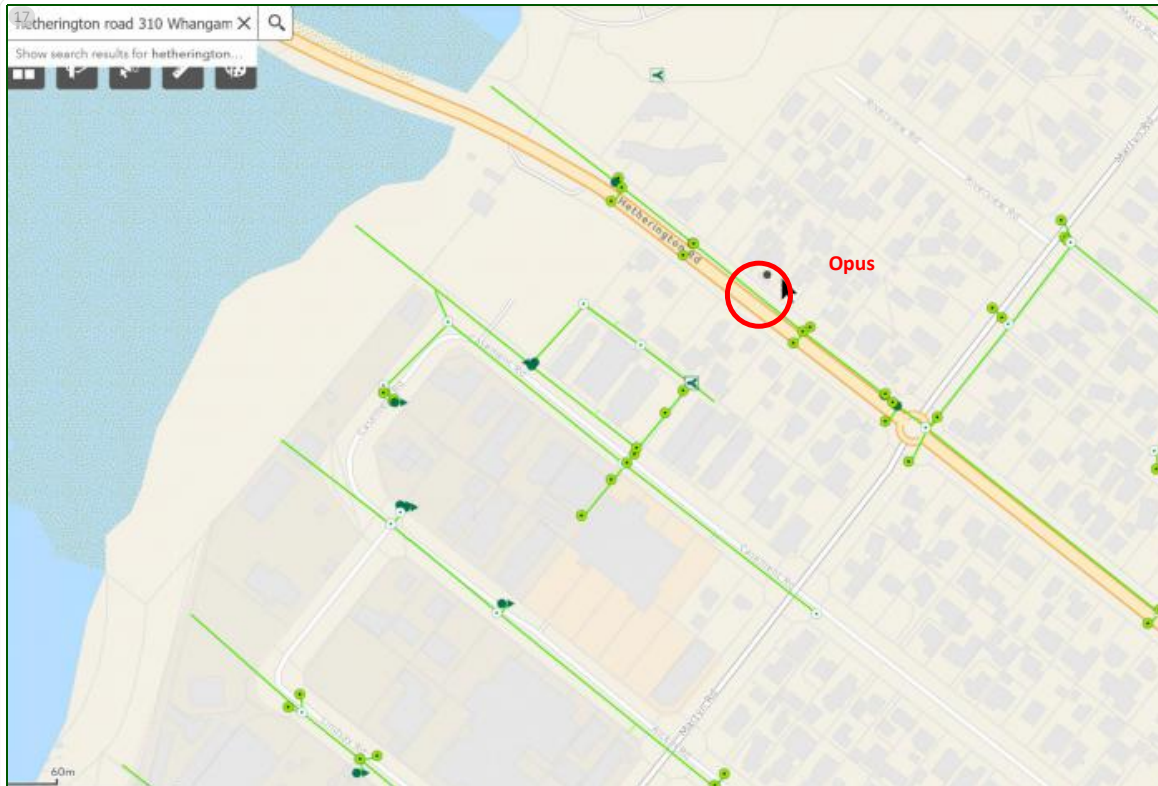
Hetherington Road 310 001SM.jpg

Hetherington Road 310, flooding into private property due to lack of cesspits

Option 1: Raise kerb and channel in vicinity of property to restrict flow from road

Option 2: Owner to Install and maintain onsite soakage system

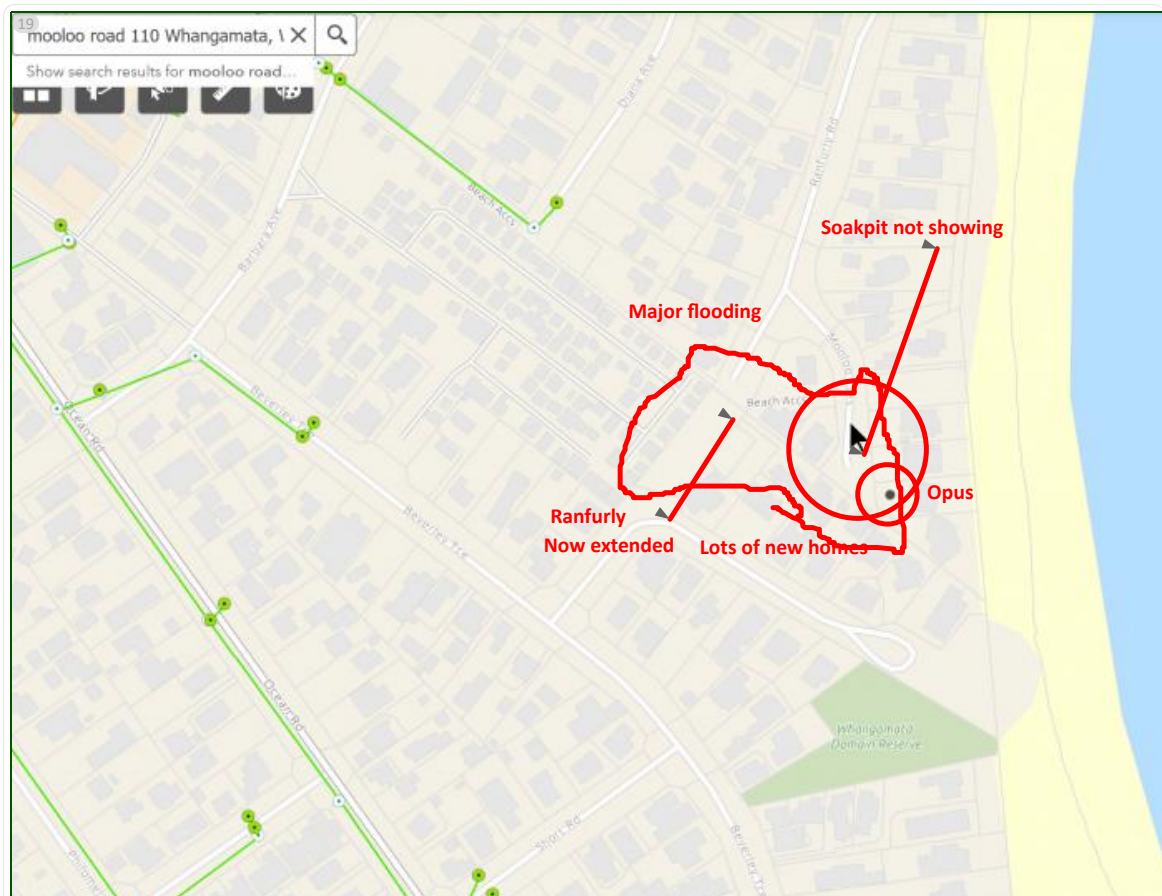
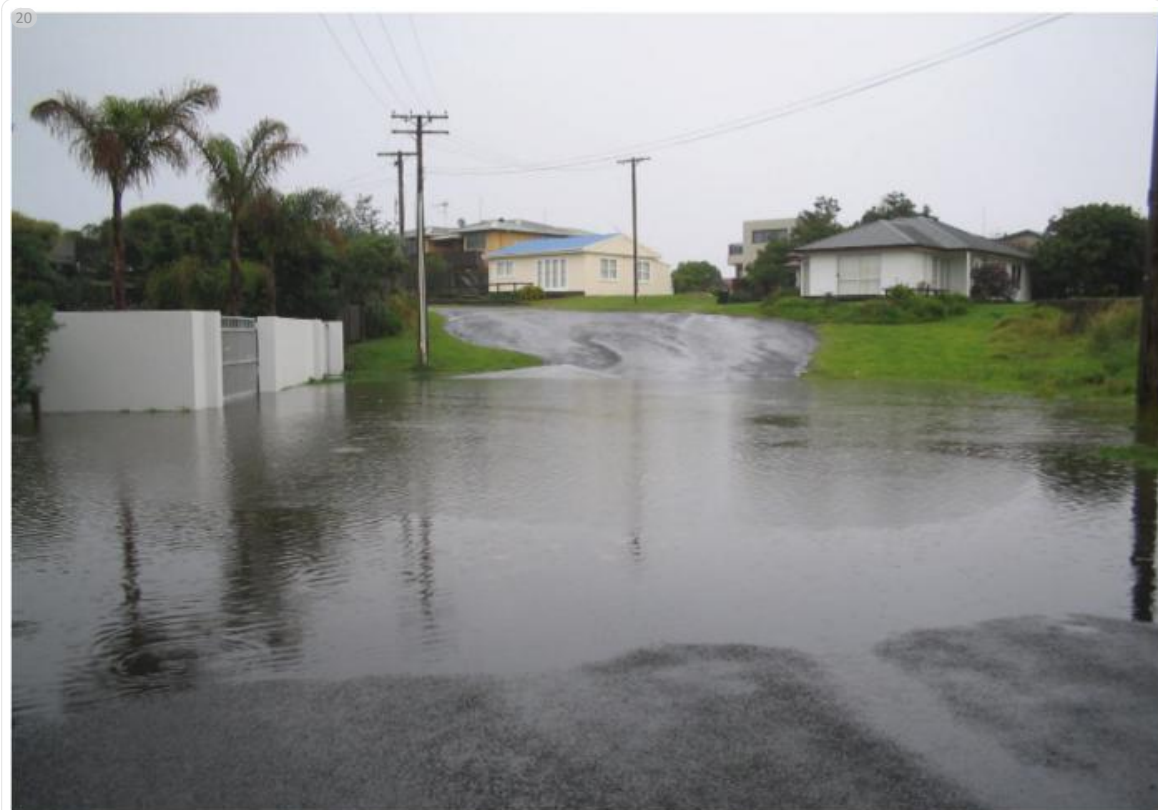
Mooloo Crescent 2005 Opus.jpg

Mooloo Crescent: Houses and road are in a deep natural sand basin, with no natural outlet.

There is no apparent solution. The basin is probably too low to drain into nearby stormwater reticulation. It is probably also impracticable to cut down the foredunes to permit drainage to the beach as this might also permit seawater entry. The house sections are well developed, so that filling of the basin would be difficult. House-raising may be practicable as a private work. Policy measures are recommended relating to maximum impervious surfaces and height of building floors above the surrounding dune level. It is possible that water from the cul-de-sac of St Patricks Row may be flowing to Mooloo Cr via a walkway which connects the two. This should be

investigated and if necessary, stormwater should be addressed from St Patricks Row.

\$19k \$22k \$25k A more detailed topographic survey of the basin and house floor levels is recommended.

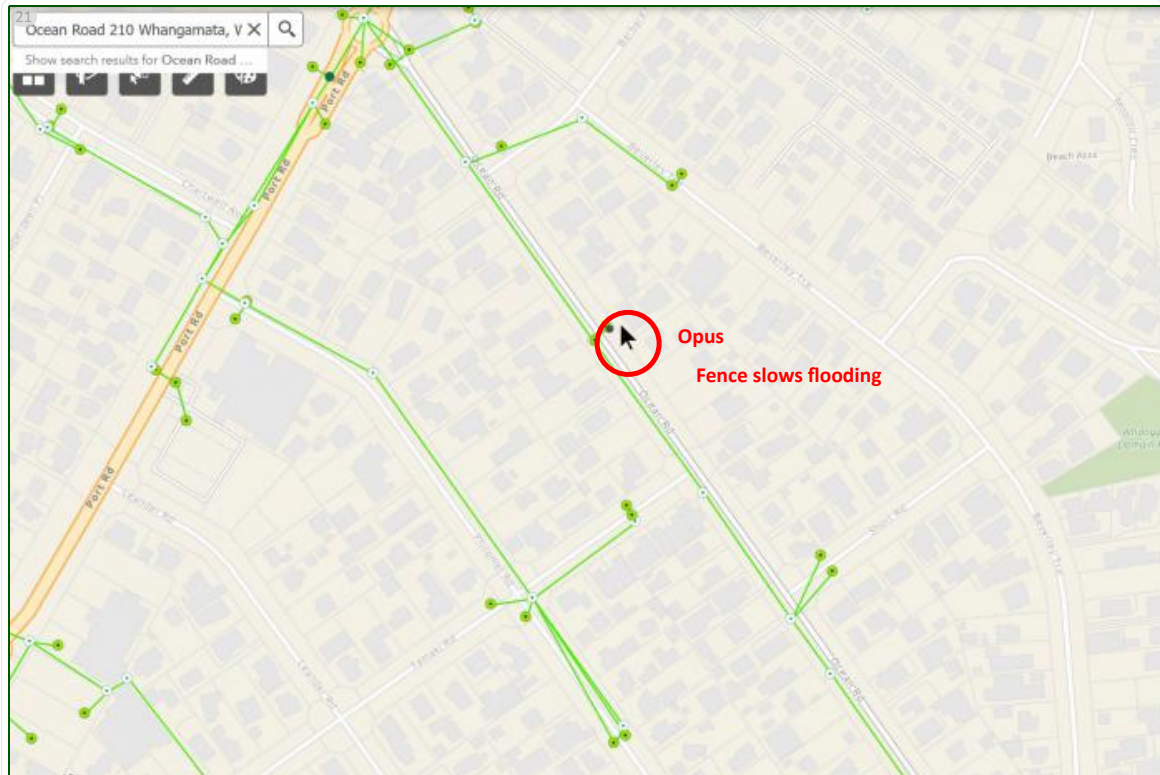
Ocean Road 210 001SM.jpg

Ocean Road 210, House lower than kerb and channel

Option 1: Owner to install private onsite soakage system

Option 2: Owner to install private pump to pump stormwater to council pipe

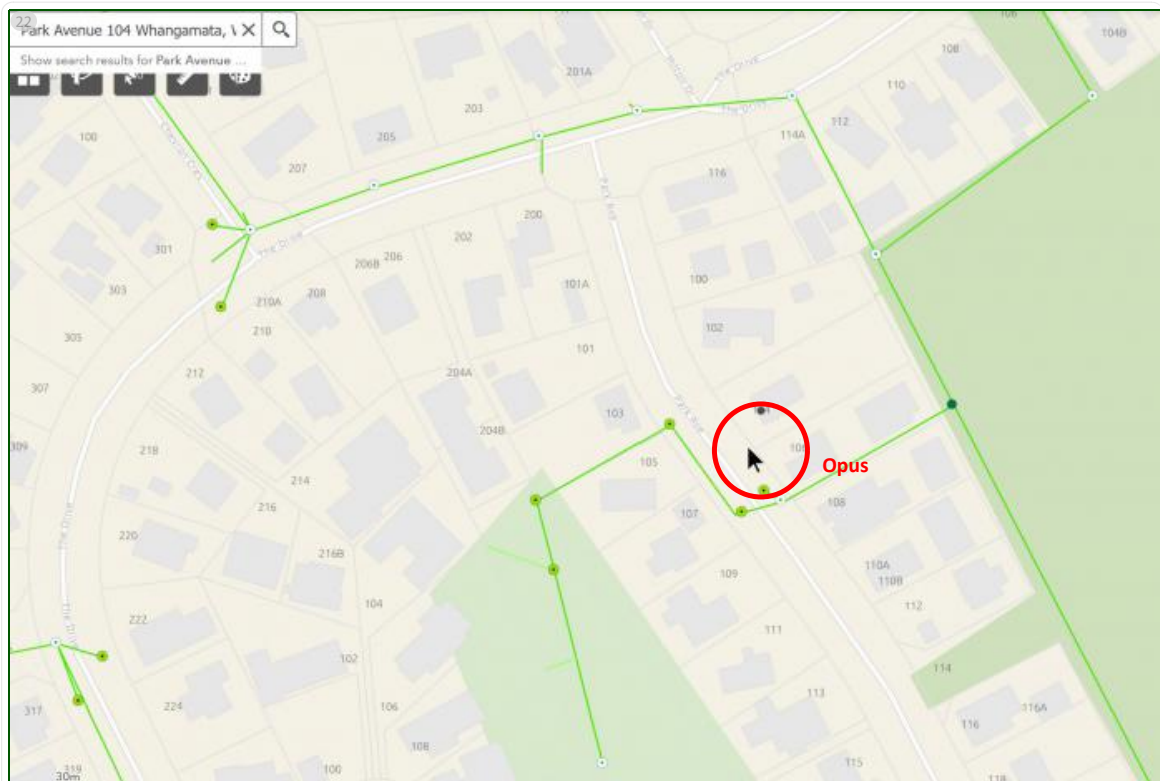
Park Avenue 104 001SM.jpg

Park Ave 104 & 106, Flooding of driveway preventing vehicle access caused by direct discharge into open drain

Existing pipe is undersized. Replace with 70m of 375mm diameter pipe \$27k \$32k \$35k

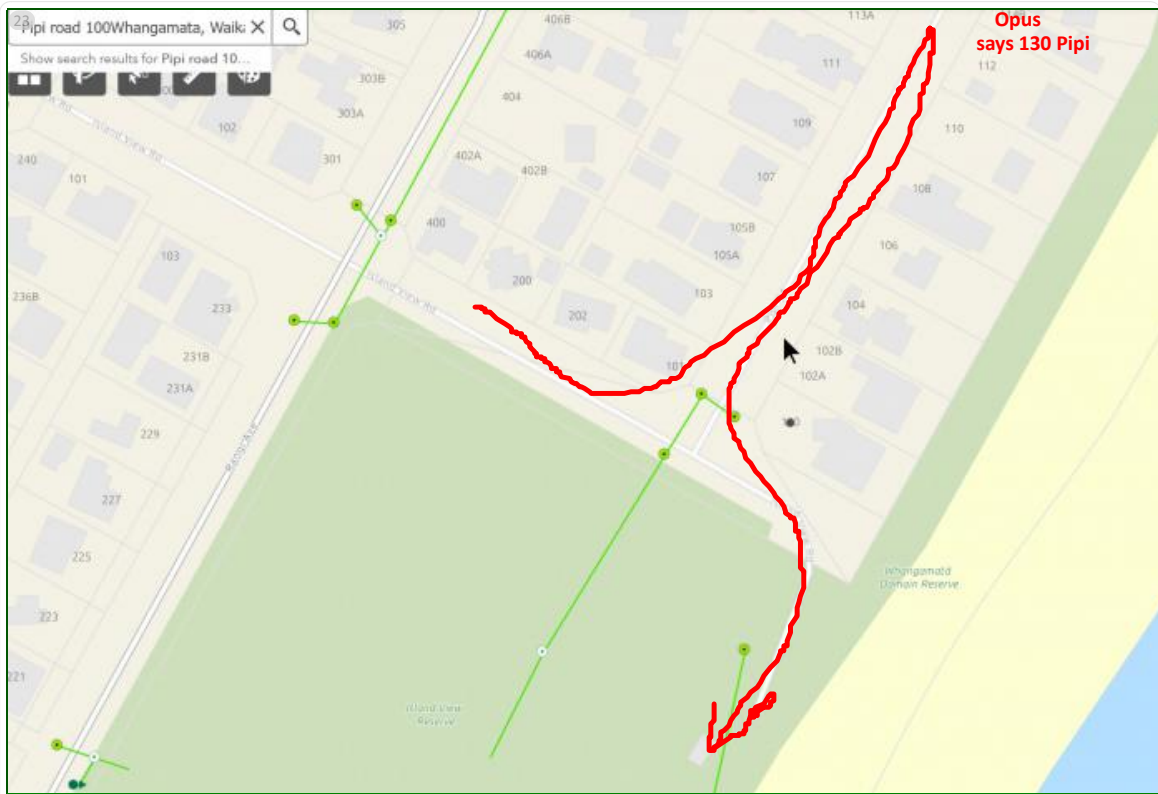
Pipi Road 001SM.jpg

Pipi Road 130, Three properties in this area have flooding problems. It appears that these houses receive road run-off.

Perceived pipe-entry problem may in fact be due to pipe capacity shortfall.

Option 1: Provide additional catchpit capacity by re-building existing catchpits or installing additional pits.

Option 2: Drainage swales on both sides of Pipi Rd may also assist.

Option 3: Lay 240m 300m diameter stormwater pipe

Review capacity of existing reticulation.
