Folder [Compiled street addresses flooding Whangamata SmartMAPS, images and notes including Opus]

WRA Whangamata Rate Payers Association >

Folder [2003 to 2005 Opus Flood report]

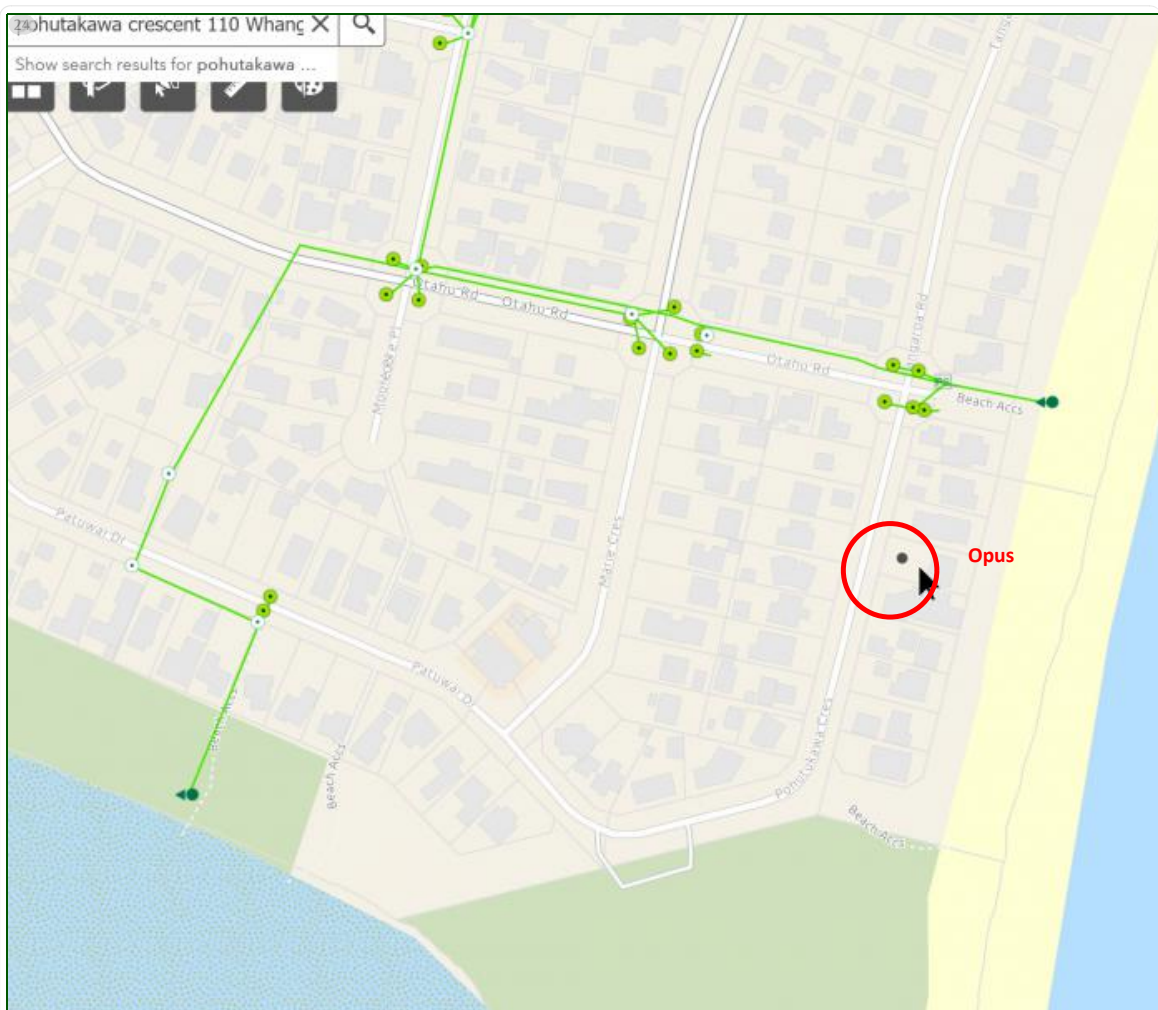
Pohutukawa Crescent 110 001SM.jpg

2005 Opus:**Pohutukawa Crescent/Otahu Road**

110 Pohutukawa Crescent & 801 Otahu Road have been flooded. The houses are located in natural sand basins behind the dunes.

Upgrade road drainage by constructing an open swale. Extend existing stormwater reticulation to serve swale.

*\$36k †\$43k ‡\$48k Carry out topo survey of the low-lying area and confirm that it is practical to drain towards the existing stormwater system

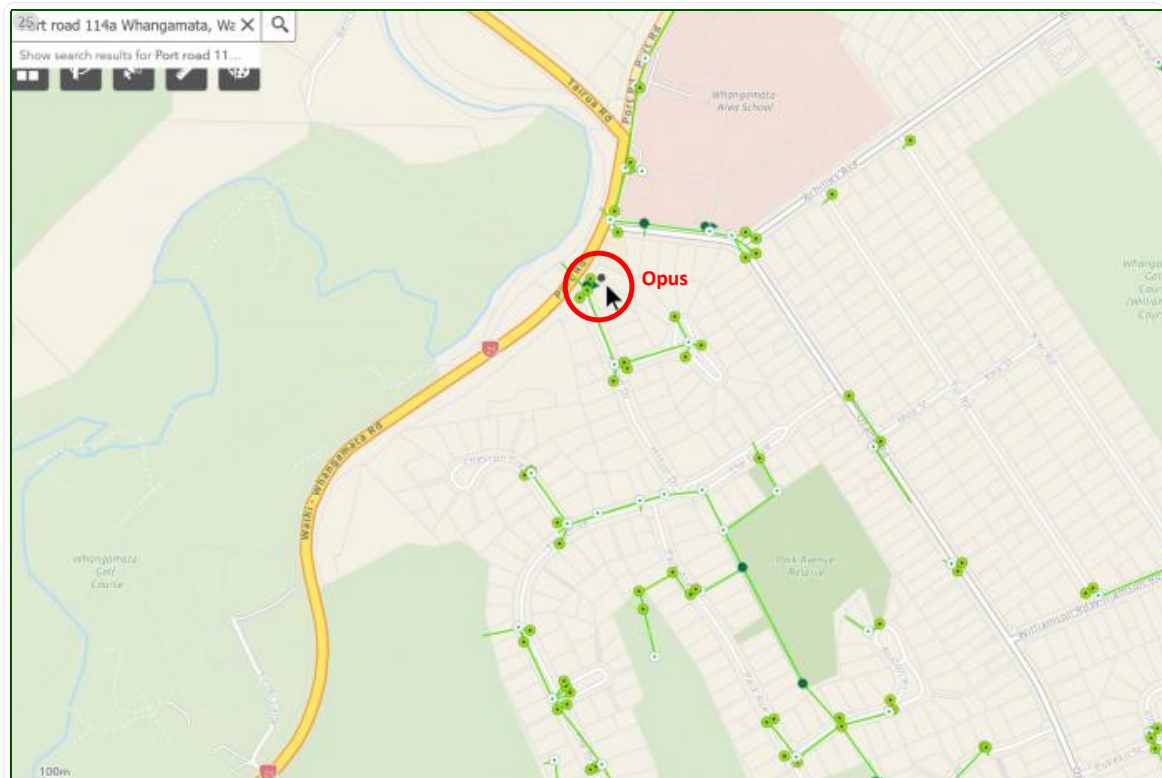
Port Road 114a 001SM.jpg

Port Road 114A & B, experiences flooding of properties and shops because stormwater system is undersized

1000 and 1001 Port Road report flooding problems. These are low-lying properties and receive road run-off. Collection of road run-off in this area

appears to be inadequate.

Option 1: Increase pipe size from cesspit to existing stormwater pipe, 10m of 225mm diameter

Replace the inadequate road catchpits with a new double catchpit each side of Port Rd. Provide increased maintenance to ensure any blockage is promptly rectified.

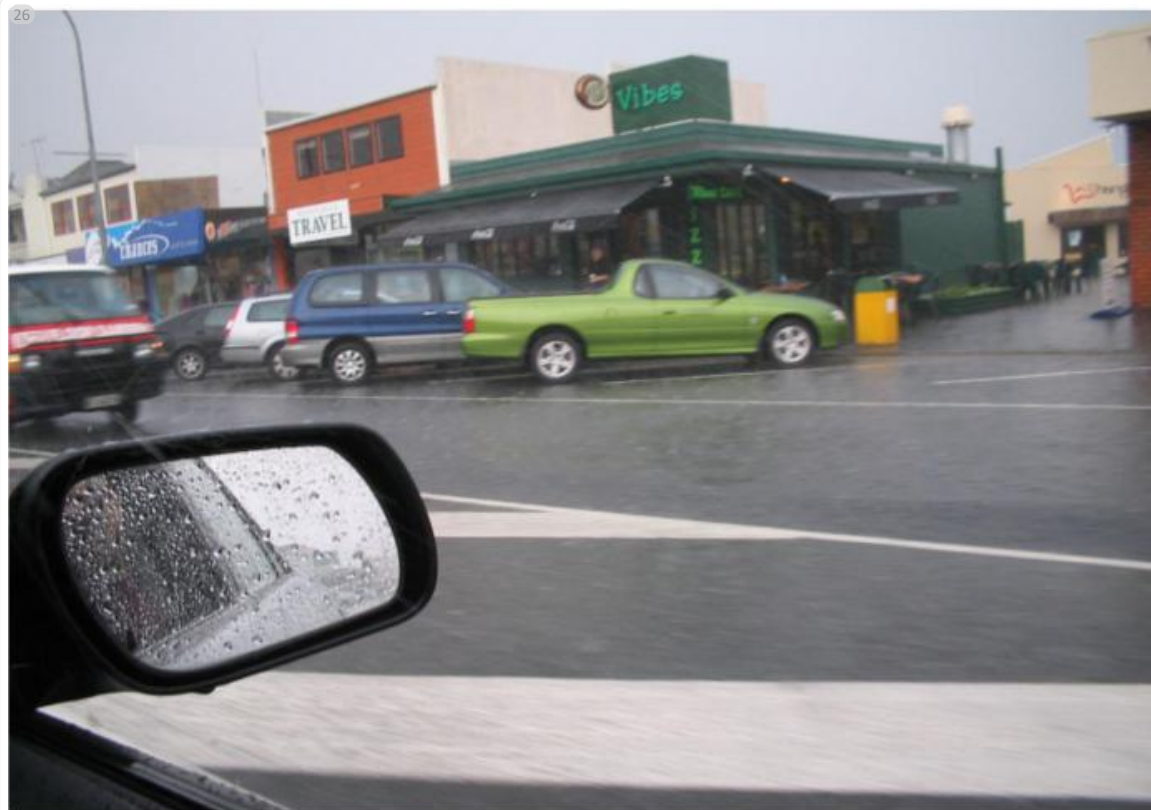
Port town 2005 Opus.jpg

Port Road 114A & B, experiences flooding of properties and shops because stormwater system is undersized

1000 and 1001 Port Road report flooding problems. These are low-lying properties and receive road run-off. Collection of road run-off in this area

appears to be inadequate.

Option 1: Increase pipe size from cesspit to existing stormwater pipe, 10m of 225mm diameter

Replace the inadequate road catchpits with a new double catchpit each side of Port Rd. Provide increased maintenance to ensure any blockage is promptly rectified.

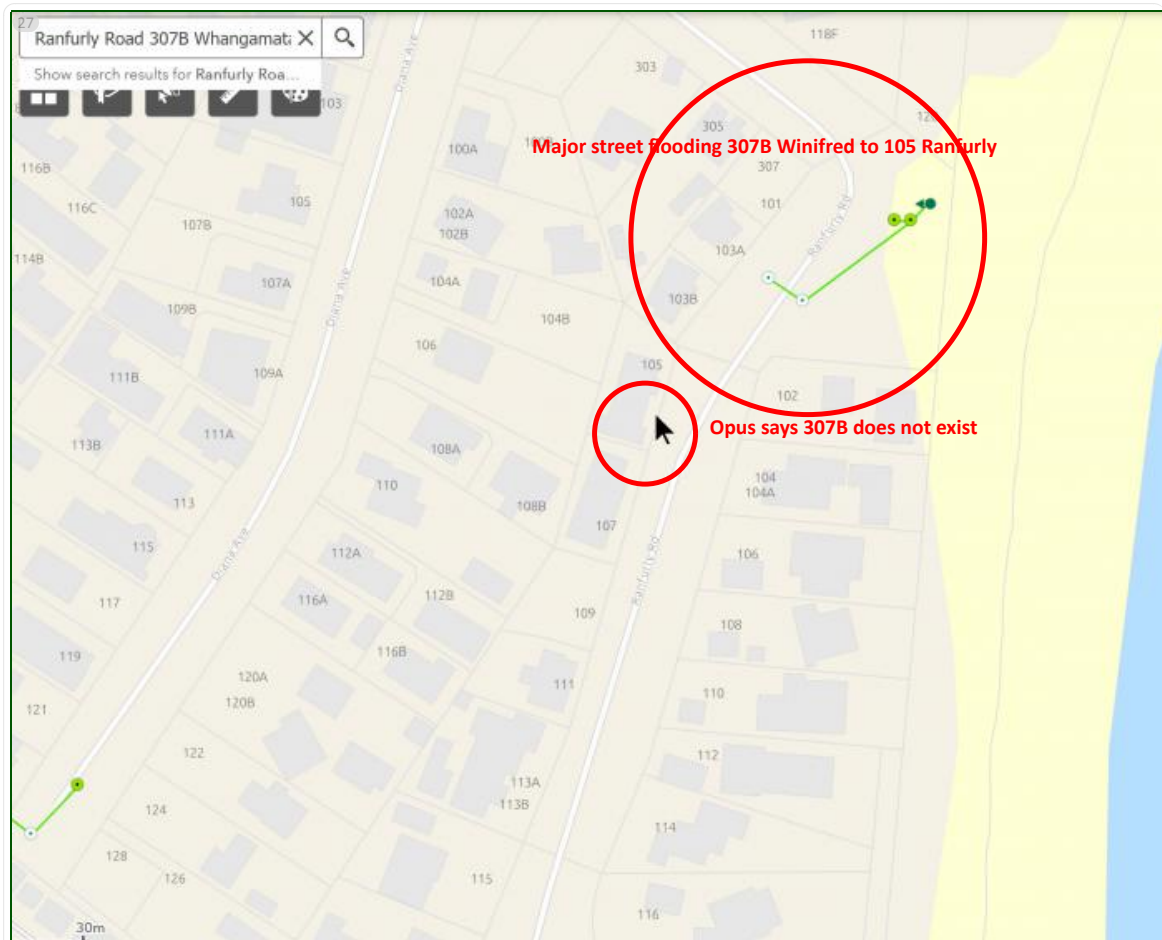
Ranfurly Road 307B 0015M.jpg

Ranfurly Rd 307B, Flooding private property, and basement garage due to lack of kerb and channel in road

Install pipe and cesspits \$61k \$73k \$80k

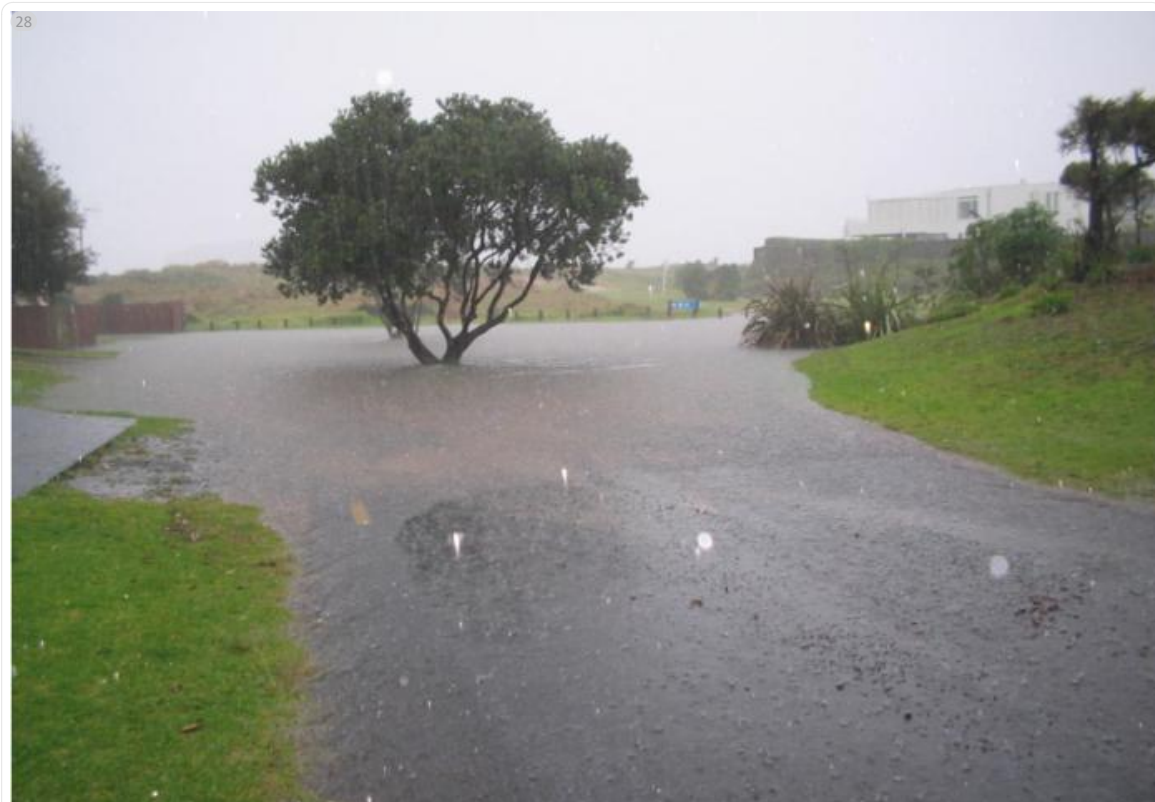
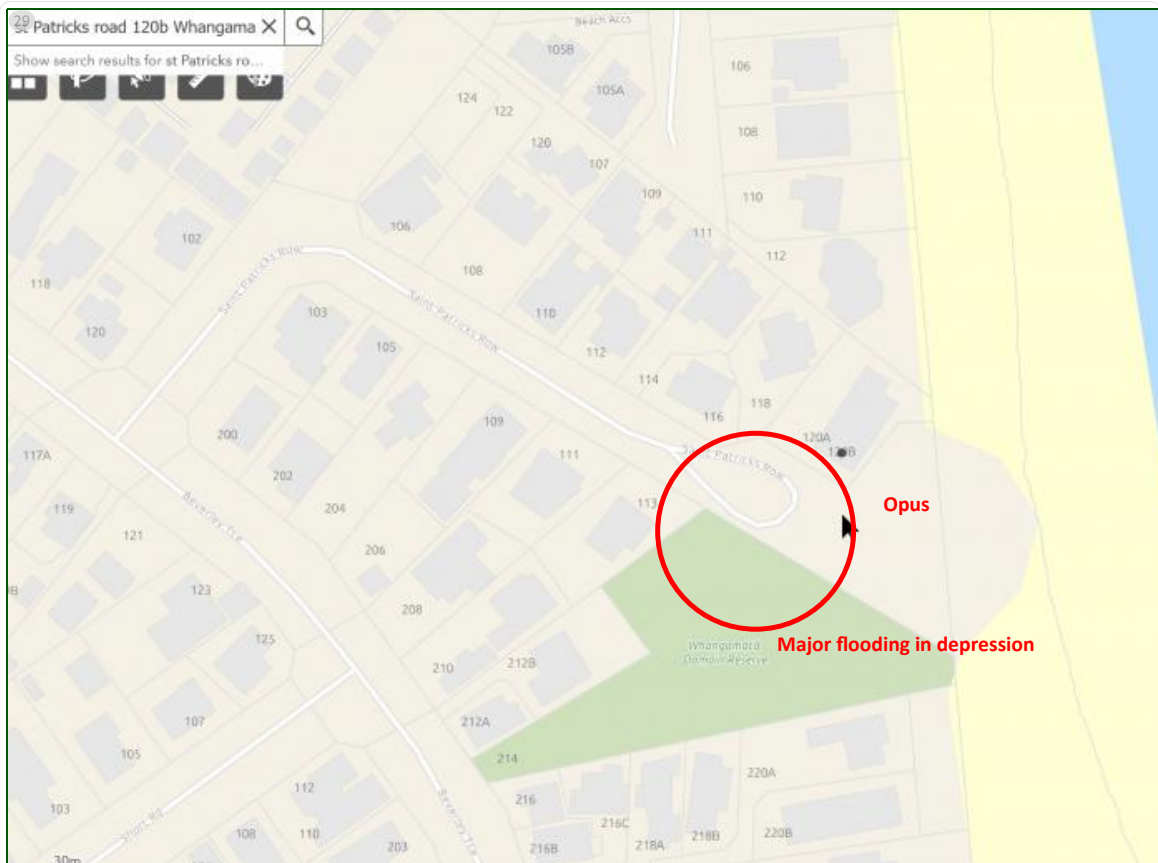
St Patricks Row 120A 2005 Opus.jpg

St Patricks Row 120B, Flooding in cul-de-sac, possibly entering Mooloo Cr via walkway which connects the two streets

Investigate the option of allowing stormwater to flow through sand dunes to beach \$16k \$19k \$21k

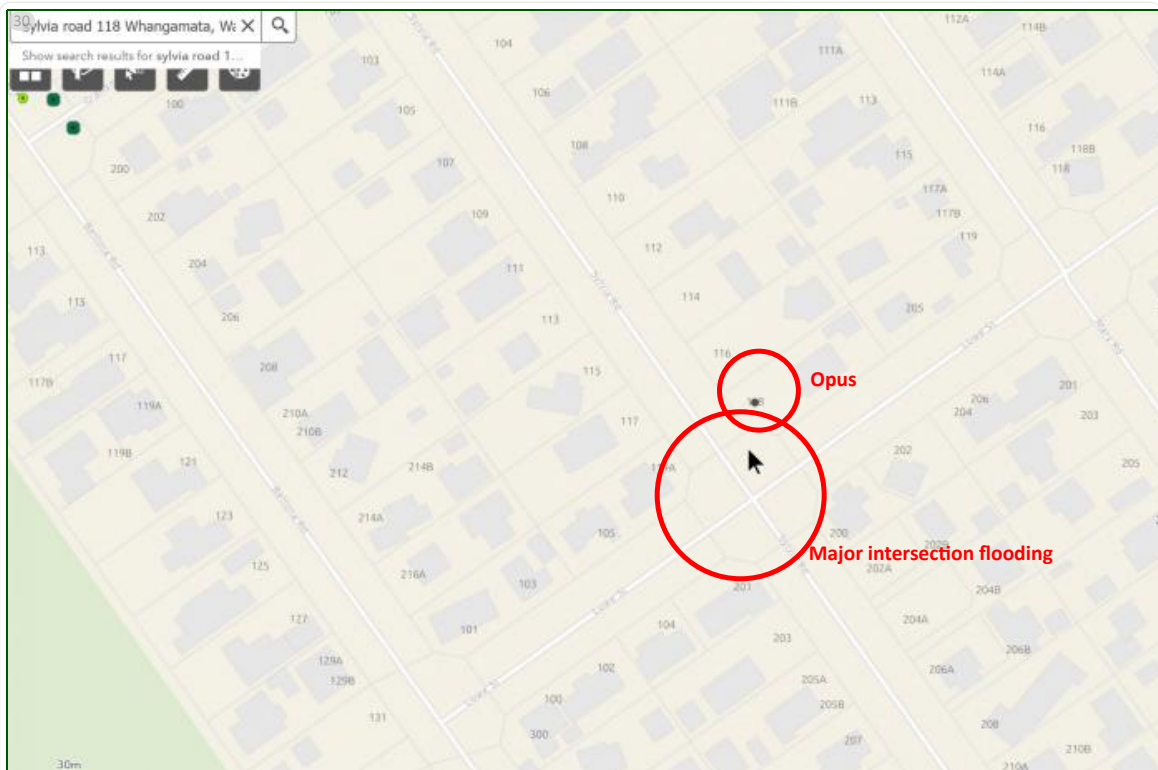
Sylvia Road 118 001SM.jpg

Sylvia Road 118, Flooding to private property due to lack of kerb and channel in road

Install kerb and channelling in road \$5.4k \$73k \$81k

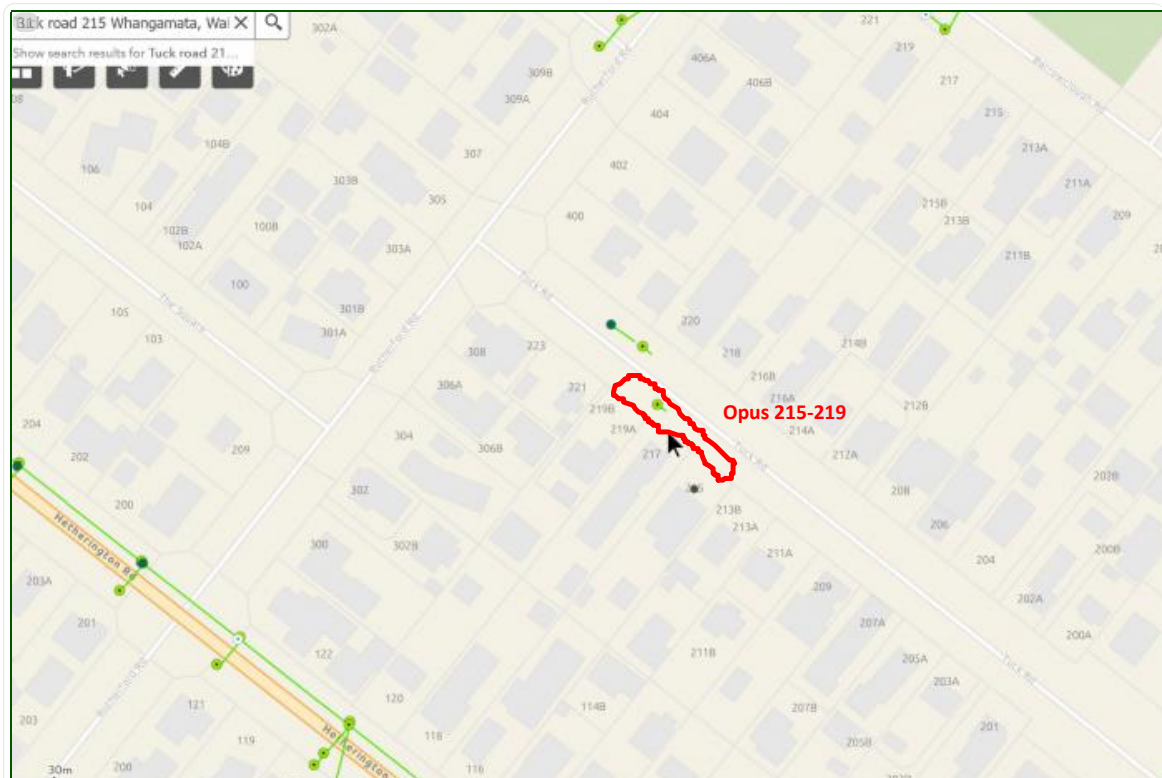
Tuck Road 219-219 002SM.jpg

Tuck Road: Area around 215 -219 Tuck Road has had a number of reported flooding problems. These houses have a low-lying basin located at the back of the sections and appear to receive road run-off from Tuck Road.

Option 1: Carry out maintenance on existing soak pit in road reserve to improve performance

Option 2: Install 150m 225mm diameter pipe to existing pipe in The Square/Rutherford Road

Option 3: Install 190m 225mm diameter pipe to existing pipe in Port Road

Confirm level and adequacy of downstream reticulation in relation to area to be drained.

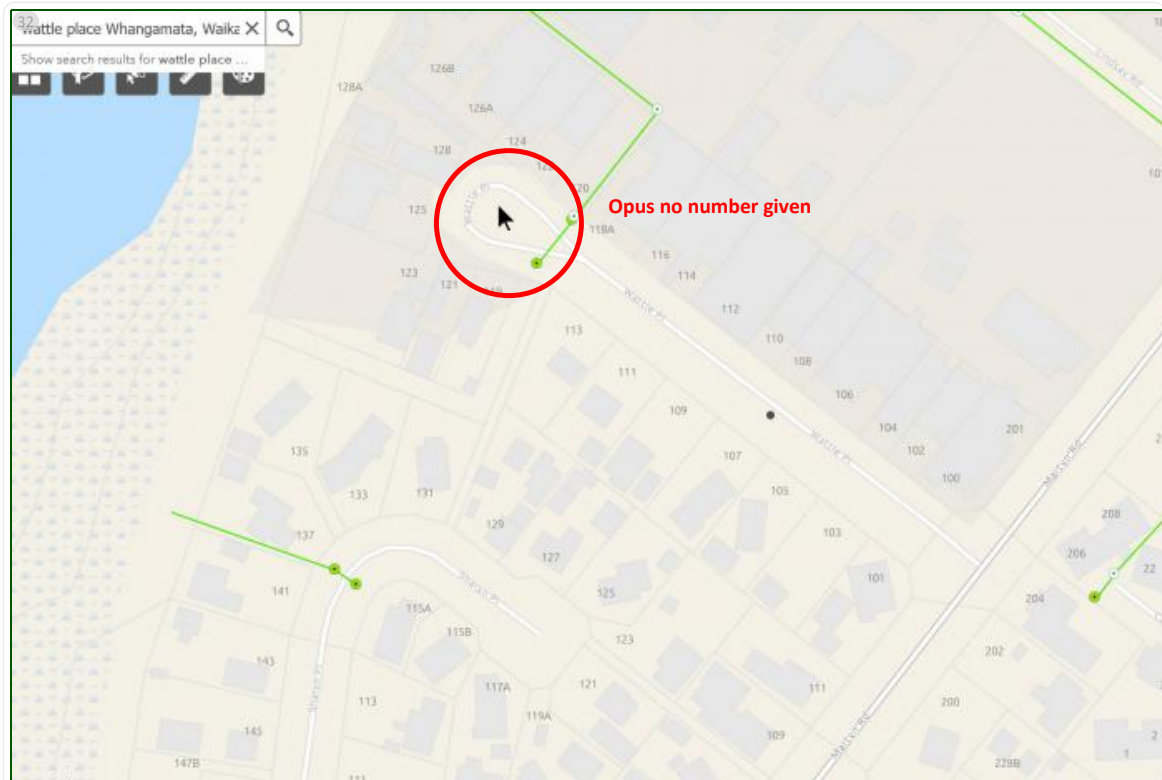
Wattle Place 001SM.jpg

Wattle Place: Flooding to factory accessways and properties

Construct a surface channel from end of road to estuary. Ensure existing kerb and channel is not blocked with gravel by cleaning out on a regular basis.

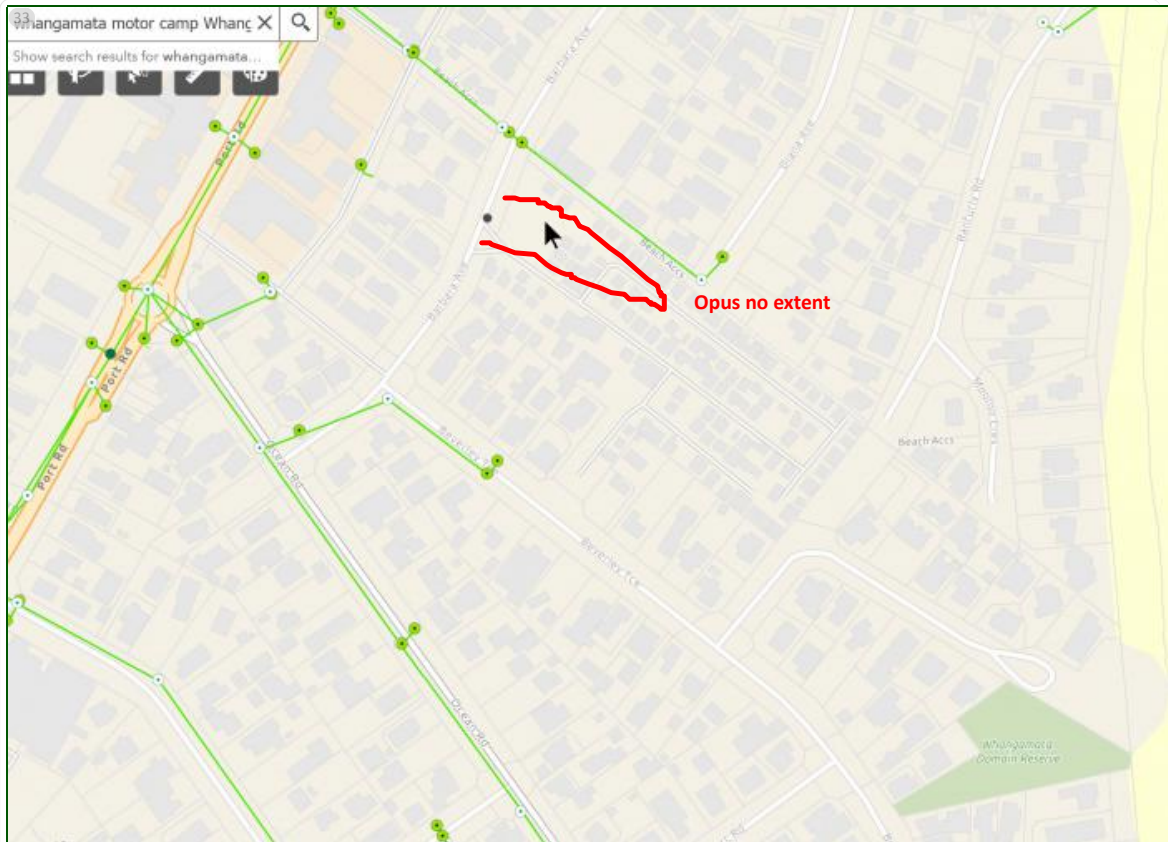
Whangamata Motor Camp 001SM.jpg

The motor camp has had overland flow, which has resulted in flooding of the camp ground in past years.

More investigation is required to adequately define source and extent of problem. May possibly be aided by construction of additional catchpit capacity in Barbara Ave.

Address this area through specific flood investigation prior to any redevelopment.

\$16k \$19k \$21k Confirm nature and extent of stormwater problem.

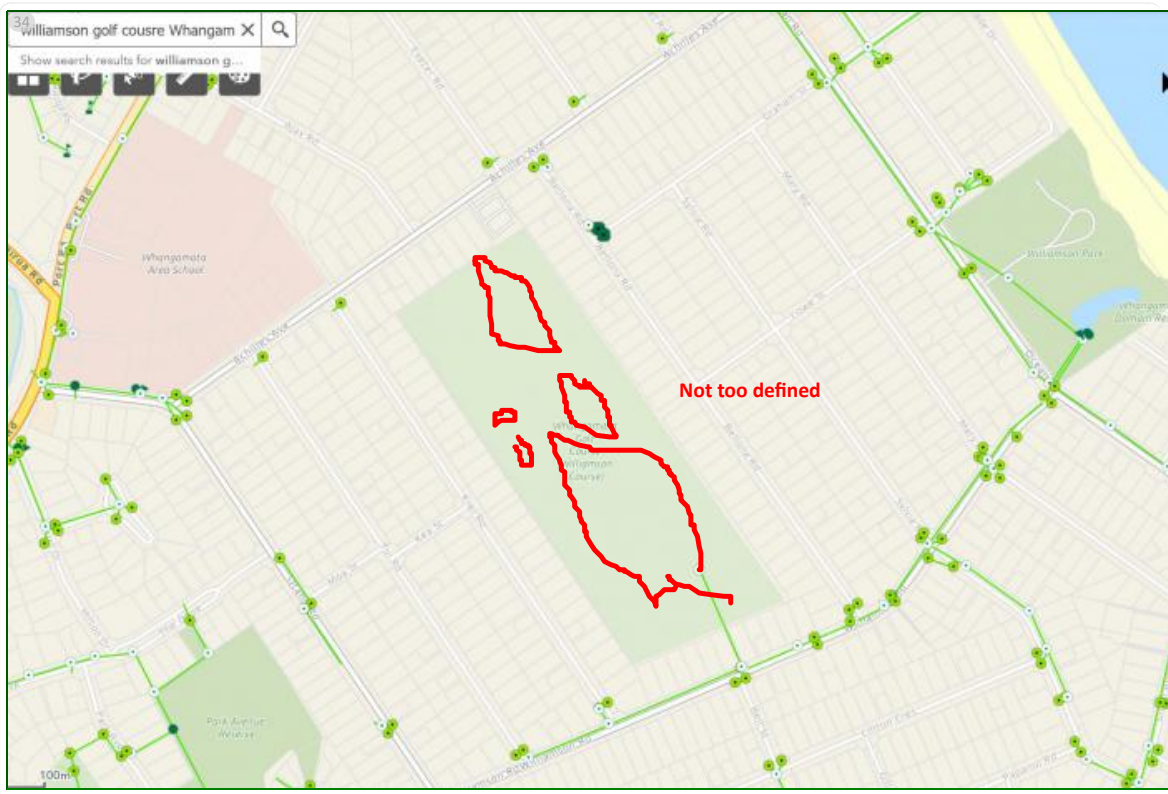
Williamson Golf Course 001SM.jpg

A number of properties surrounding the golf course report some stormwater issues. The golf

course is bounded by a number of mounds resulting in ponding between the golf course and the houses bordering the course. The golf course also reports issues, which are probably related to water ponding on site.

A site survey is needed to confirm levels and define the precise nature of the problem.

The golf course represents a large pervious area, and it may be practicable to utilise the soakage potential of the site. Once survey is available it may be practicable to re-contour to move floodwaters away from the private properties and manage them on the golf course

\$19k \$22k \$25k A specific investigation is required to determine the reason for the reported house flooding. A soils/soakage investigation is therefore also recommended.

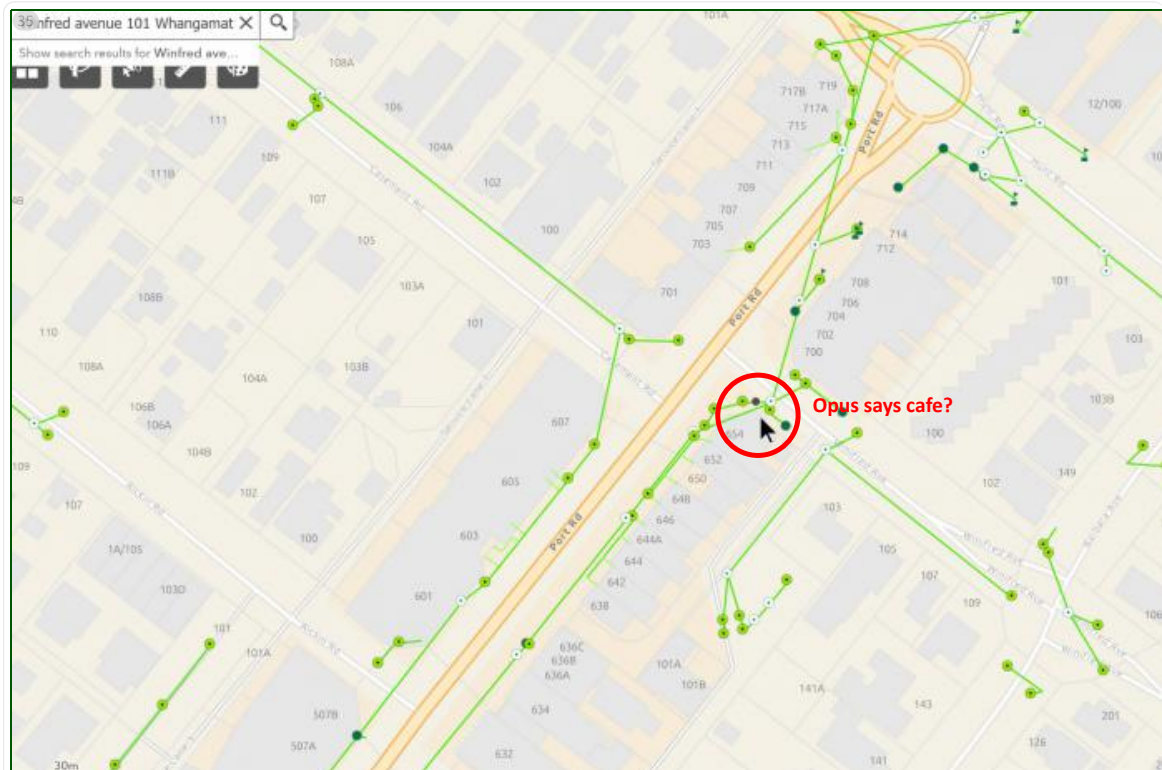
Winfred Avenue 101 001SM.jpg

Winfred Ave 101: flooding of café, due to inadequate stormwater system and cesspits

Option 1: Install soak pit in car park

Option 2: Install gobi blocks in car park
