### Folder [Flooding 20240222 Photos collected]

WRA Whangamata Rate Payers Association > Folder [Library: Stormwater Working Group 2023]

## 20240222 Flood Event

Overnight 29249221 and into the morning of 20240222 its reported we received 40mm of rain.

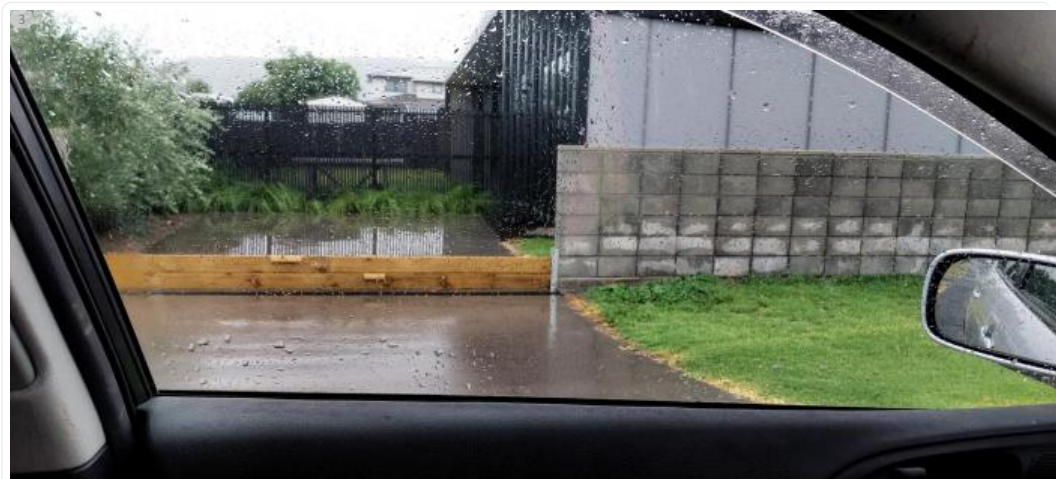
20240222 Aickin 114a 2.jpg

114A Aickin new build 2022 - FFL about -250mm flooded in Gabrielle

Owner has installed defences - concrete block wall, boarded gate and pump.

NB: Water did not get down to 112 Aickin so never tested new defences

Can see trespass water but not to stage of flowing

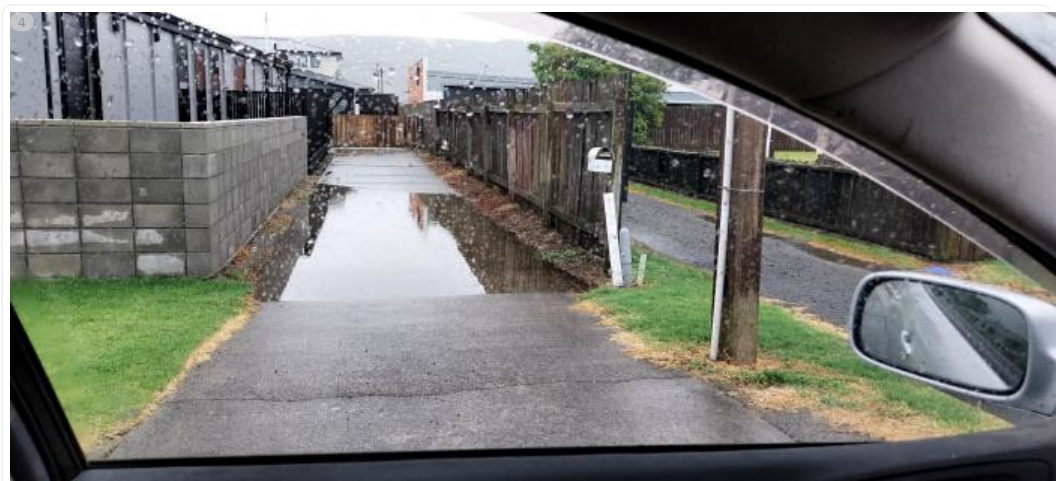
20240222 Aickin 114a 3.jpg

Driveway to 114 Aickin ponding water

114A defence the block wall has contained the water.

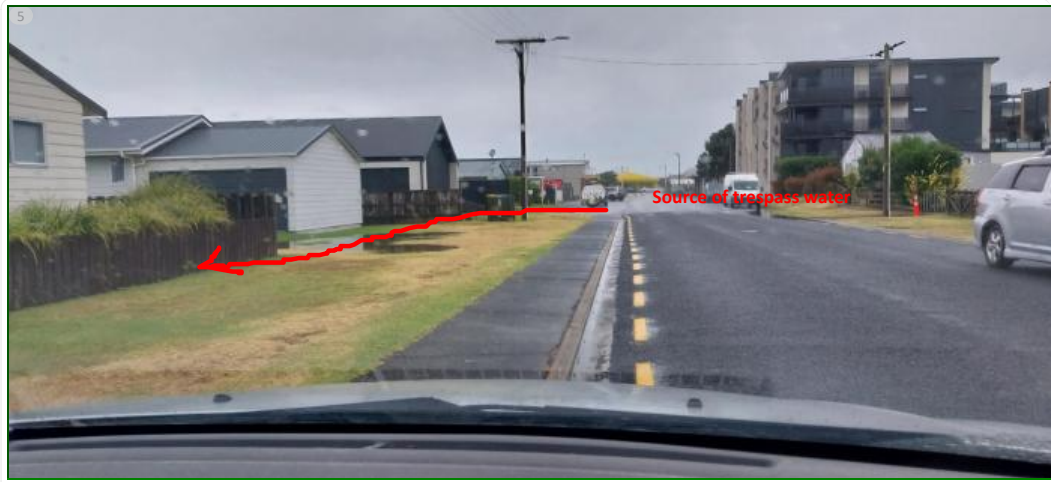
20240222 Aickin 114a 4.jpg

Top end of Aickin

Trespass water comes in over curb and channel then along verge and into properties below verge.

Ponding flowing down now.

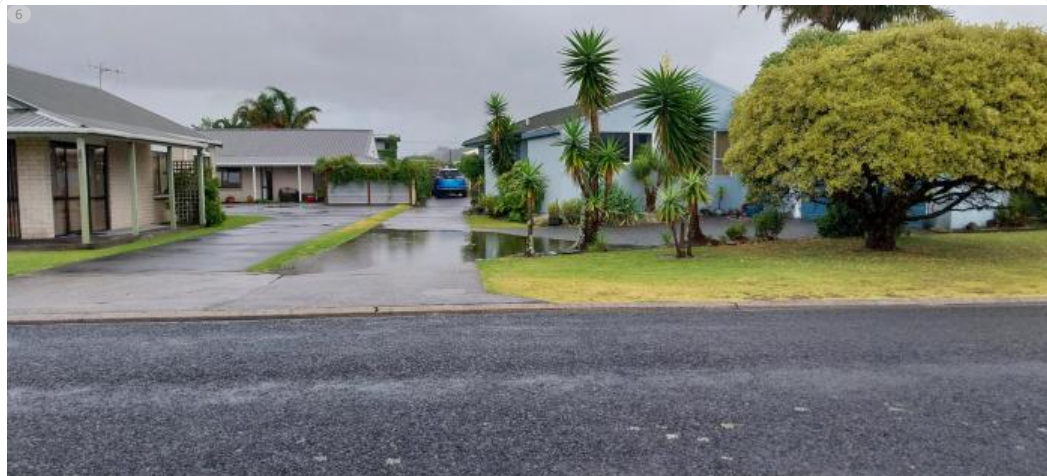
20240222 Aickin1.jpg

Opposite 114 Aickin driveway below road crown receives road water and verge water. NB: Verges less permeable as compacted. In Gabrielle ponding went right up to blue car.

Left of screen owner has installed pumps

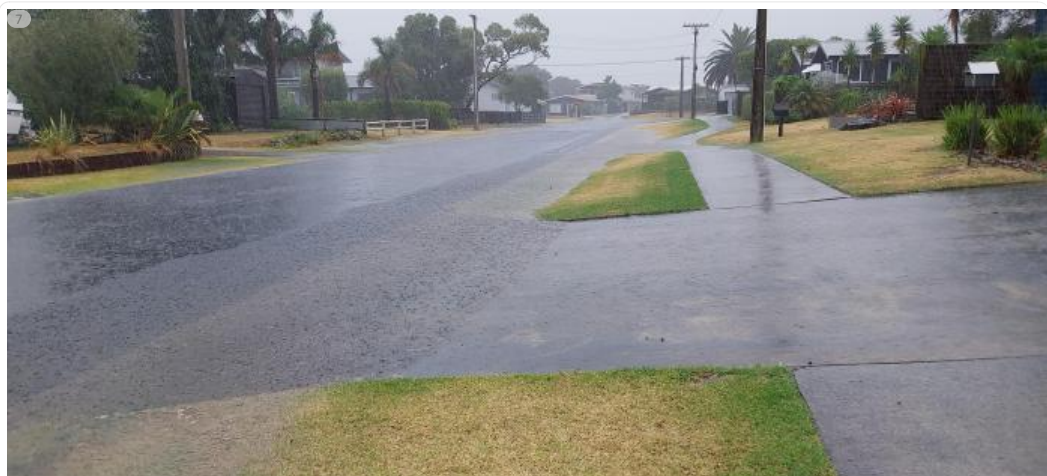
20240222 Bellona 223 onwards.jpg

Bellona from 223 looking down

NB: Verge well formed BUT at power pole driveway has been dug to just above level for 2 story home. This flooded in 2017 through the block basement and came up through cracks in the concrete floor.

Water enters driveway BUT does not get to garage in these smaller events.

NB: verge on opposite side also well formed and above the road.

These properties get nuisance surface flooding but it soon goes away.

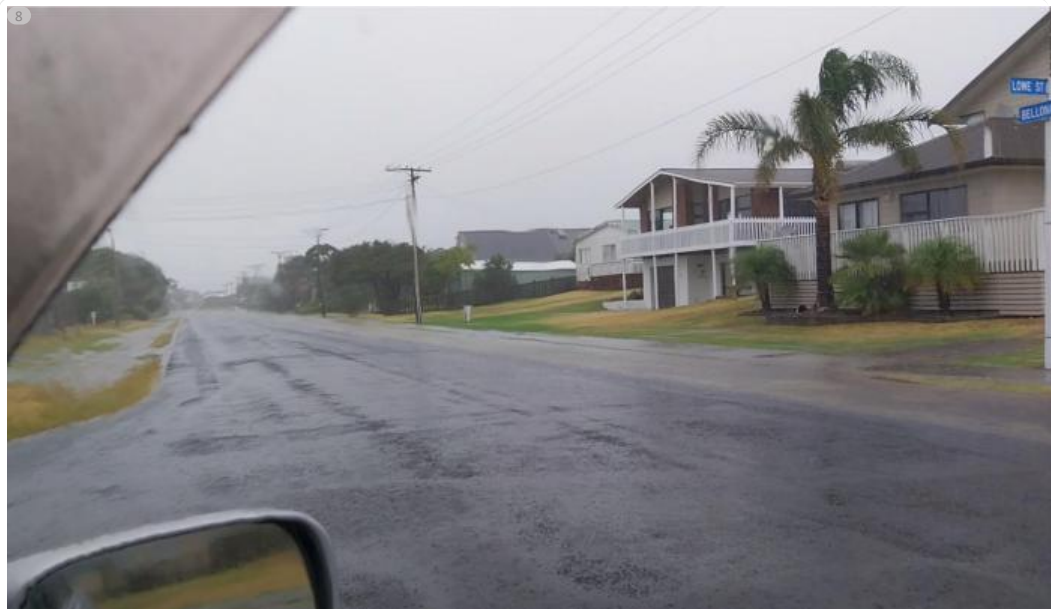
20240222 Bellona from Lowe intersection.jpg

Bellona from Lowe Street

NB: Verges good example of containing road water.

NB: The soakage devices are too small to absorb the 40mm overnight. It took a day and the soakage pits caught up.

Bigger soakage devices would contain this water and prevent it rising to breach where verges are lower or not well defined or altered to create driveways.

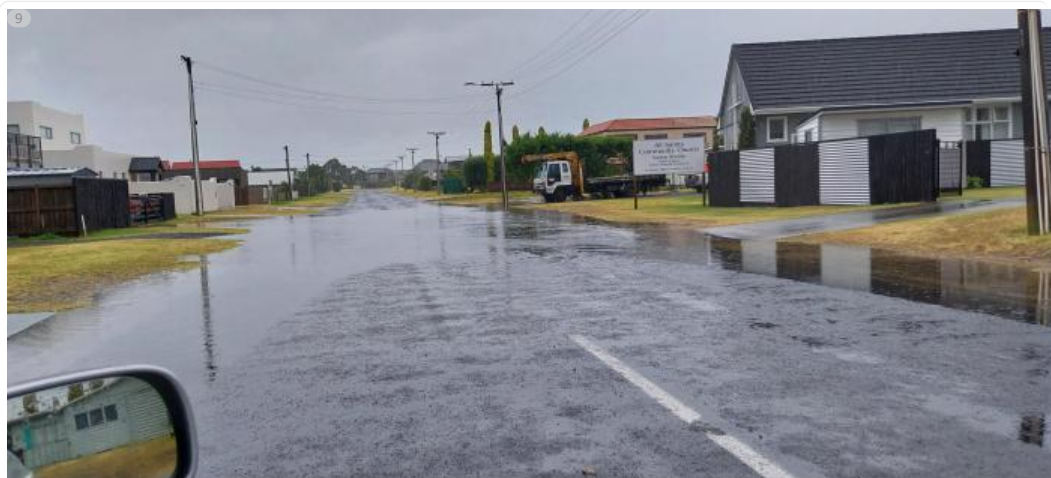
20240222 Beverly1.jpg

Beverly at Barbara end where the Church is.

Water has nowhere to go. Relies on soakage through impermeable verges or runoff onto lawns.

Needs extensive soakage pits which will only work when water table is low.

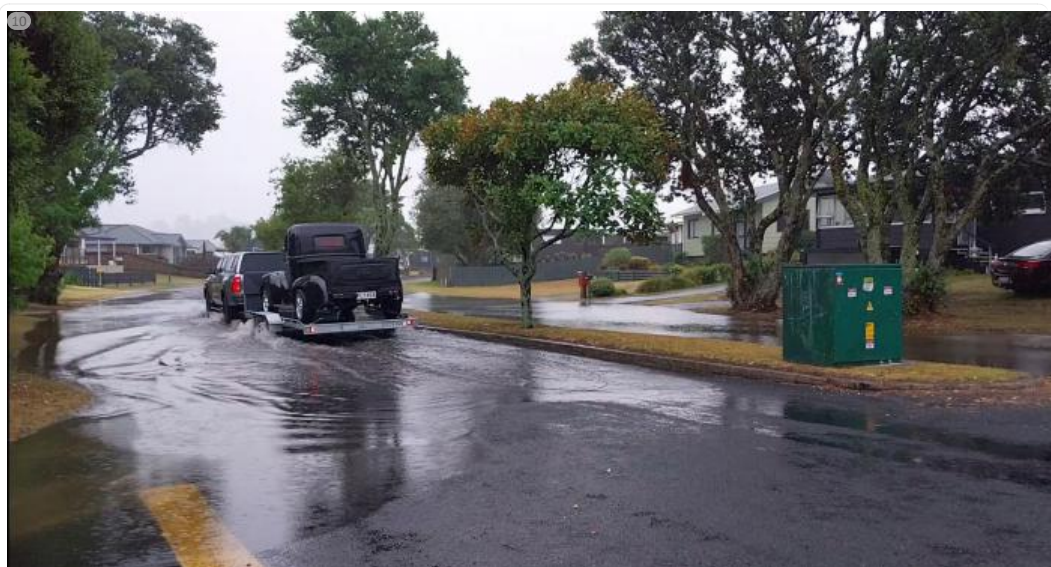
20240222 Chartwell.jpg

Chartwell remained passable but car owners were thinking twice.

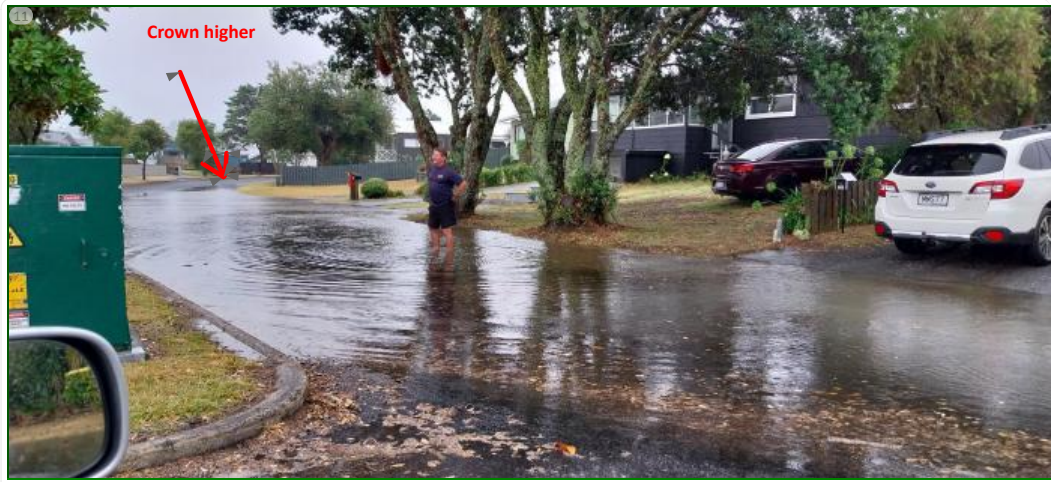
20240222 Chartwell sumps clear but not draining.jpg

Chartwell at about 10am 20240222

Owner of property by white car was out checking the grates on the sumps - all clear but nothing going down drains. He has sandbags at the ready because depth of water gets a lot higher

Dave said the FireService generally have to call in here often.

NB: the road has a dip here - can see the crown in the distance.

Port Road is higher this end by at least 1m.

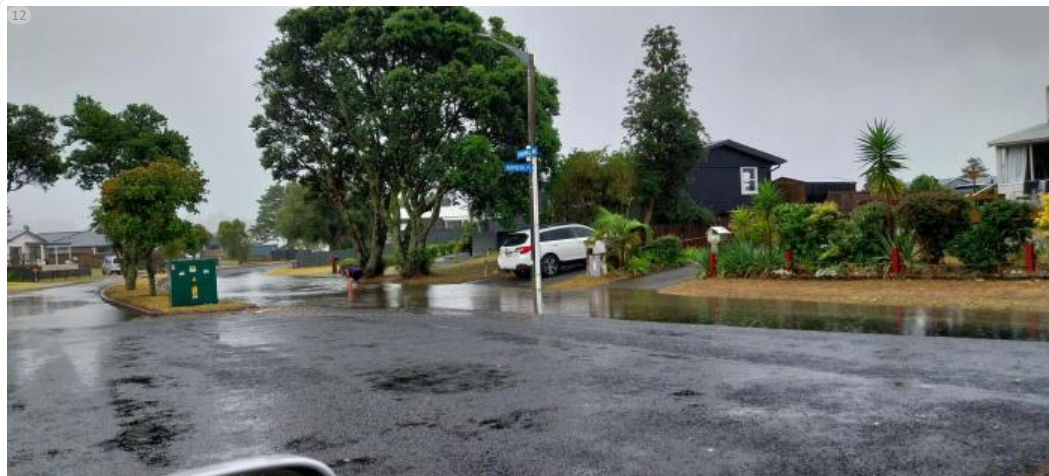
20240222 Chartwell2.jpg

Chartwell

Well formed verges but not every property

Water comes down from Port and back from the 2 side roads

This becomes the central depression of the area.

Trees in middle of the road have been cut down

Concept is lots of space to form good overland flow path - just needs somewhere to go and not flood downstream properties.

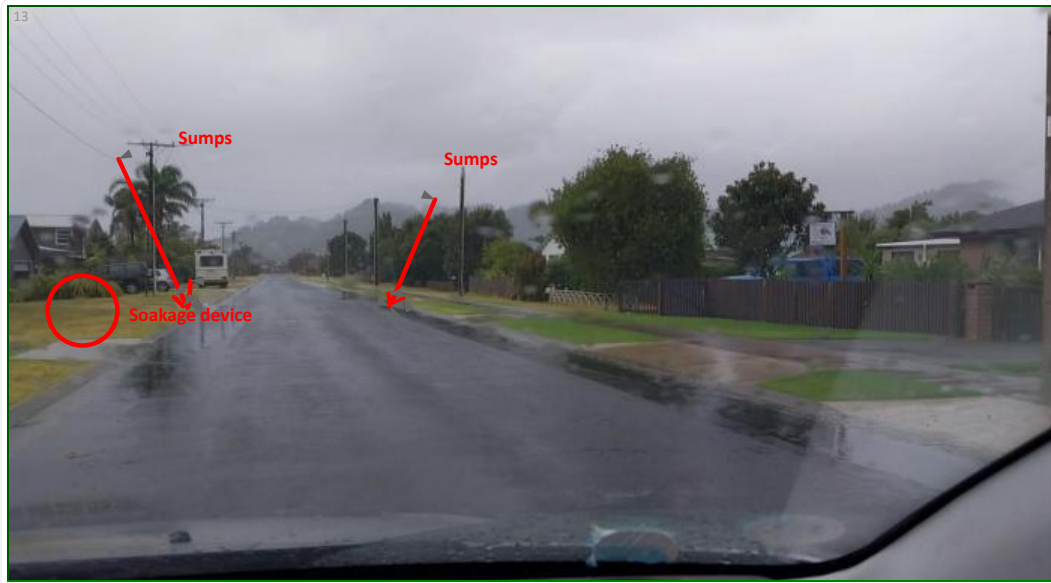
20240222 Kiwi at 110 looking down.jpg

Kiwi Rd was not as flooded as expected.

Some very minor ponding on lawn of 110 but not much.

Sumps are full and water went down to Kea.

Verges not adequately formed along a lot of Kiwi.

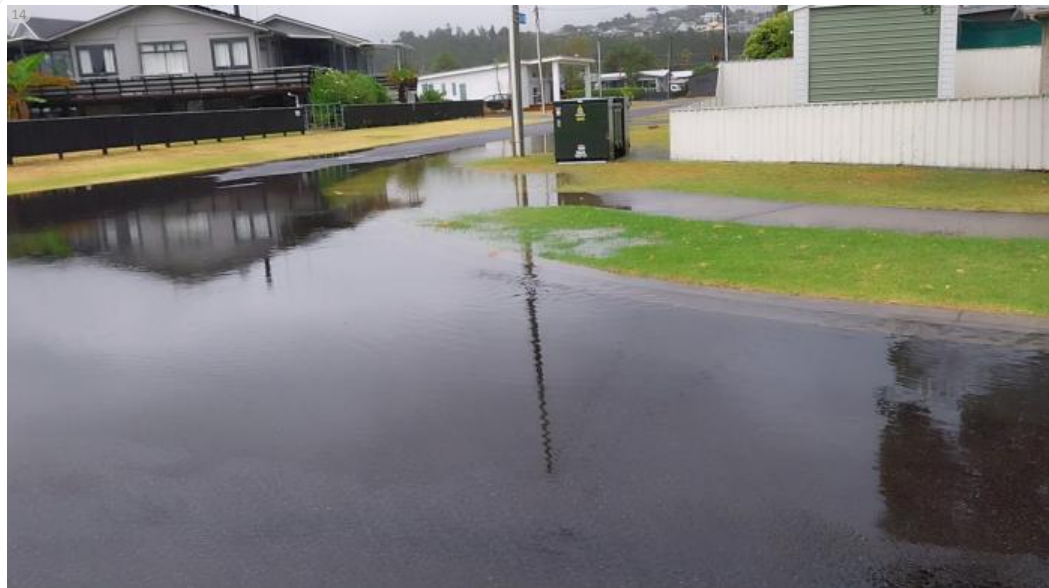
20240222 Kiwi Kea.jpg

Intersection Kiwi and Kea - has series of sumps collecting water and taking it to a soakage device which is completely overwhelmed. Even with a low water table.

If rain carried on the depth of surface ponding would increase and trespass onto a lot more properties (at depth)

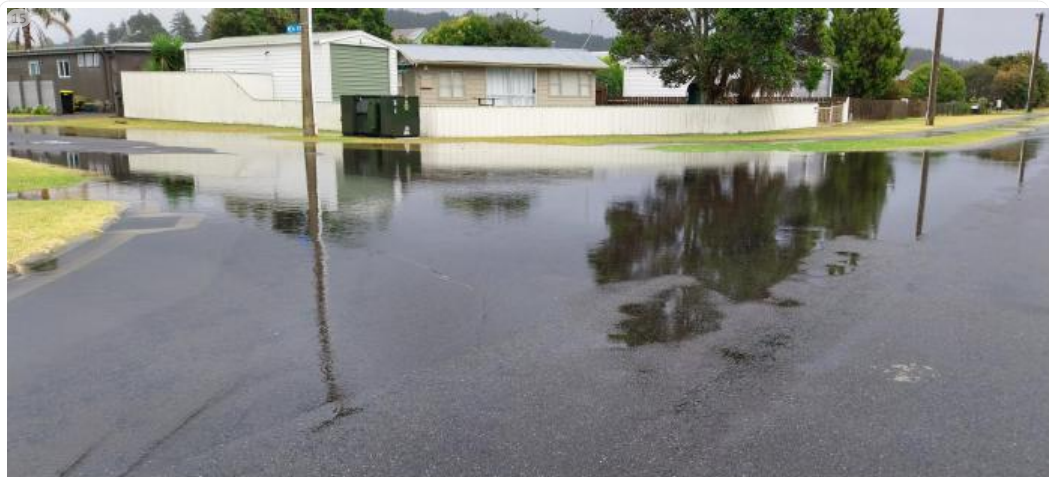
20240222 Kiwi Kea intersection.jpg

Kiwi Kea intersection wider angle looking back from Williamson end

Can see the grates are flooded.

All gone by the next morning.

Means soakage works but soakage surface area too small

Also means soakage device if uses as temporary detention device is under capacity.

NB: Without seeing LVL I would pick this is about 2-3m above Park Avenue Reserve

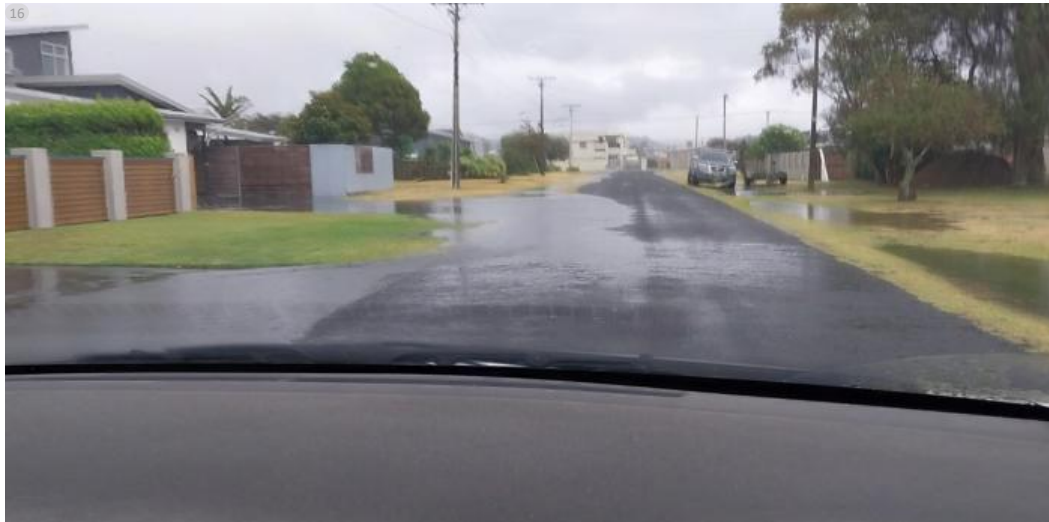
20240222 Mary down to Graham.jpg

Mary looking down to Graham

NB: Verges fall away from the crown.

This allows trespass water onto low lying private land.

The lower the ground the deeper the ponding.

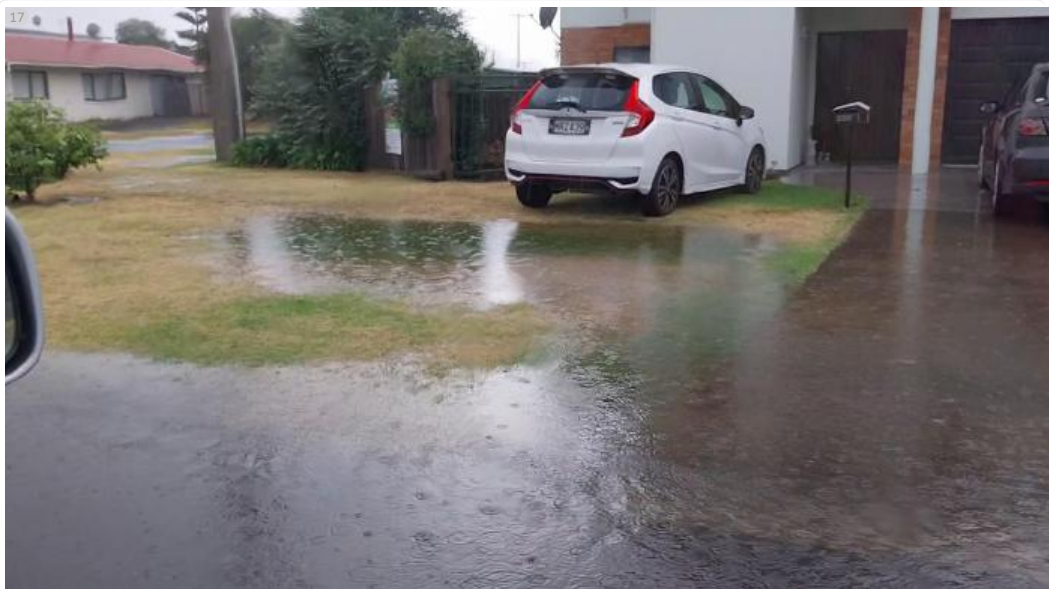
20240222 Mary or Sylvia (2).jpg

Verge merges into driveway all below crown.

Flooding eminent.

No overland flow path down verge to Ocean Rd

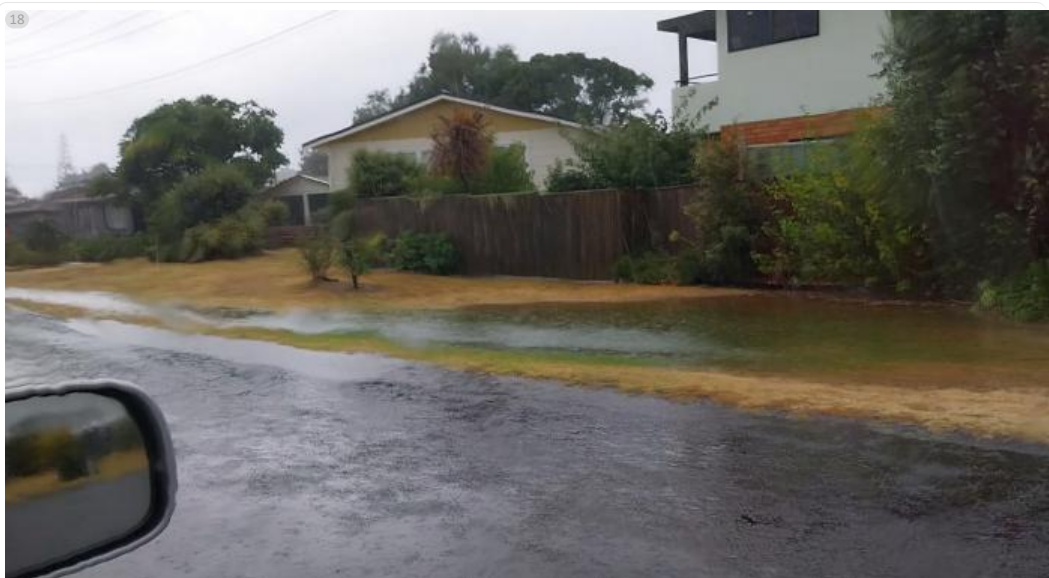
20240222 Mary or Sylvia.jpg

Mary or Sylvia same issue road water and verges only partly formed flowing through low parts of verge into properties.

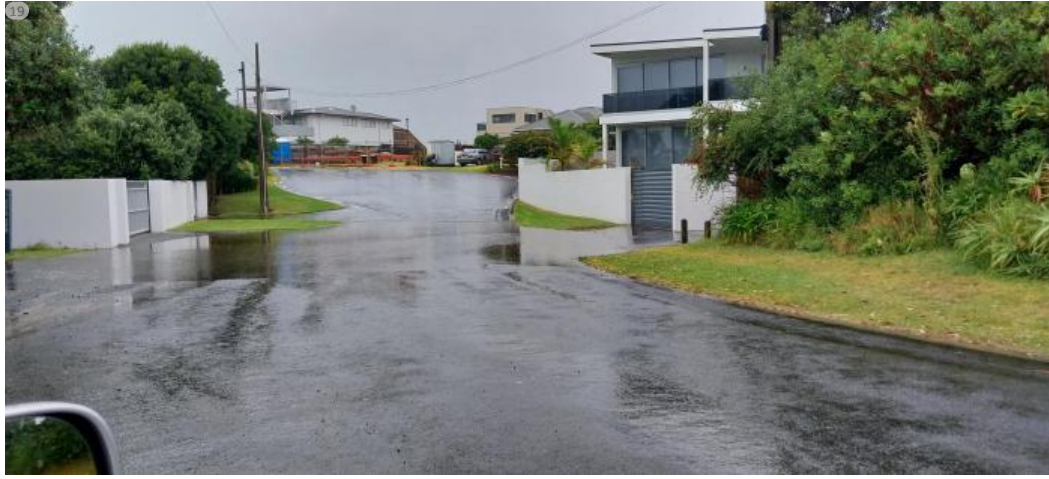
20240222 Mooloo1.jpg

Mooloo was impassible in my car - too deep.

Mooloo features in Opus - no solutions as the road level is below King Tide

Advice was no further impervious for this area.

Despite this 5-6 new properties since 2003, now Ranfurly road is concreted and 5 more BC approved at this end of the camping ground all with plans showing driveways flowing onto Ranfurly.

110 St Patricks has been ordered to remove electrical to basement as they predict 400mm deep flooding. That puts Mooloo at another aprox meter depth.

NB: Resource compliance must stop consents

Fill road up by 1.5m so its passable - that means at least 8 homes will be below the new crown. All driveways will need redoing.

Garages lifted.

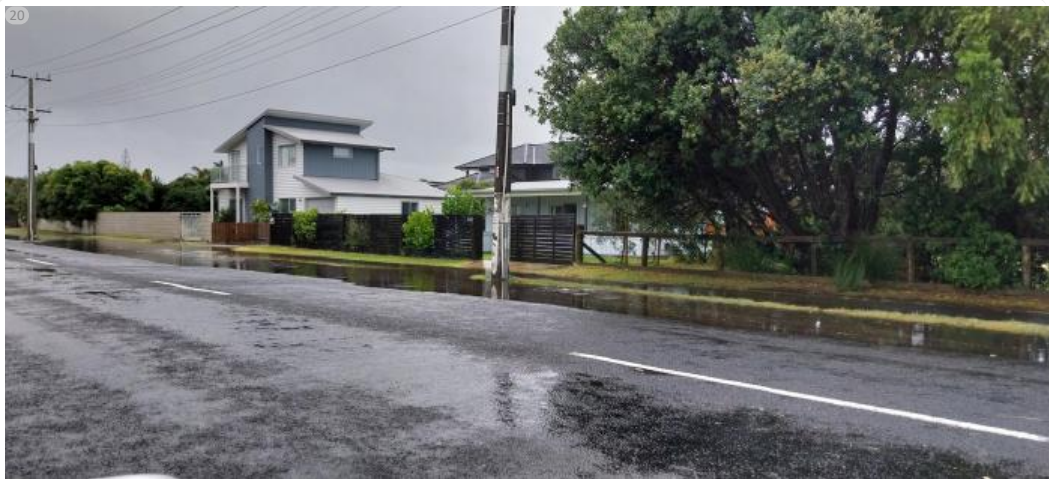
20240222 Ocean 210a.jpg

210a Ocean Rd

Flooding partly managed by verges but not to all properties

Because the drains don't work the surface flooding gets deeper until it breaches poorly formed verges.

The road should be the overland flow path but to do this it must have verges well above the crown.

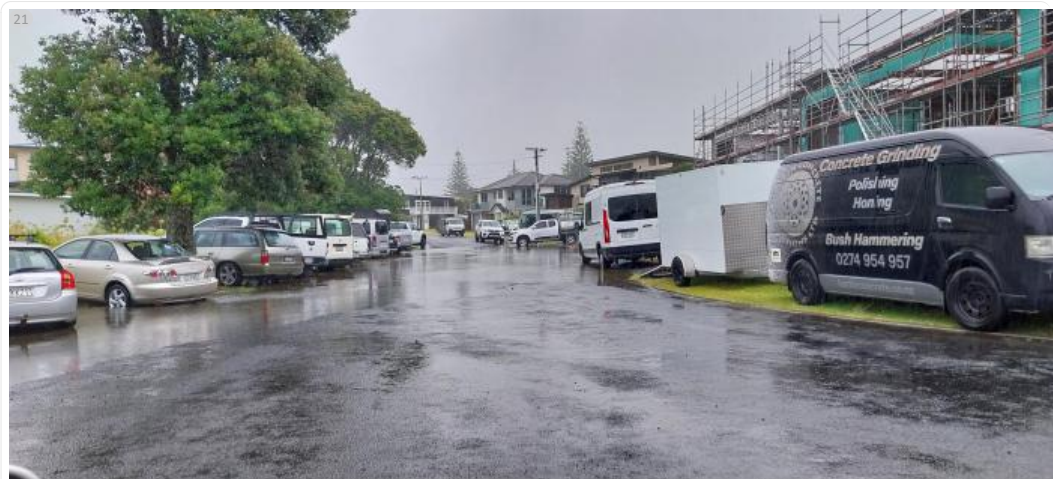
20240222 Ranfury.jpg

Ranfury from Winifred end showing road water with vans parked in water.

This end of the road always floods

The sand dunes are higher so has no flow path away.

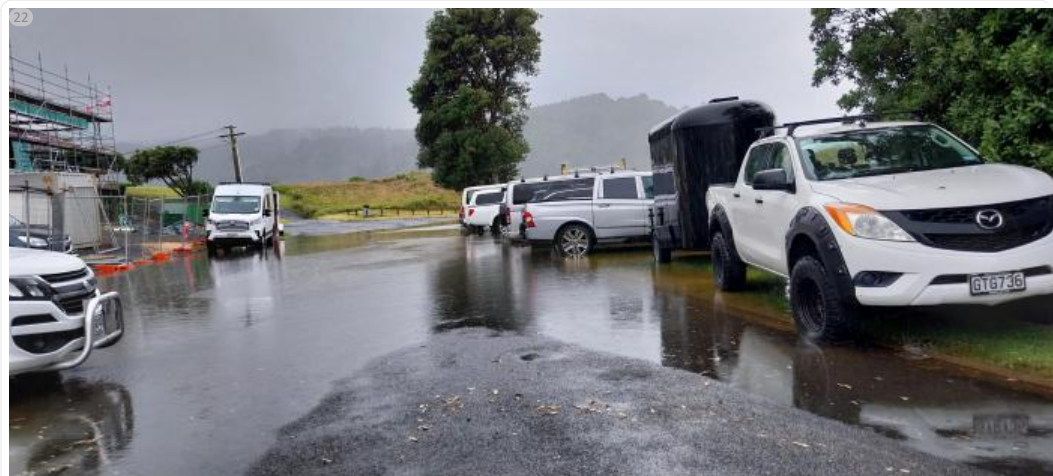
20240222 Ranfury3.jpg

Ranfury looking to Winifred better angle showing deep water. My car went through okay but would have come in through the doors ie crown is flooded.

There is a property further along with a dug out basement for his boat. Water does not seem to get that deep to build up this far down Ranfury.

The corner is the depression.

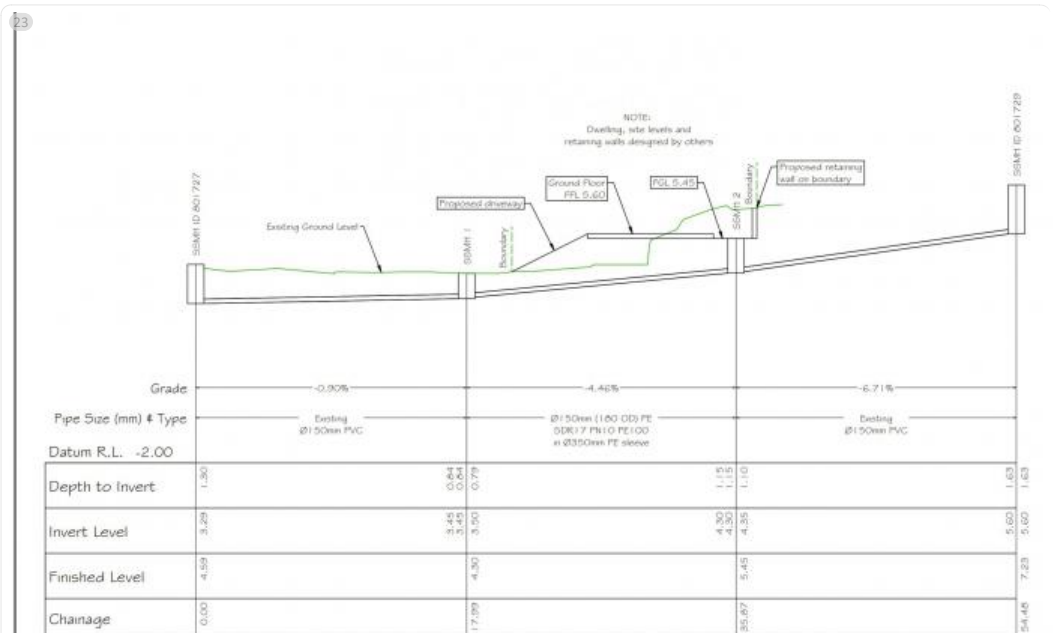
20240222 Ranfury4 cross section FFL.jpg

This is the cross section for the 3 new apartments.

Crown is 4.3 (not specified but looks like)

FFL 5.6 so about 1.3m above crown so probably around 600mm above high water mark.

I haven't looked at all the plans but don't see contour lines of dunes height.

If water was to run over the dunes it could scour like Island View has when Pipi overflowed and washed out from the toilets to Hinemoa.

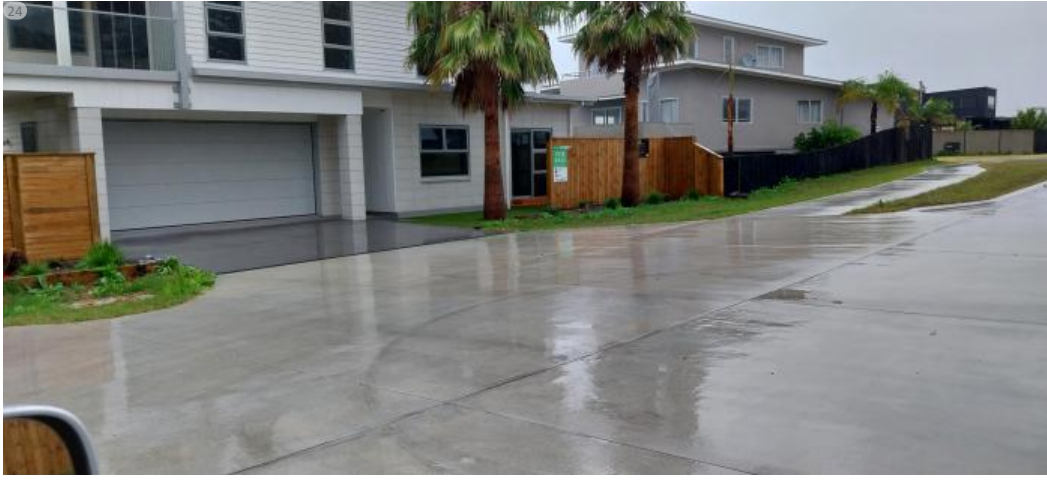
20240222 St Patricks Ranfurly new houses.jpg

Showing Ranfurly extension and 2 new townhouses with 110 St Patricks behind - the consent for the new townhouses included an order to make basement uninhabitable as it expects 400mm depth of flooding.

NB: The plans for 110 St Patricks have a out of date satellite view before the 2 lots of 110 Mooloo got built. These 2 homes have built a retaining wall through the old overland flow path. They are on wooden floors but maybe not to the expected new depth with all the additional impervious runoff.

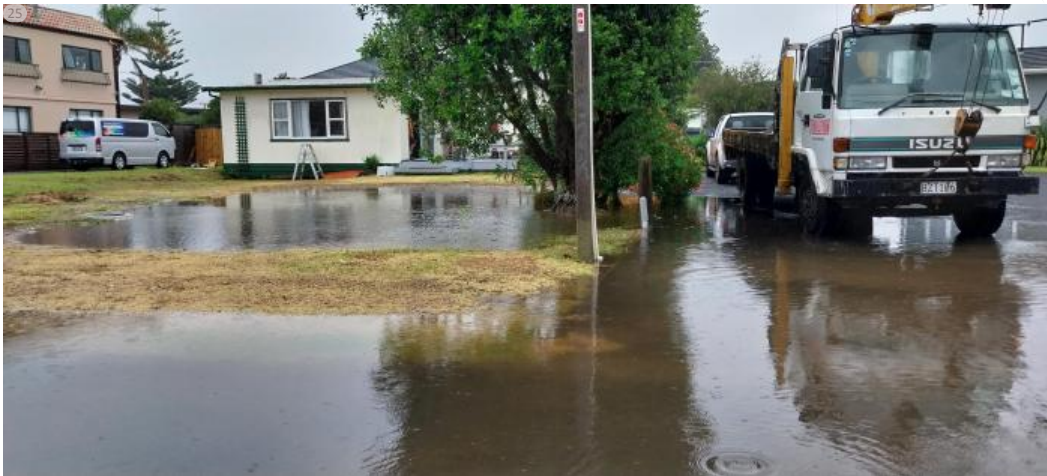
20240222 St Patricks and Beverly.jpg

Need to check but corner of St Patricks and Beverly surface flooding

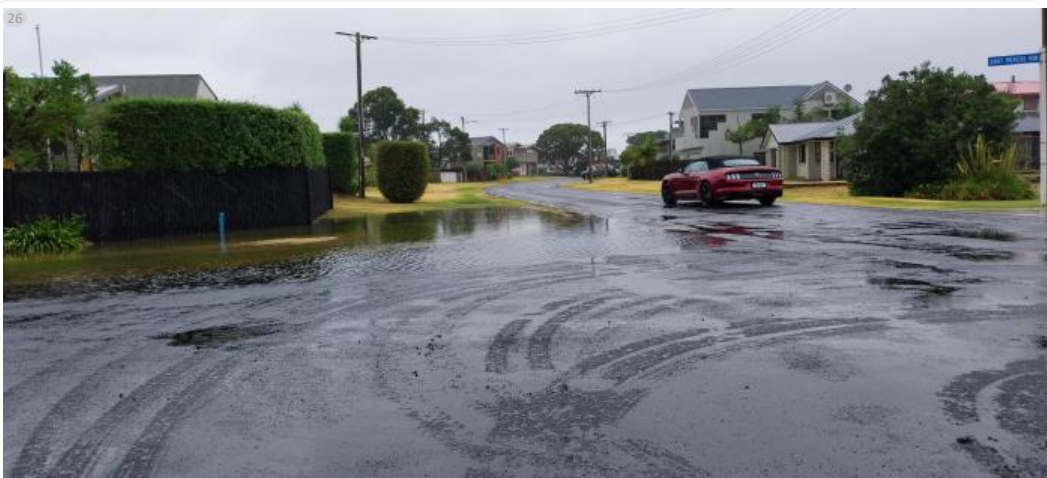
20240222 St Patricks Beverly.jpg

St Patricks and Beverly flooding

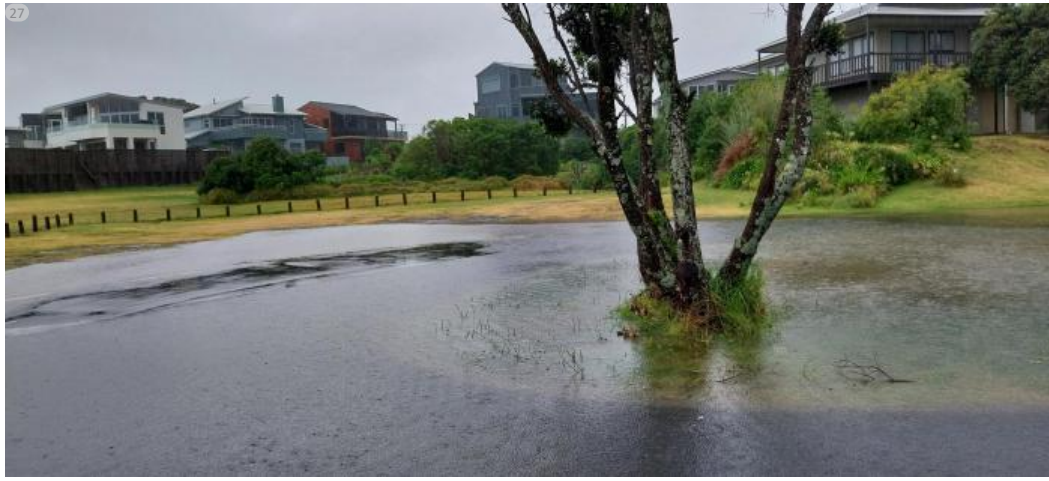
20240222 St Patricks turnaround.jpg

#### Turnaround of St Patricks

This was much deeper after Gabrielle and remained for months with the winter rains. Was impassible.

Needs accurate contours BUT may be good as a natural depression to drain the surplus water.

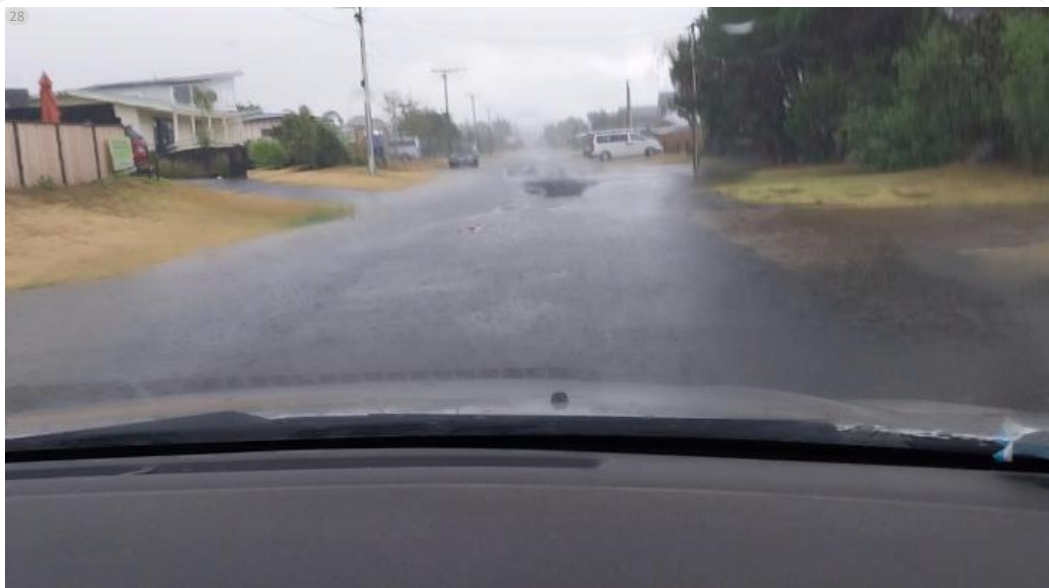
20240222 Sylvia from Williamson.jpg

#### Sylvia from Williamson Rd.

Massive ponding right across the crown

Verges not well formed to right.

What is preventing water flowing to Williamson is the way verges and driveways have been formed.

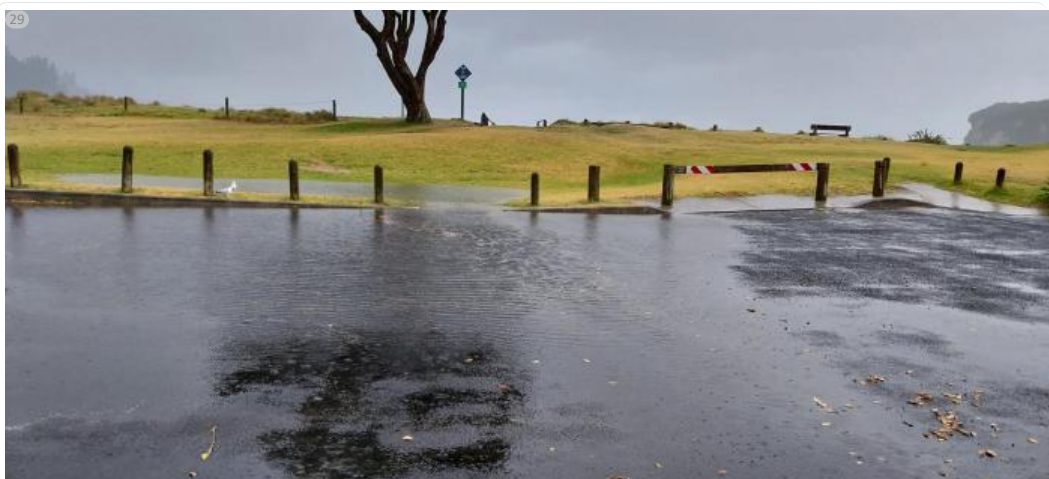
20240222 The Esplanade.jpg

#### The Esplanade at Graham end.

This is where council cut off the crown and directed water to a new soak pit and detention pond dug into the dunes where the ponding is.

This is relatively recent work the rumour mill says is by agreement with the owners of 203-205 (4)

that get flooded by trespass water - prevented being sued.

Since the work was done the sump gets continuously blocked with sand - the blow ups put sand right across the road and onto the lawns - once the sand was above the curb and channel. The depression is probably half its original size through build up of sand.

Lesson here is no sumps within range of blow up sand - or if they have to be there they need cleaning out after every blow up.
