MEMO

Subject: WILLIAMSON ROAD STORMWATER ASSESSMENT

Date: 9 May 2018

File number: J000056.01

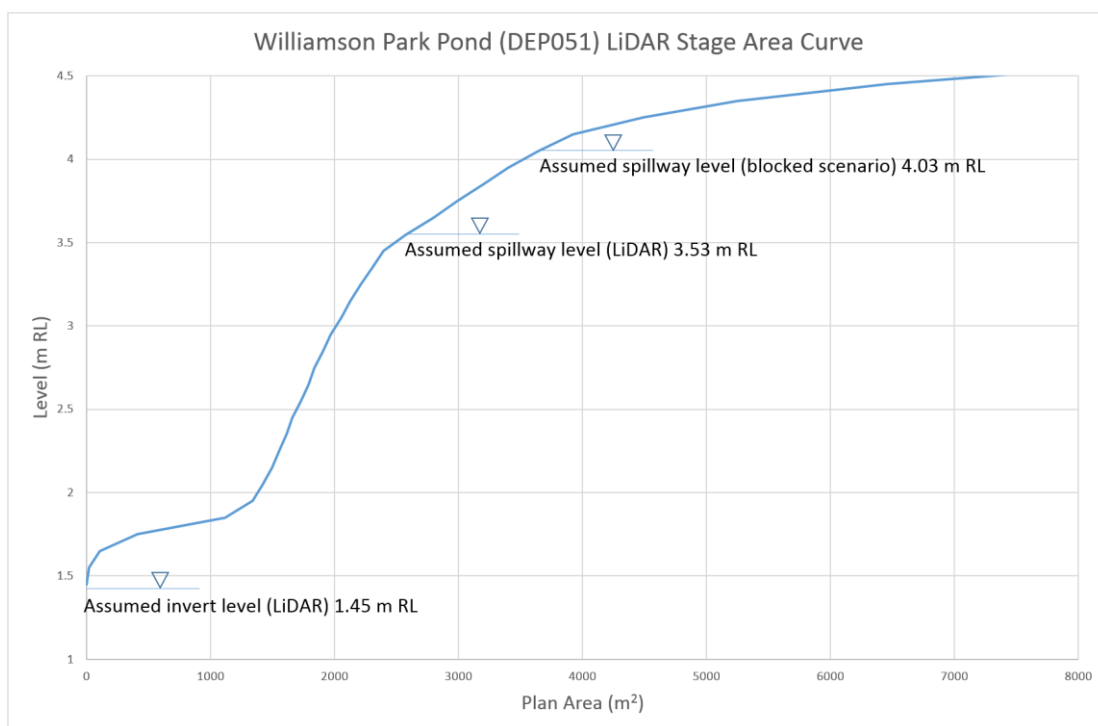
The Williamson Park Pond geometry has been modified to represent the surface shown in recent LiDAR capture. The corresponding stage-area curve of the basin is shown in Figure 1 below. The spillway geometry was also modified according to the cross-section of the LiDAR surface at the overflow level, shown in Figure 2 below.

Figure 1 Williamson Park Pond Stage-Area Curve based on LiDAR surface

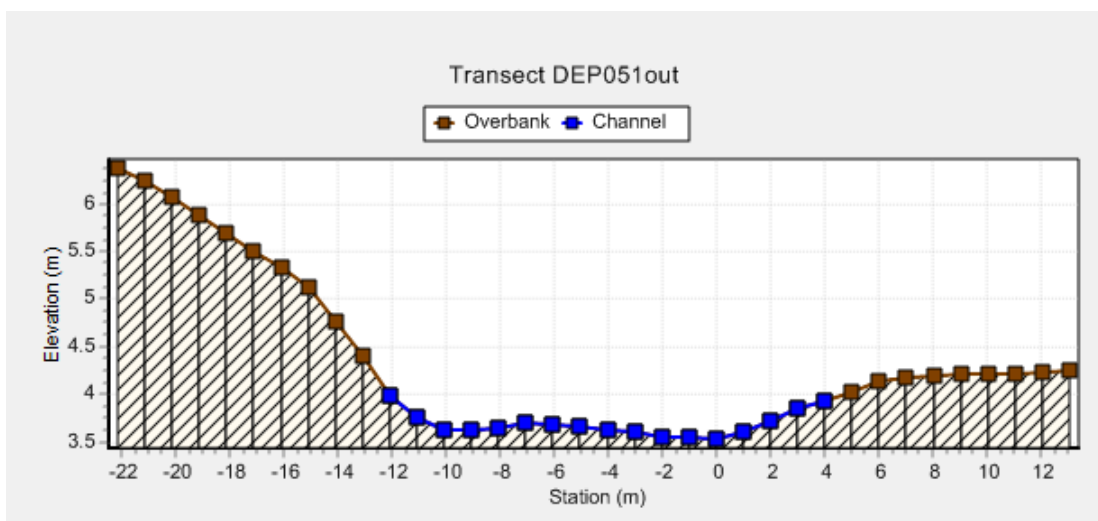
Figure 2 Williamson Park Pond Spillway Cross-Section based on LiDAR surface

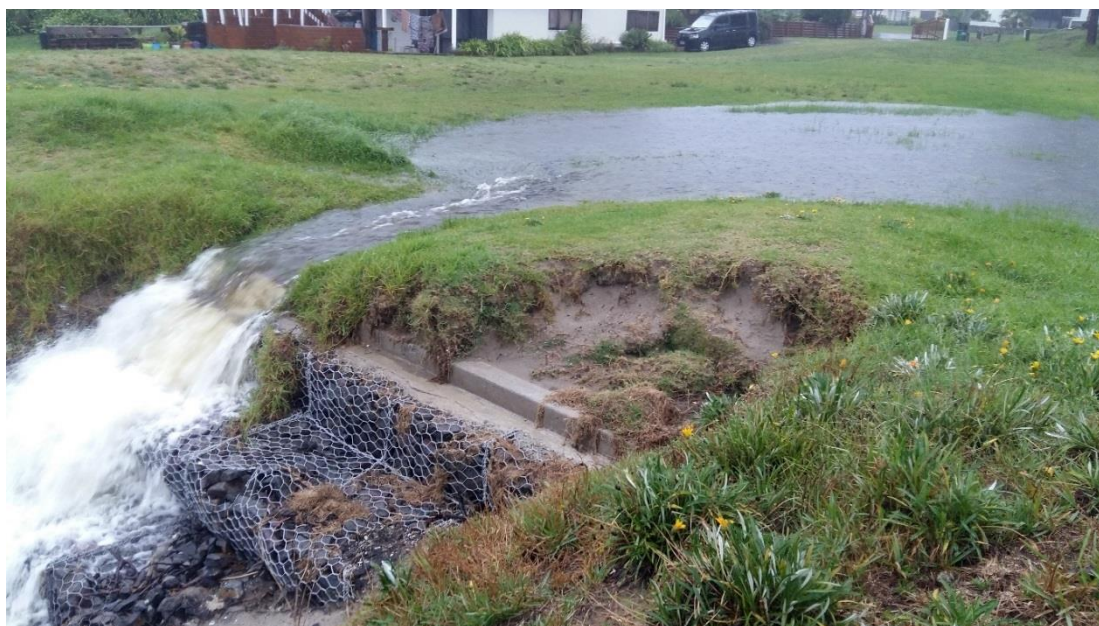
We understand that in April 2017, Williamson Golf Course and some adjacent properties experienced ponding for an extended period. During the same period, the Williamson Park Pond remained full, at a water level that was partly elevated by prior build-up of grass and sand on the overflow spillway, reportedly raising the spillway level by about 500 – 600 mm over the original level.

Note that under this scenario, the spillway level is at 4.03 m RL. According to design drawings for the spillway, overflow levels at the time of weir construction appear to be at a maximum of 3.0 m RL (Riley Consultants Drawing 05284-1, Nov 2005, appended to this report). Based on this, and comparing photos of spillway clean-out on 5 April 2017 (figure 3), a spillway level of 4.03 m RL seems conservatively high above the spillway design level. Further survey is needed to verify the actual spillway as-built level and the level at the time of flooding. However, the levels as stated here are sufficient for this sensitivity analysis.

Figure 3 Williamson Park Pond Spillway with sediment build-up, overflowing 5 April 2017.

- Regular maintenance of the pond is recommended, including removal of sludge and periodically clearing sediment and vegetation from the spillway.
- If Council wish to carry out options analysis for additional work to address wider flood issues in the Williamson Road area, it is recommended that the 1D model is updated to a coupled 1D/2D model. Better efficiencies and economies of scale can be achieved if this is carried out for the entire Whangamata Catchment as part of a wider strategy to develop a Catchment Management Plan.

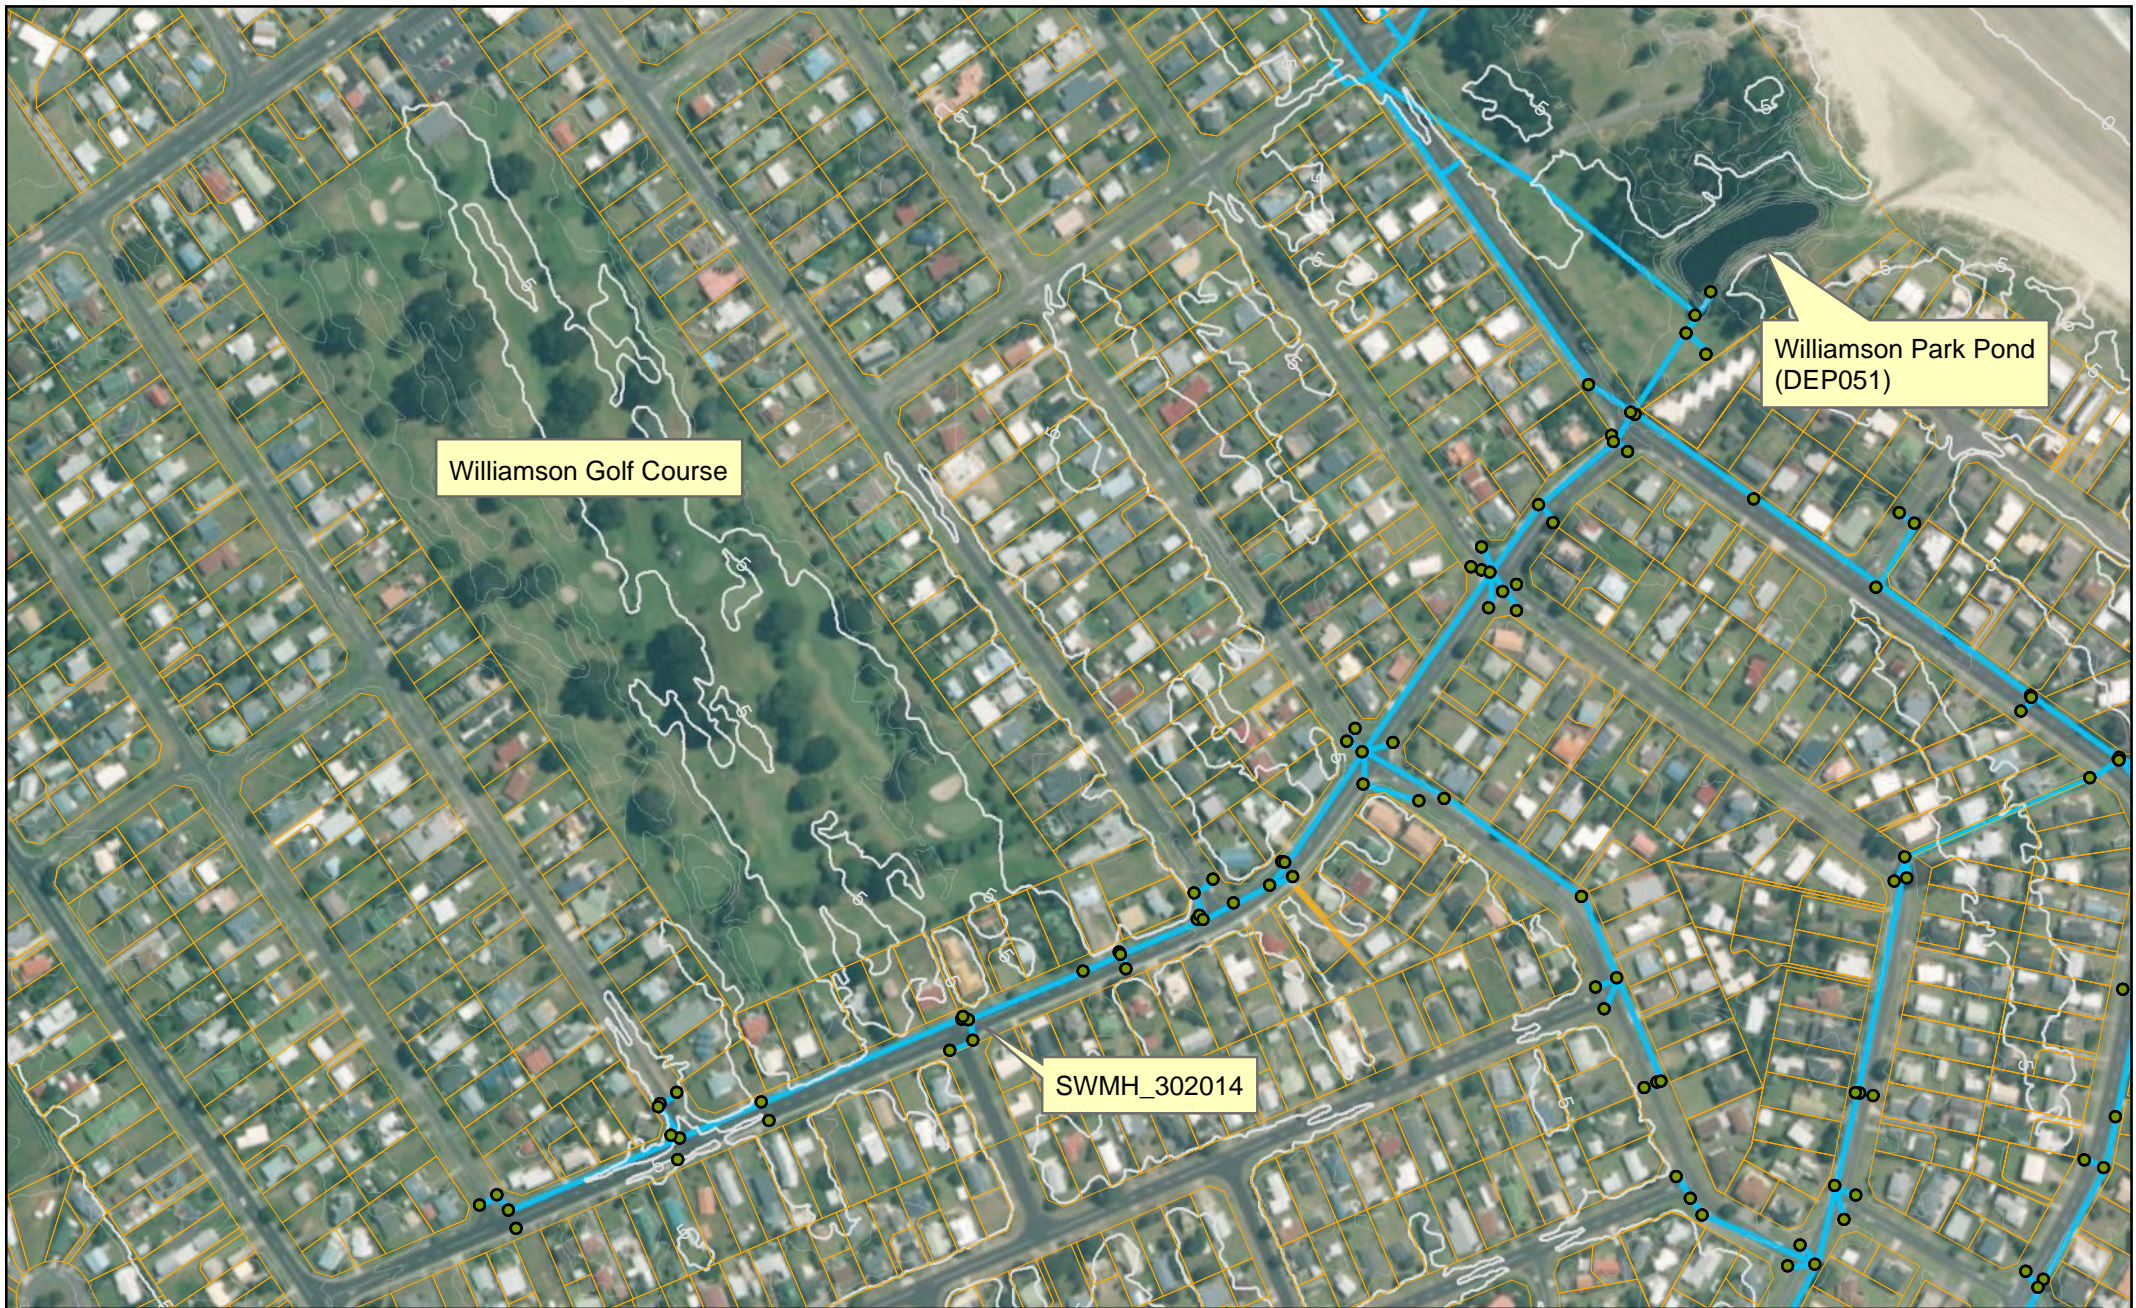
Figure 4: Williamson Road, Whangamata Stormwater Assessment

Note that surface depressions within the golf course area have not been explicitly represented in the model, so for the purposes of this study water levels have been examined at the manhole adjacent 312 Williamson St and the access corridor between the road and the golf course. The location of this manhole (SWMH_302014) and the Williamson Park Pond (DEP051) are indicated in the attached map (Figure 4).

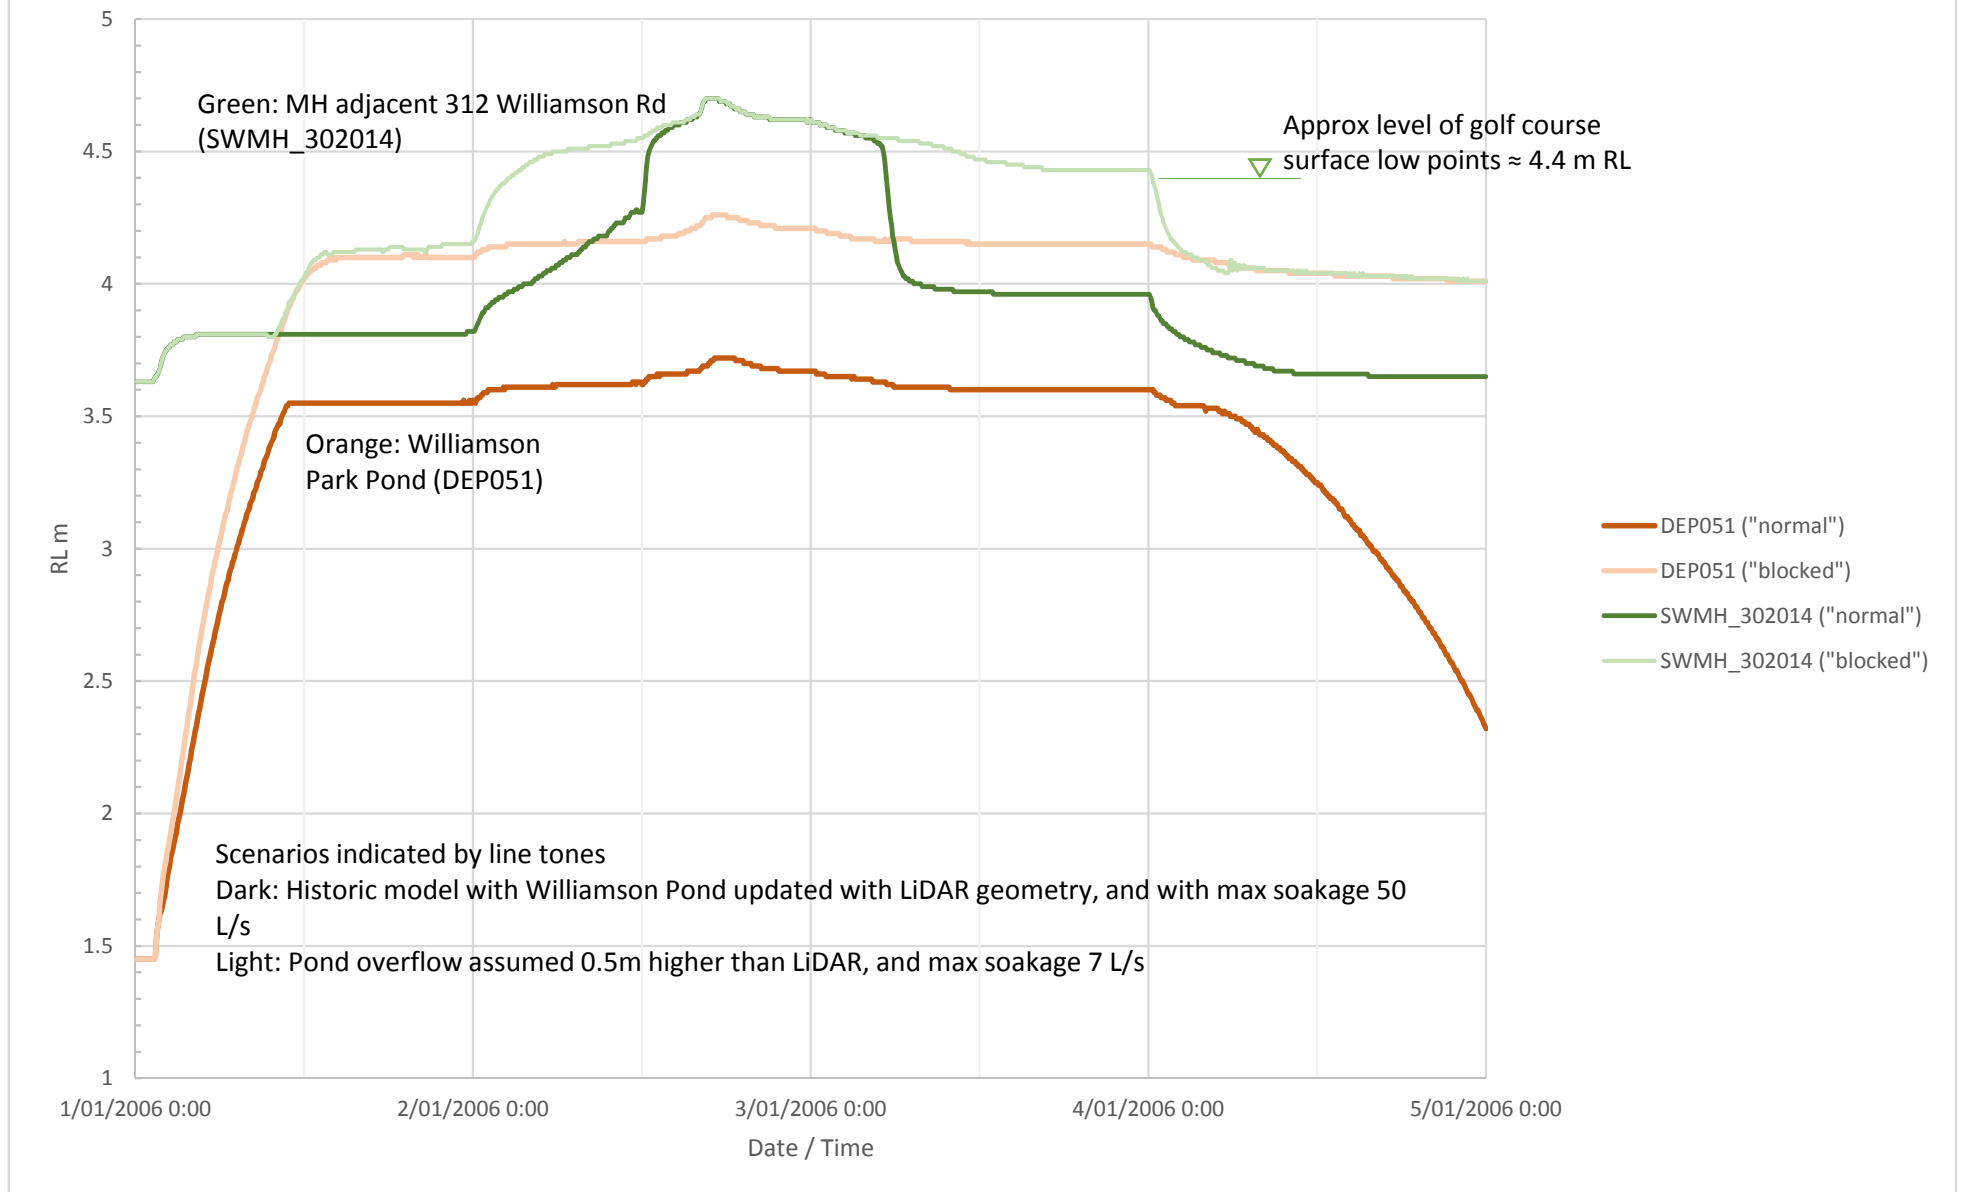
FIGURE 5: SWMM 5YR MODELLED LEVELS

Modelled 5-year TWL	
	“Normal” conditions	“Blocked” conditions
Manhole near Williamson Golf Course (SWMH_302014)	4.70 m RL	4.70 m RL
Williamson Park Pond (DEP051)	3.72 m RL	4.26 m RL

The results indicate that the actual peak water levels in the upstream network in the area of Williamson Golf Course are not affected by the spillway blockage and reduced soakage at Williamson Park Pond.

However, spillway blockage and reduced soakage at the pond does appear to affect the length of time that water levels are raised within in the upstream network. At the manhole near Williamson Golf Course, water levels are higher than 4.4 m RL for 17.1 hours under “normal” conditions, but 45.8 hours under “blocked” conditions (compare the dark and light green lines in Figure 4 attached). According to LiDAR information, low points in the golf course surface are at about 4.4 m RL, so flooding is expected when TWLs are above that level.

This longer period of elevated water levels near the golf course correlates to the experience of the ponding in April 2017. Interestingly, however, the model shows that when rainfall ceases (after timestep 4/01/2006 00:00), water levels in the network quickly drop to levels equivalent to the Williamson Park Pond, which in the “blocked” scenario are held at about the assumed spillway level just above 4.0 m RL.
