Stormwater Monitoring Programme:

***Ecological Assessment
Thames-Coromandel Urban Areas
2018***

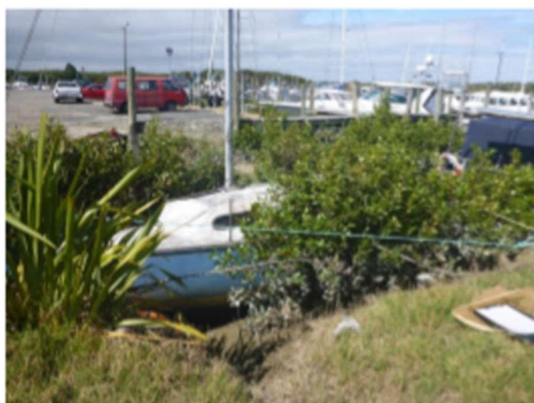
Photo 1. Site 1: Thames Marina.

The outlet flows into a short channel then into the estuary. The channel banks are moderately steep with a narrowly incised channel. The marine mud substrate was deep, with some gravel in the base and no woody debris. Flow through the culvert was very low at the time of sampling.

Mangrove seedlings present at the 2014 survey have established and were 0.5-1 m tall. Tunnelling mud crab (*Austrohelice crassa*) burrows were abundant over all surfaces of the channel. Rock oysters (*Saccostrea glomerata*), mud snail (*Potamopyrgus* sp.) and whelks (*Caminella*) were abundant. One mudflat snail (*Amphibola crenata*) was also found. Fish access into the culvert was not impeded, but is tide dependent. Oligochaete worms and Tanypod fly larvae were present in the 2014 survey, but were not observed in 2018.

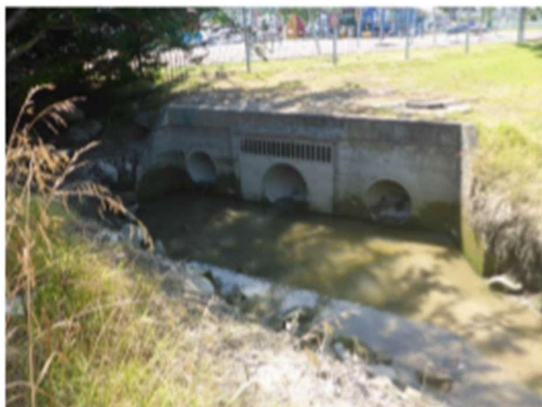
Photo 2. Site 2: Sealey St, Thames.

The outlet flows into a 100 m long, mangrove-lined channel then into the estuary. The substrate was gravel, sand and rocks, leading into deeper marine muds. No woody debris or aquatic plants were present and minimal organic matter or leaf litter. Flow through the culvert was low at the time of sampling.

The tunnelling mud crab burrows and mud snails were abundant, other fauna include estuarine mudflat snail, oligochaetes, chironomid non-biting midge larvae, and the pest fish *Gambusia affinis*. Fish access into the culvert was blocked due to the metal cones fixed into the culvert openings.

This site was physically very different to 2014. Built-up mud and debris present on the culvert apron at the previous survey have been removed or washed out, and metal cones had been fitted to the culvert openings.

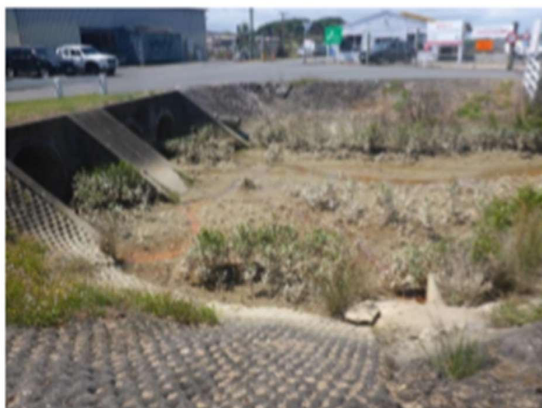
Photo 3. Site 3: Burke St outlet, Thames.

The outlet flows into a long tidal channel then into the estuary. The channel was wide and flat-bottomed; iron flocculates were conspicuous in the shallow water channels. The substrate was deep tidal mud with mangrove seedlings. Flow through the culvert was low at the time of sampling.

Tunnelling mud crab burrows and mud snail and tubificid oligochaete worms were abundant; and chironomid non-biting midge larvae were also present. Fish access was unimpeded.

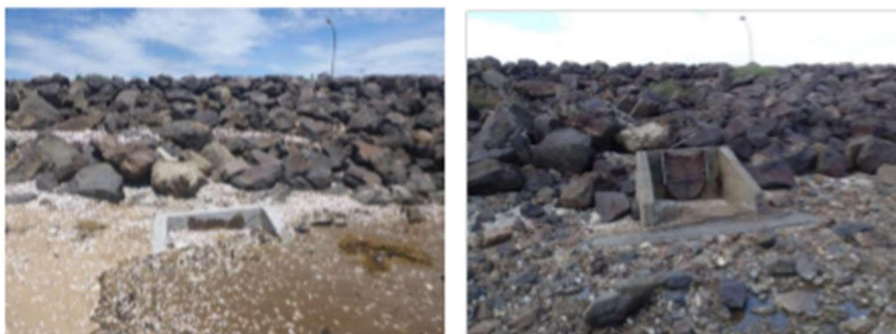
This stormwater outlet is controlled by a tide gate which opens directly onto the beach. At the time of survey, the concrete structure was buried in sand, almost to the top of the structure, possibly by the recent storm event, and could not be surveyed.

Photo 4. Site 4: Fergusson Dr, Thames in 2018 (left) and 2014 (right).

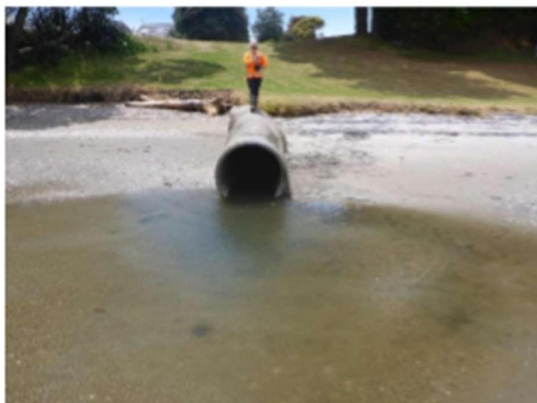
Photo 5. Site 5: Sheppard Ave, Pāuanui.

This outlet flows directly into the estuary. The culvert is constructed from several interlinked concrete pipes, the outer of which was coming loose. There was no flow from the culvert at the time of sampling. The substrate was sand with many empty marine shells.

No aquatic plants were present, and the inside of the pipe was lined with rock oysters (*Saccostrea glomerata*). Other fauna species present included; shrimp which were abundant as well as mudflat snail and spire shells (*Zeacumantus* sp.). Fish access was unimpeded.

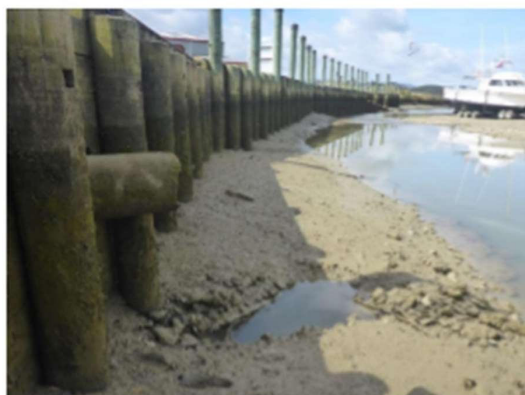
Photo 6. Site 6: Wharf Rd, Coromandel.

This outlet pipe is set in a retaining wall 1 m above the mud in a tidal section of the Whangarahi Stream. the top of the culvert pipe is submerged at high tide, which would allow fish access. The substrate was tidal mud with embedded cobbles and there was no flow through the culvert at the time of sampling.

No aquatic plants were present. Tunnelling mud crab burrows and mud snails were abundant during the survey, and shrimp and amphipods were present.

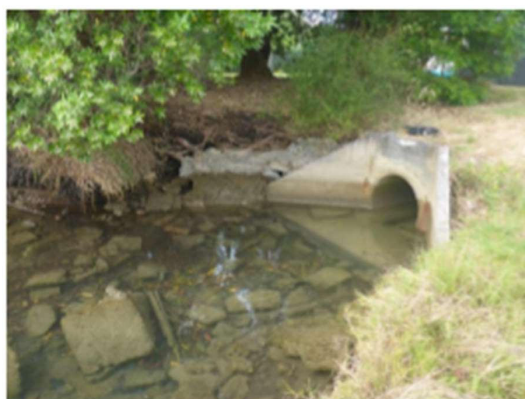
Photo 7. Site 7: Marquet Place, Tairua Harbour.

The outlet flows directly into the harbour. The substrate was rocks, concrete blocks, sand and marine mud. Several *Juncus* reeds were present on the edge of the banks and no aquatic plants were present. There was no or very low flow from the culvert, so the water chemistry measurements reflect tidal water at the mouth of the culvert.

Common fauna species observed were shrimp, estuarine triplefin (*Grahamina nigripenne*), tunnelling mud crab, mudflat snail, spotted whelk (*Cominella maculosa*), mud whelk (*Cominella glandiformis*) and top shell (*Diloma* sp.). Fish access is unimpeded, except possibly by the lip of the culvert apron at low tide

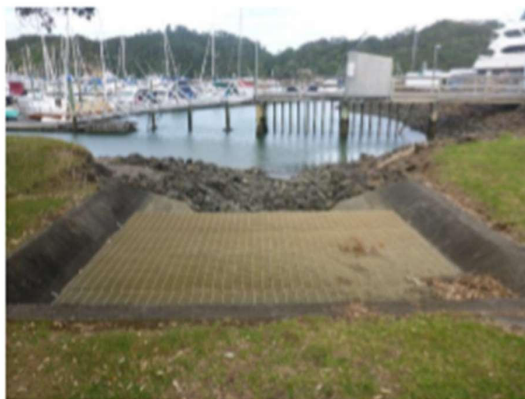
Photo 8. Site 8: Marina hardstand, Whitianga.

The outlet flows into the marina over a concrete weir only during times of high flows and high tides. Within the metal-grilled chamber, water flows out of a large culvert and diverts into a smaller culvert. The channel beyond the structure is lined with riprap which was embedded in sand. There was no flow of water from the culvert to the channel during the survey.

There were no aquatic plants present. Topshell snails (*Nerita* sp.) were clustered near the concrete block and mud whelks were also present. There was no fish access at this location. Bullies (*Gobiomorphus* sp.), a

common fish species, were abundant within the chamber. This fish species has an estuarine larval stage, and are likely entering from

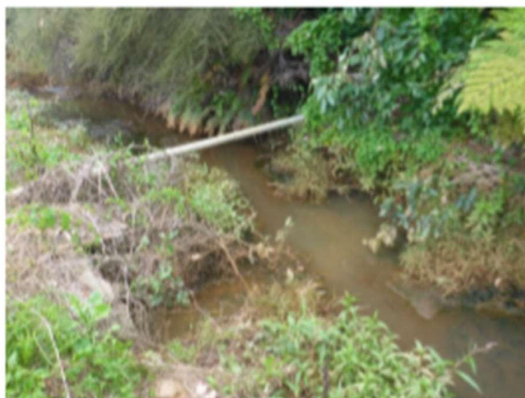
Photo 9. Site 9: Moewai Rd, Whitianga.

The outlet flows into a freshwater stream. The stream was lined with rank grasses, *Convolvulus*, blackberry (*Rubus fruticosus*) and other low weeds on the true left bank, and pine (*Pinus sp.*), flax (*Phormium tenax*), tutu (*Coriaria arborea*) and reeds on the true right bank. The streambed was mostly clear of vegetation, with water pepper (*Persicaria hydropiper*) along the edge of the banks, and leaf litter and woody debris present in the stream. The water level in the stream was exceptionally low, with 40-50% of the substrate exposed. The water was slightly milky and algal mats were growing on the substrate. Water flowing from the outlet was clear and contained large amounts of iron flocculate.

A large longfin eel (*Anguilla dieffenbachii*) was hiding amongst detritus beside the culvert outlet. Mud snails and chironomid non-biting midge larvae were abundant; also present were oligochaete worms and a caddisfly larva (Hydroptilidae). Fish access was unimpeded at high water levels but could be impeded at low water levels by a slight drop at the mouth of the culvert.

Compared with the 2014 survey, the site has changed dramatically. In 2014, the stream channel was overgrown and partly obscured by weeds and rank grasses. Slightly fewer invertebrate groups were found in 2018 compared to 2014.

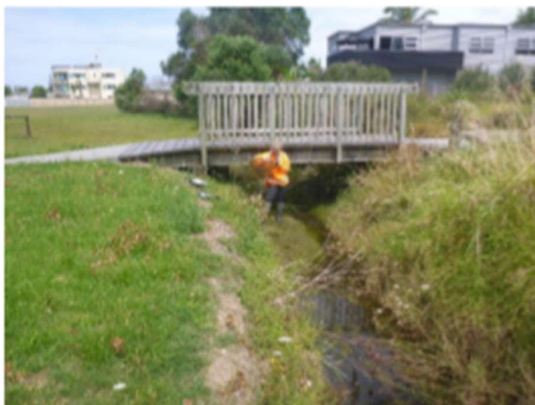
Photo 10. Site 10: Casement Rd, Whangamatā.

The outlet flows into a long, wide channel which then flows into the harbour. The substrate was predominantly sand with fine gravel with some mud. The flow was very low, with plenty of built-up surface scum and green filamentous algae.

No aquatic plants or mangroves were present at the site, weedy terrestrial vegetation along the bank provided some stream shade and cover in places. Mud snails were especially abundant. There were also non-biting chironomid midge larvae and burrows from tunnelling mud crabs.

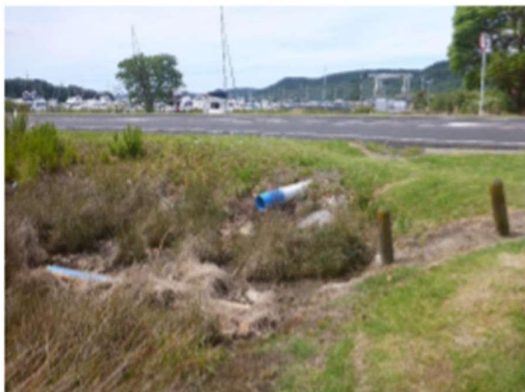
Photo 11. Site 11: Hetherington Rd, Whangamatā.

This outlet flows into a small saltmarsh on the edge of the harbour, although there was no flow at the time of the survey. The sediment around the outlet was dry, soft sand and soil, densely vegetated with *Juncus* sp., and glasswort (*Salicornia quinqueflora*), oioi (*Apodasmia similis*), and the creeper (*Samolus* sp.). No aquatic plants were present at the site. Tunnelling mud crab burrows were present but no other fauna were observed and there was no fish access to the culvert pipe.

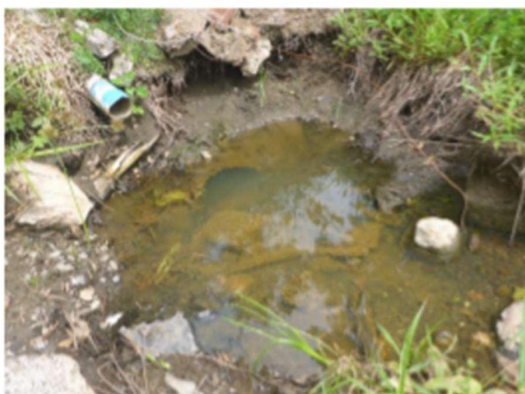
Photo 12. Site 12: Aicken Rd, Whangamatā.

This outlet flows into a short channel then enters the estuary. Water was flowing at a very low rate from the submerged pipe. The substrate was gravel and sand, with iron flocs and oily scum from iron bacteria were present. The banks of the channel were eroding, either actively or as the result of a very large rainfall event. There were no aquatic plants present.

There were a few mud snails, chironomid non-biting midge larvae and oligochaete worms present and fish access was unimpeded.

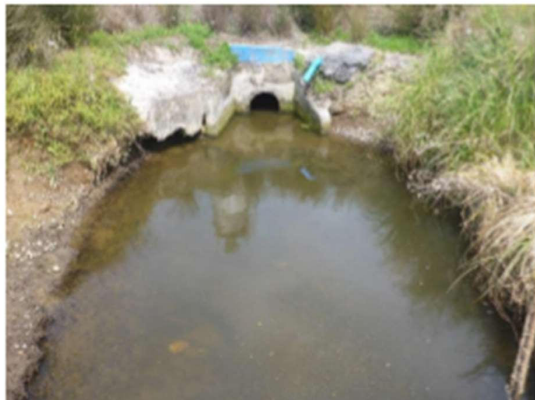
Photo 13. Site 13: Lindsay Rd, Whangamatā.

This outlet flows into large scour pool, then a short channel and finally enters the estuary. Four pipes exit into the pool. The banks of the channel were eroding, either actively or as the result of a very large rainfall event. The substrate was gravel with a light covering of sediment, leaf litter and filamentous algae. Iron flocs and an oily scum from iron bacteria were present.

Shrimp and mud snail were abundant. Fish were observed in the pool – estuarine triplefins (*Forsterygion nigripenne*) were abundant and a 15 cm mullet (*Mudgil sp.*) was present. There were no aquatic plants and there was fish access into the lower outlets.

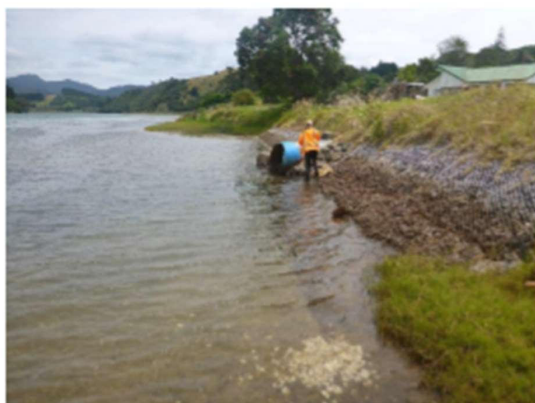
Photo 14. Site 14: Kotuku St, Whangamatā.

This outlet flows into a raised concrete trough, which overflows into the estuary. The substrate was sand and gravel with gabion bank armouring and iron floc was present.

Cat's eye snails (*Lunella smaragda*) were abundant. Other species included shrimp, rock oyster (*Saccostrea glomerata*), limpet (Lottidae), oligochaete worms, amphipods, estuarine mud snail and whelk. No aquatic plants were present and fish access was not impeded.

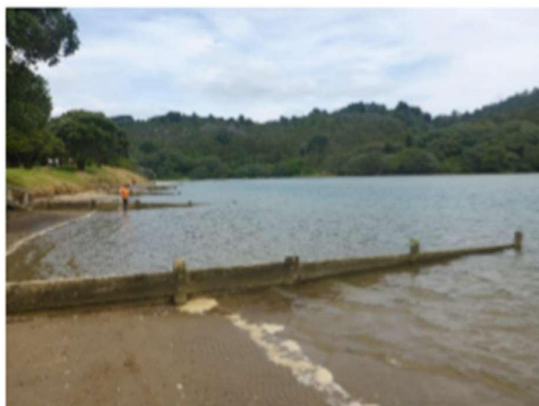
Photo 15. Site 15: Otahu Estuary, Whangamatā.

Site 15 is the estuary control site, with no stormwater outlet present. The substrate at this site was sandy. Fauna present included tunnelling mud crab, little black mussel (*Xenostrobus neozelanicus*), whelk, amphipods, isopods, mudflat topshell (*Diloma* sp.), cat's eye snail and shrimp. The estuarine triplefin fish (*Forsterygion nigripenne*) was common. No aquatic plants were present.
