Folder [20231205 Williamson Park Pond Stormwater Detention Basin Alternate Design]

Alternate Stormwater Proposal for Williamson Pond

Ian Holyoake. 5 December 2023

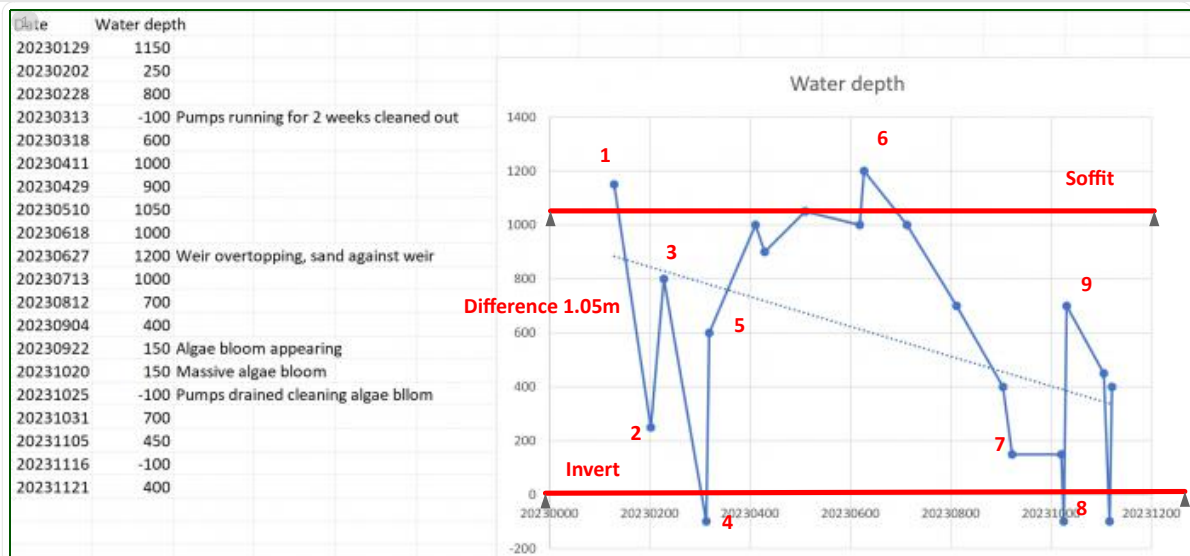
001 water depth Williamson Pond.jpg

Water Table at Discharge Pipe into Williamson Pond

I believe the lake level will not drop below mean tide level which must be about -200 below invert.

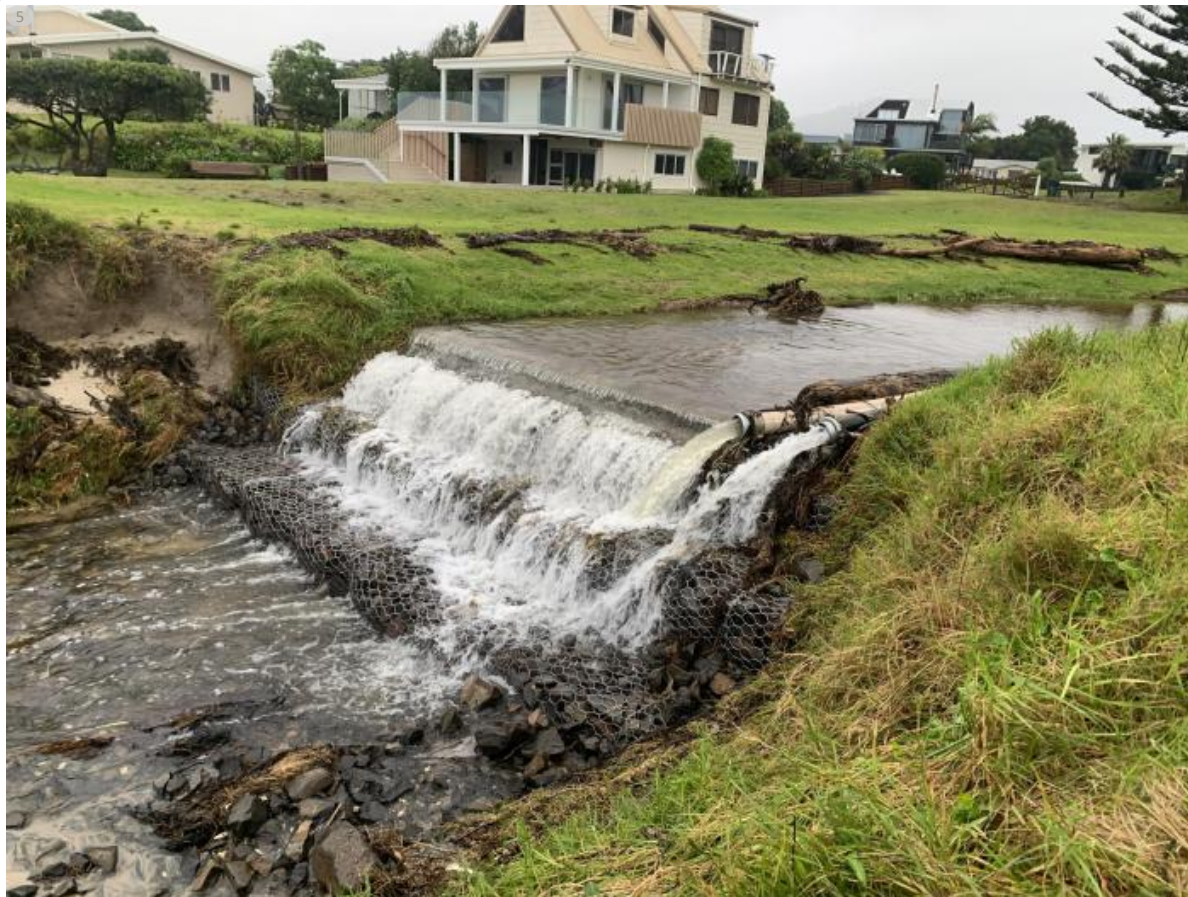
105 Weir at 13 March with pumps running.jpeg

This was about 4 weeks after Gabrielle when the pumps were working and weir was still overflowing.

One decent log is washed up

Flutter valves will need to be sturdy

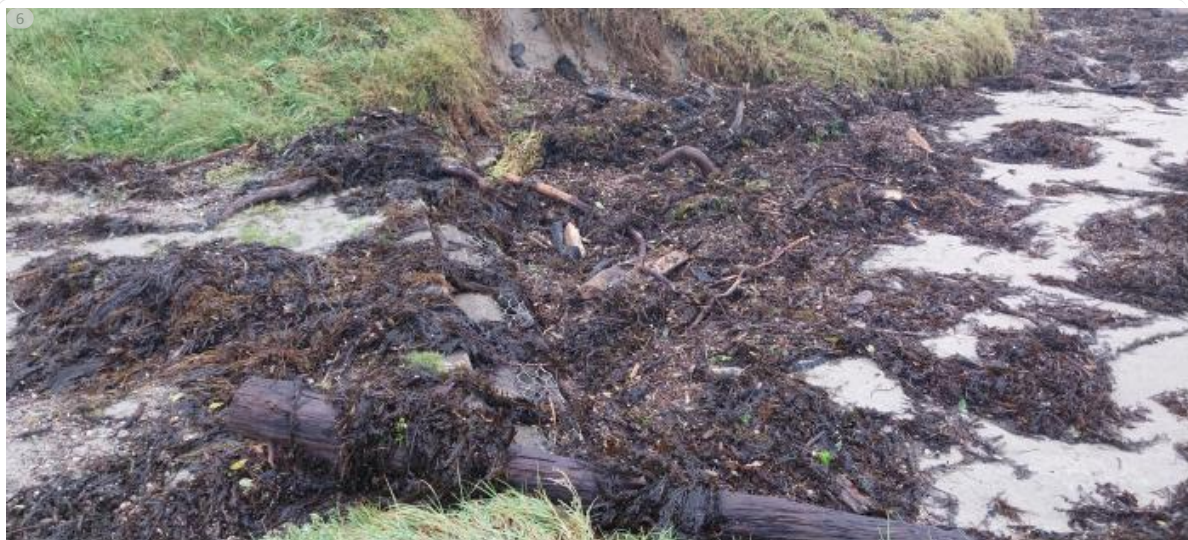
110 Weir after King Tides 1 November.jpg

Weir buried in sand up to last gabeon with driftwood topping.

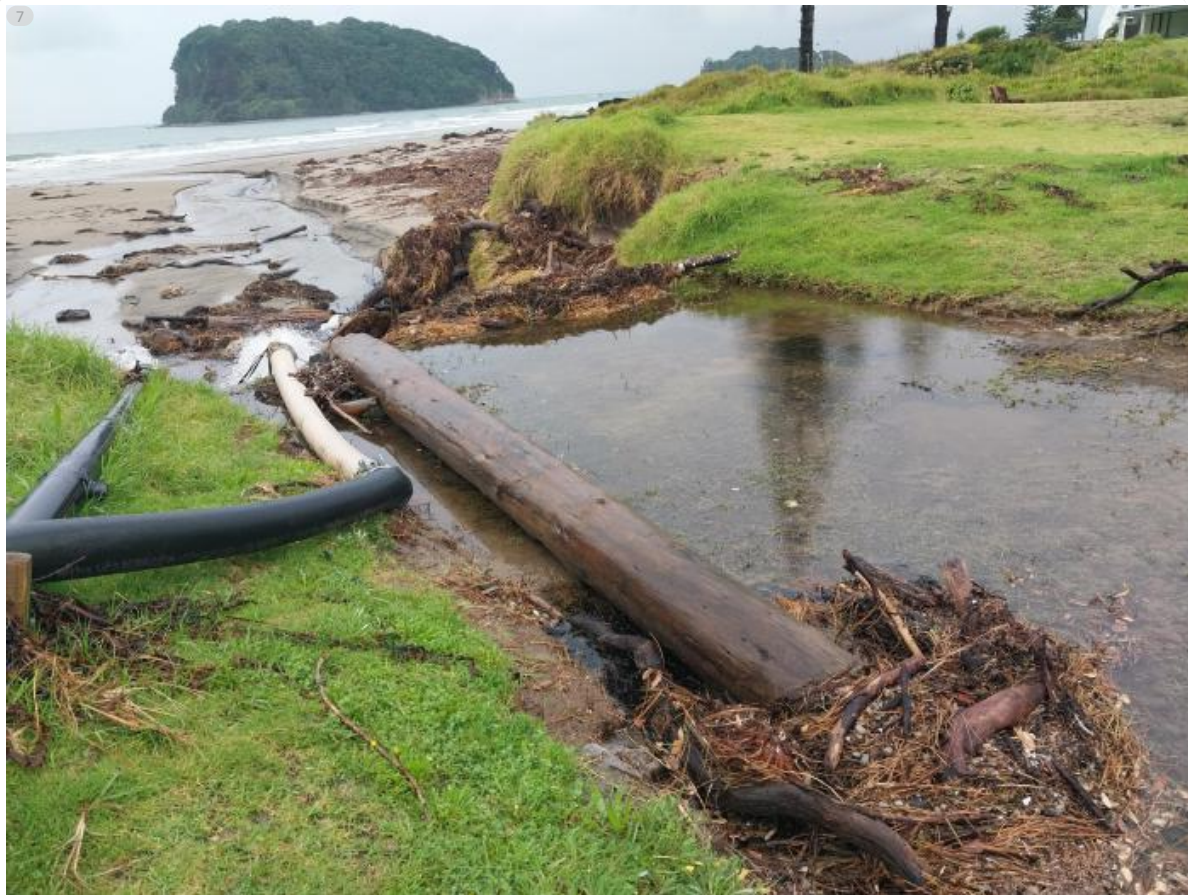
124 King Tides breach weir 20230227_105746.jpg

Level of breach is significant

Weir MUST be raised

If sea levels do rise the level needs to take account of this.

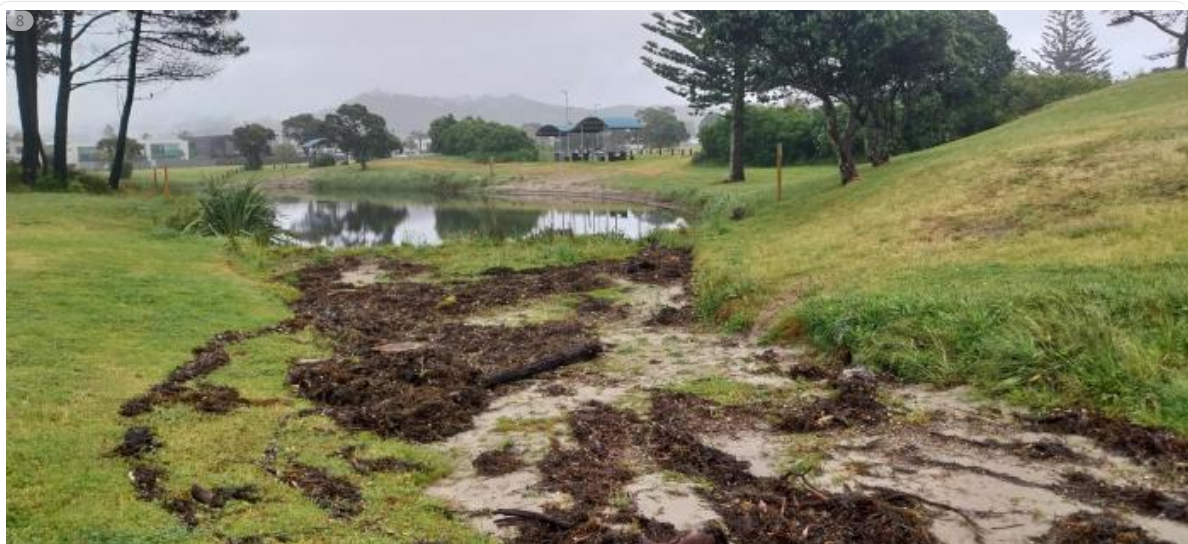
130 King Tides breached weir 1 November 2023.jpg

Storm tides breached the weir on 1 November.

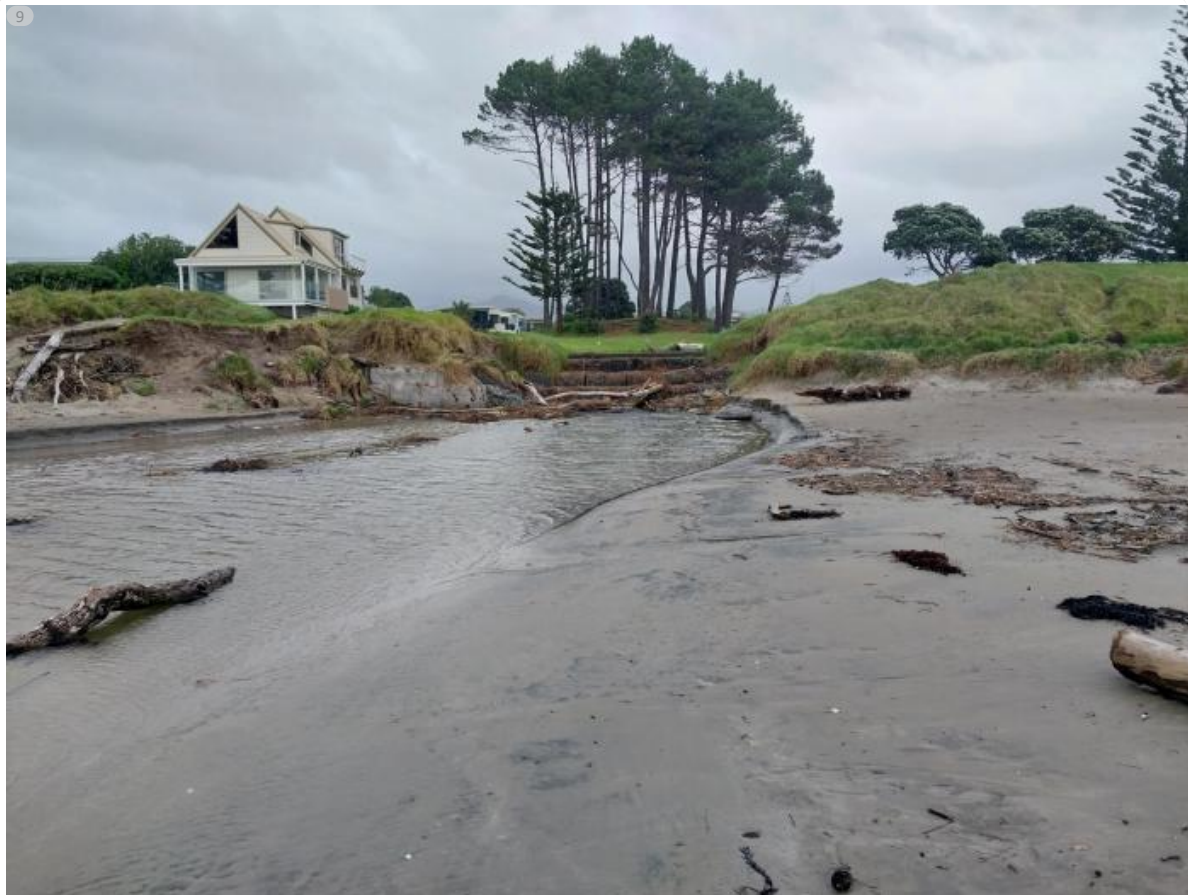
140 20230418_081644.jpg

Lake forming on the Beach in front of the weir as 18 April 2023

Note erosion

The shape of the Vee to the weir location is poorly designed as it forms the surge and magnifies the surges velocity and momentum so makes it worse.

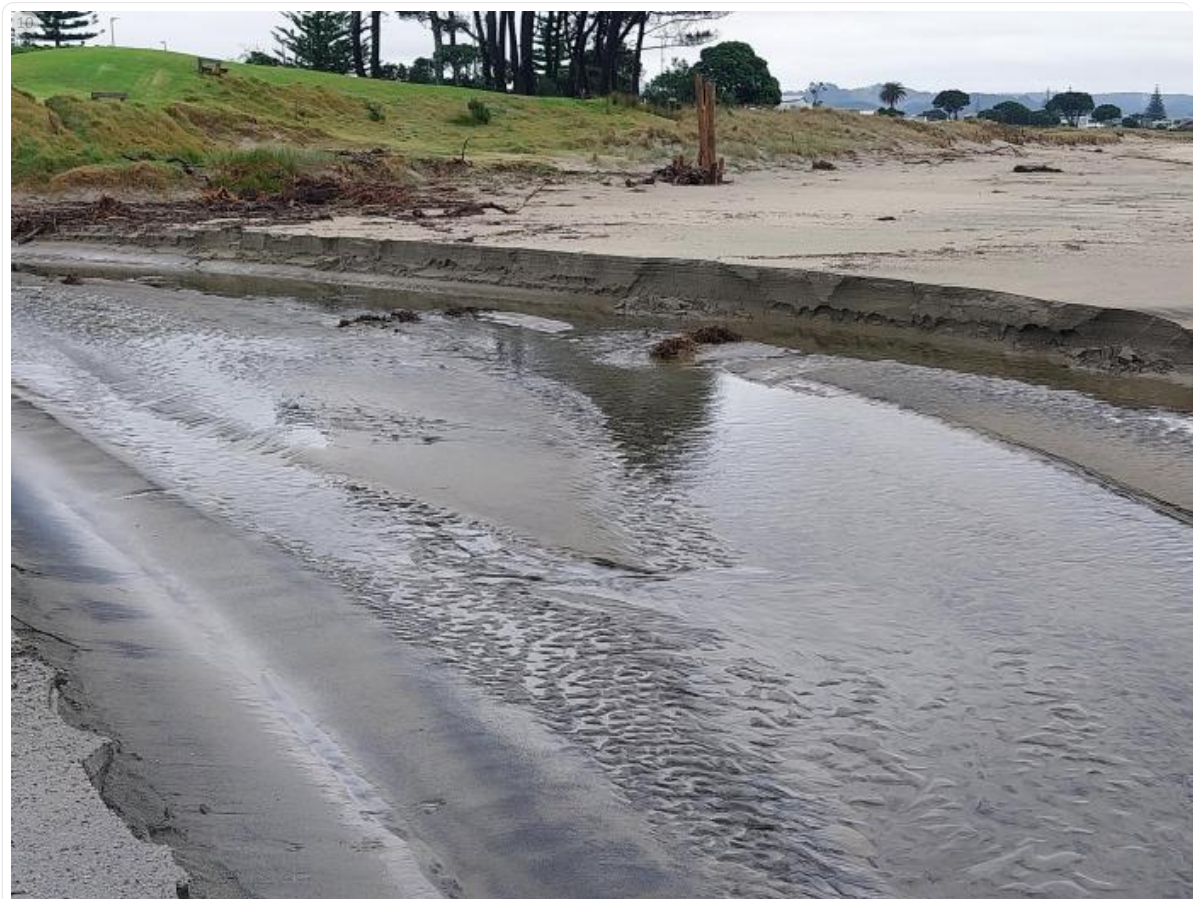
141 erosion of beach into channel 20230618_090914.jpg

Whilst the water tops the weir we get erosion as water makes its way to the Ocean.

Normally the sand recovers quite quickly but it is not desirable

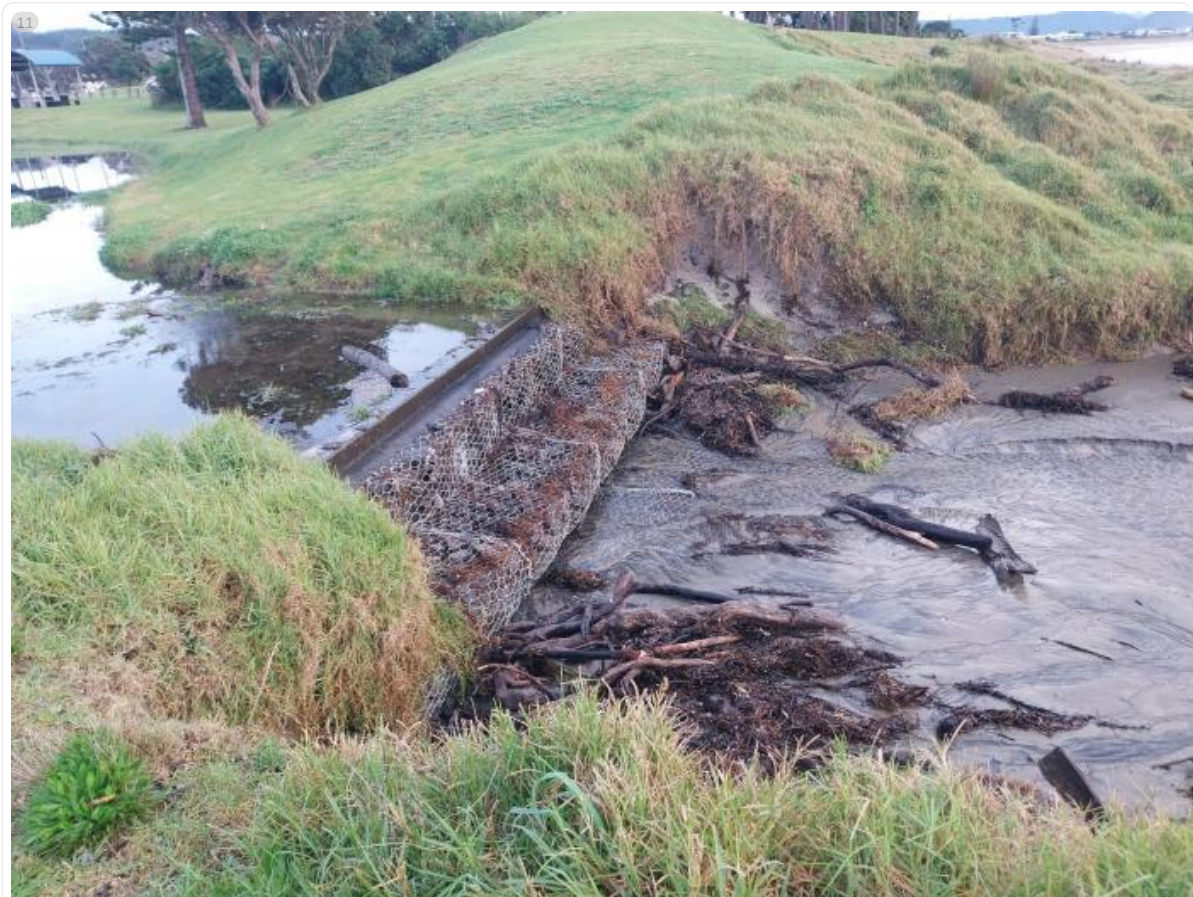
149 sand build up 20230627_082336.jpg

Sand builds up and then retreats

This was at 27 June 2023

Note water level in Lake just over topping the weir

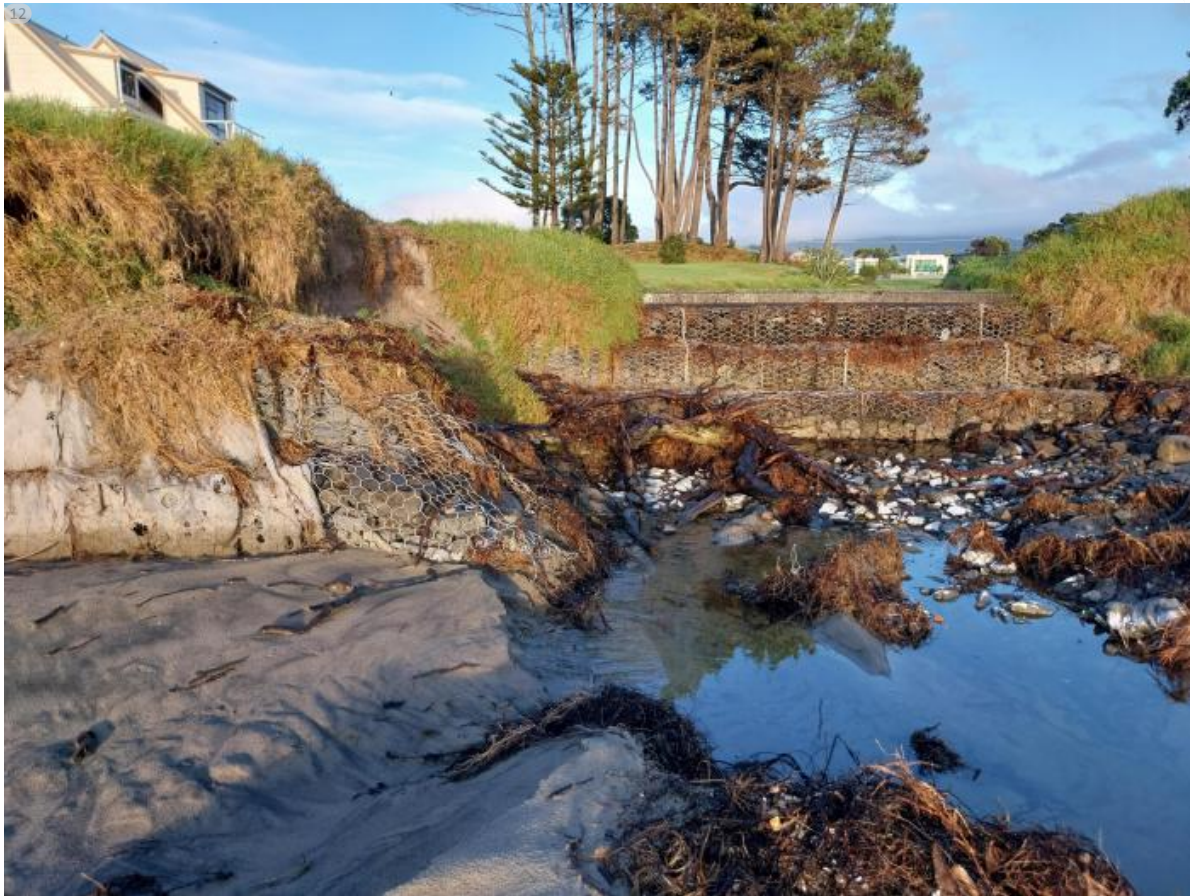
150 20230620_082053.jpg

Weir on 20 June 2023

Note depth of erosion

Old weir is the wire cages in the foreground.

It is unknown if this was pulverized by the Ocean or broken through to create the new weir behind

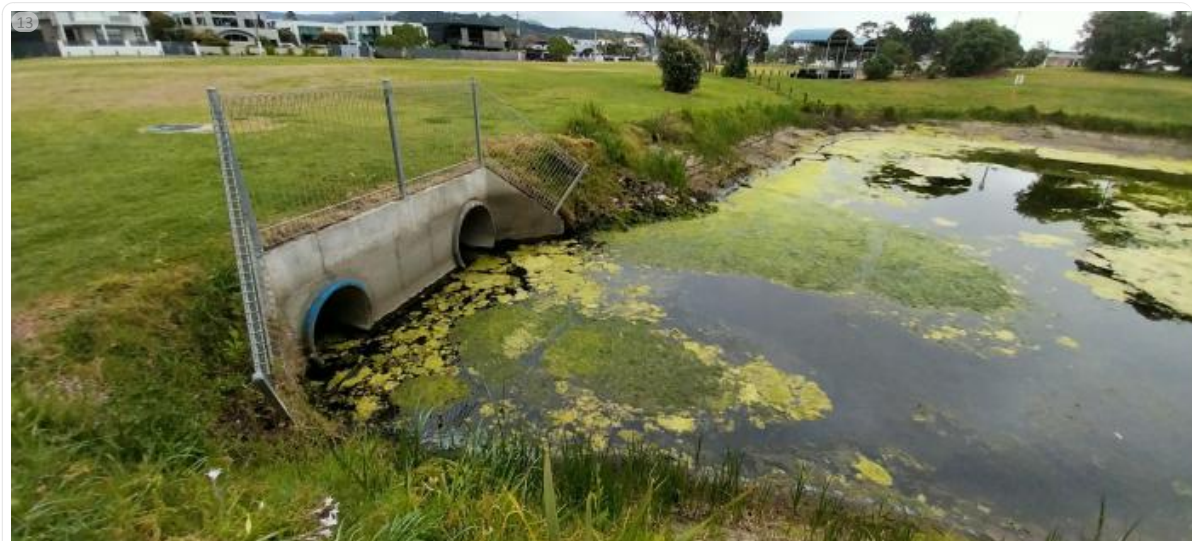
160 20231020_080047.jpg

HAB quite concentrated on 20 October 2023 just before draining and cleaning.

Due to the temperate climate we will always get algae bloom in spring and summer.

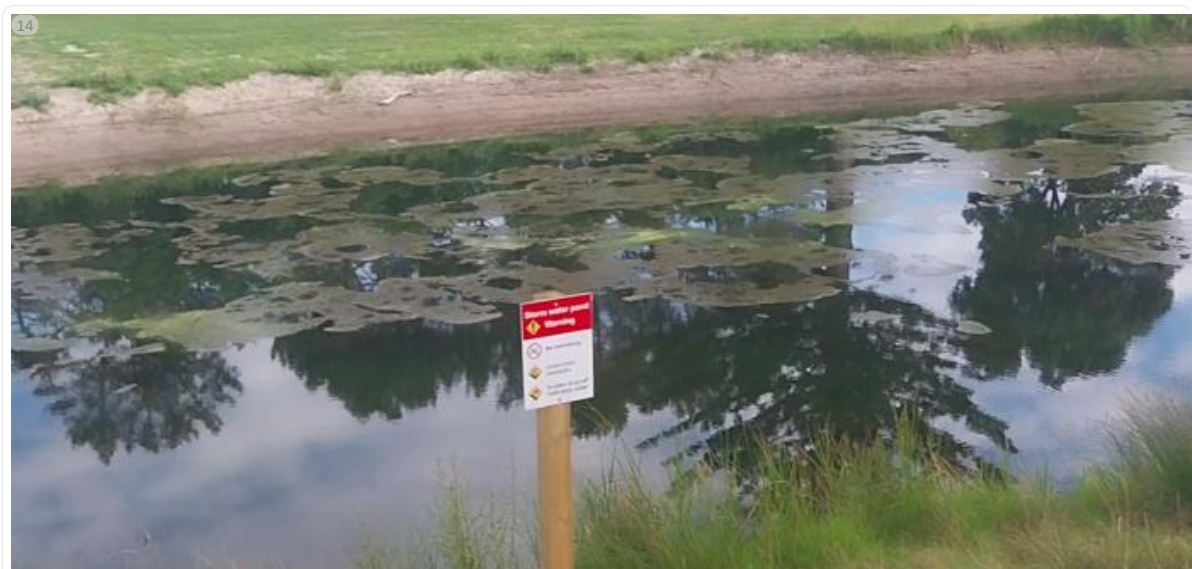
162 Algae bloom back already 20231204_233904_SC_.jpg

HAB back already just a month after cleaning.

Our tropical spring and summer will cause this to happen in still water.

Note cleaning involved pumping as much water out as could be pumped - pond floor is sand and solid to work on. But once the pipes were shut down water seeped straight back in. See water tracks around banks.

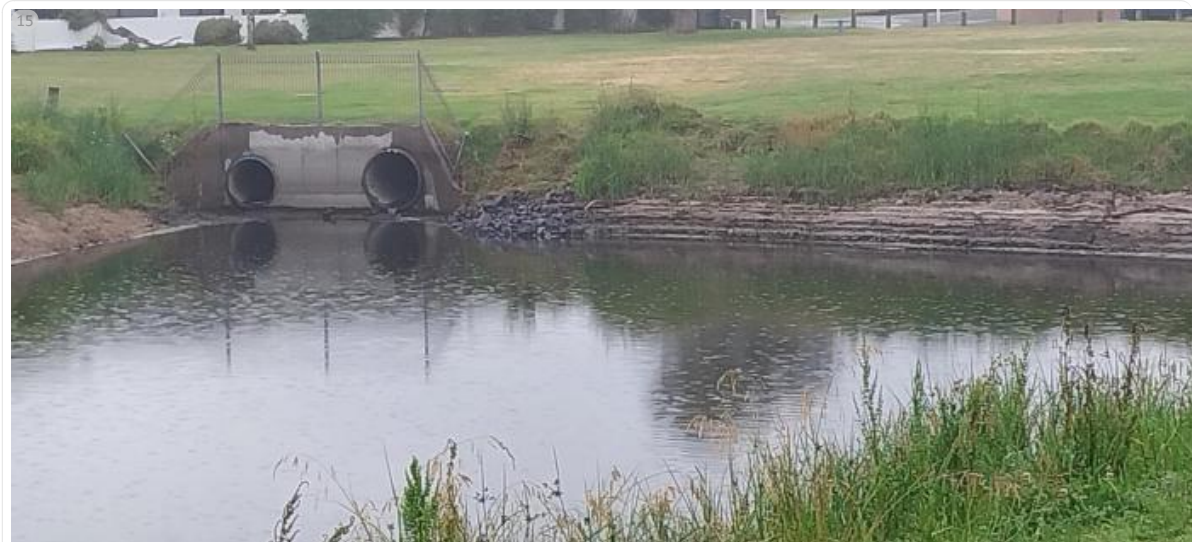
163 water table bleed tracks 20231118_085403.jpg

Photo shows the water tracks as ground water bleeds back into the lake (and vice versa). Both the pond water and groundwater influence each other just like when we walk around the beach at low tide the water table is seen bleeding onto sand higher up. This is the relationship between the water table and pond level.

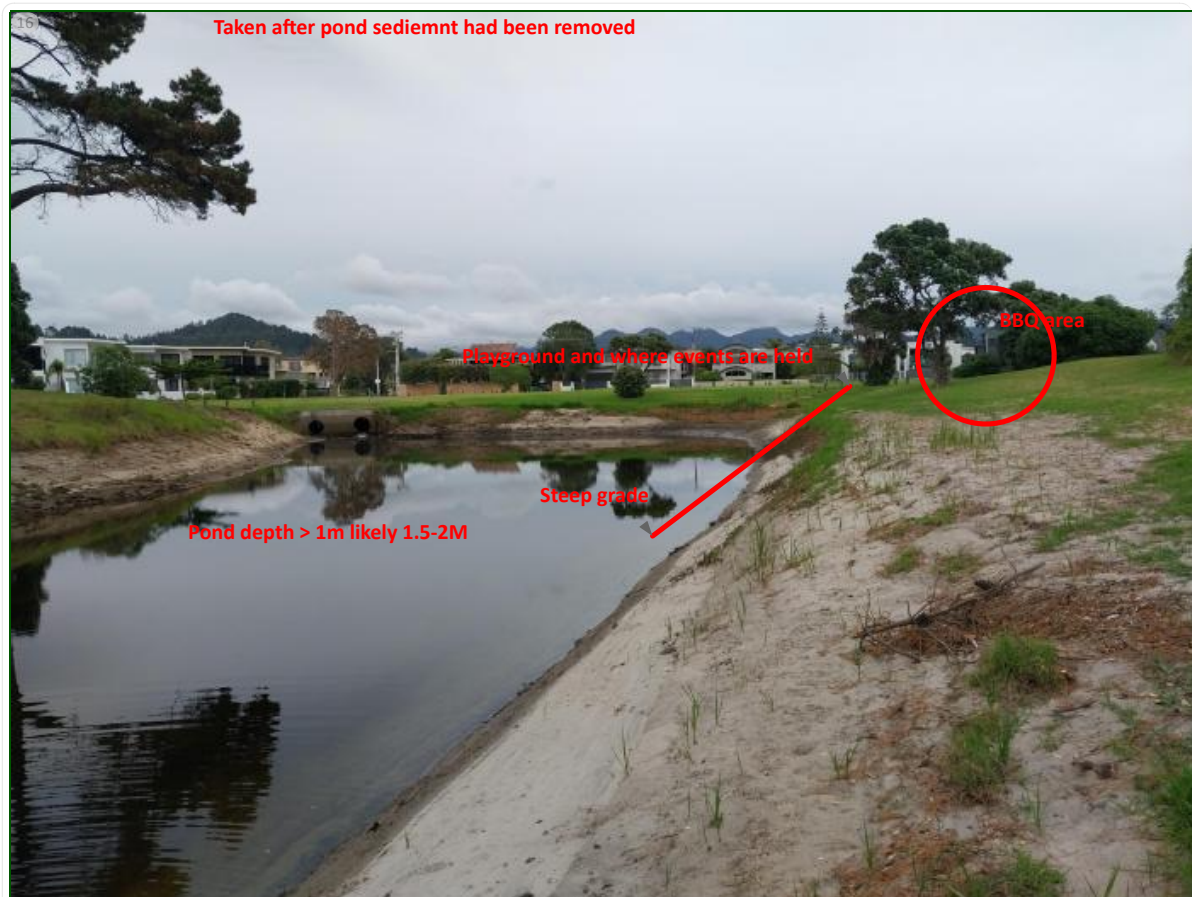
170 Lake shape steep grade 20230313_092342.jpg

Showing pond drained after 2 mobile pumps worked for around 2 weeks and not been raining for about a month after Gabrielle

NB: see severe slope of embankment - my understanding is this is not acceptable as kids could fall in and be unable to crawl out.

Signs have recently been posted but these are not fail safe in close proximity to playgrounds.

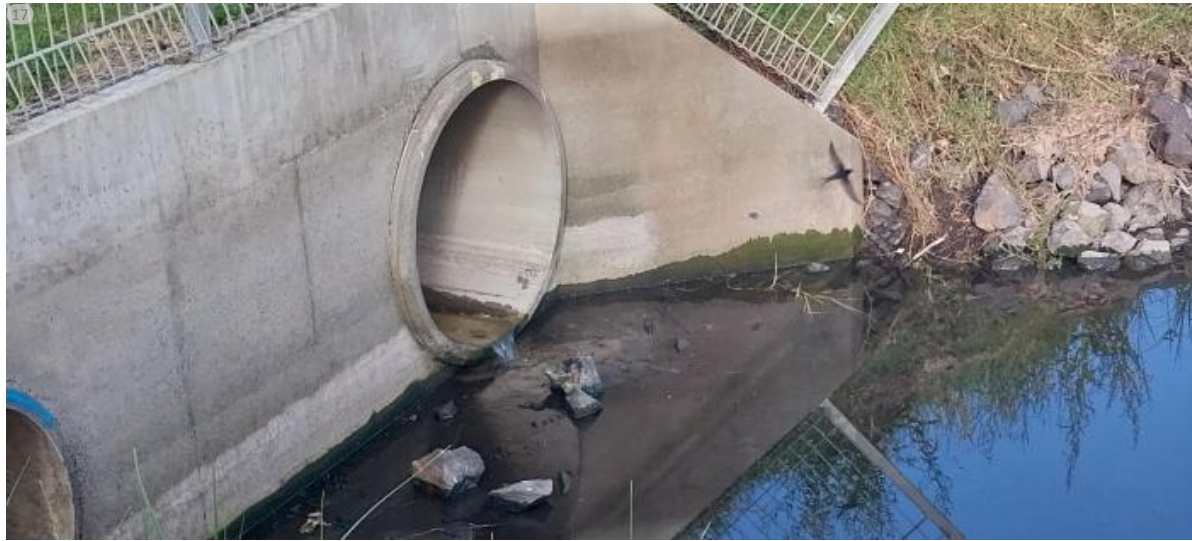
171 Discharge pipe flow rate small 20231116_081130.jpg

Discharge flow rate very small as at 16 November 2023.

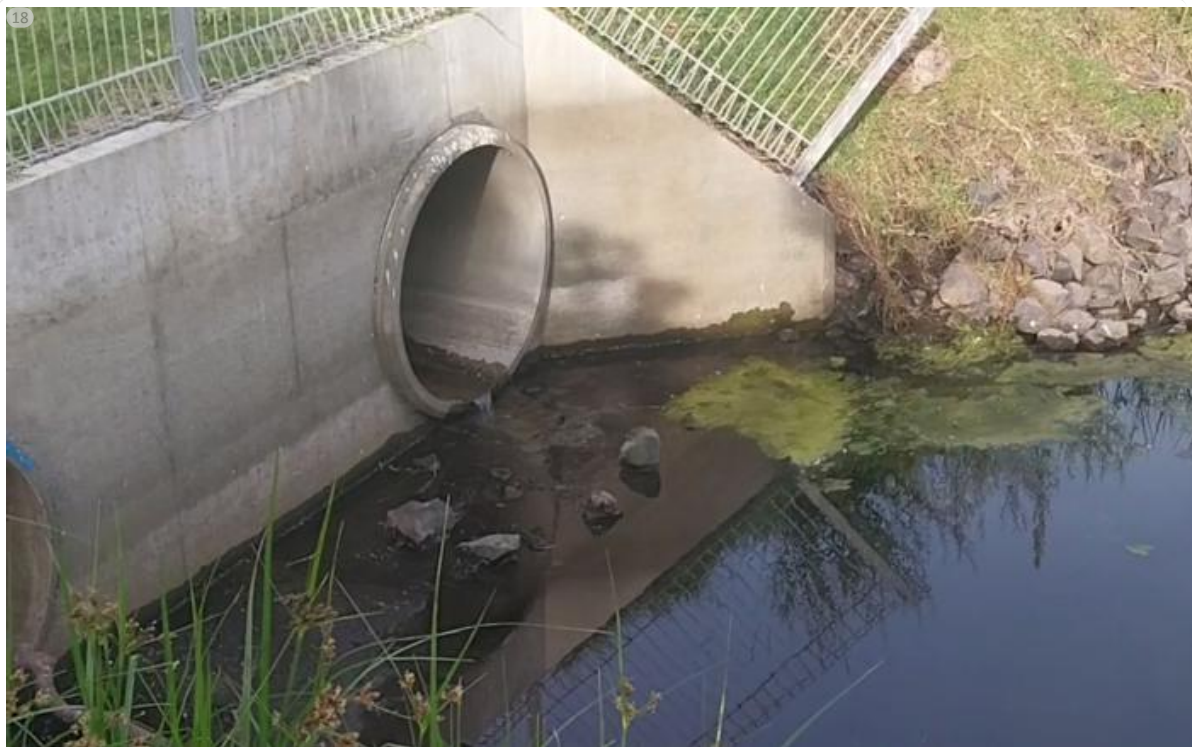
172 Discharge flow rate minor 20231205_000348_SC_.jpg

Discharge flow rate remains minor as at 5 December 2023

Water is clear and clean.

It is likely the water is from a broken water pipe or slow bleeding of the water table.

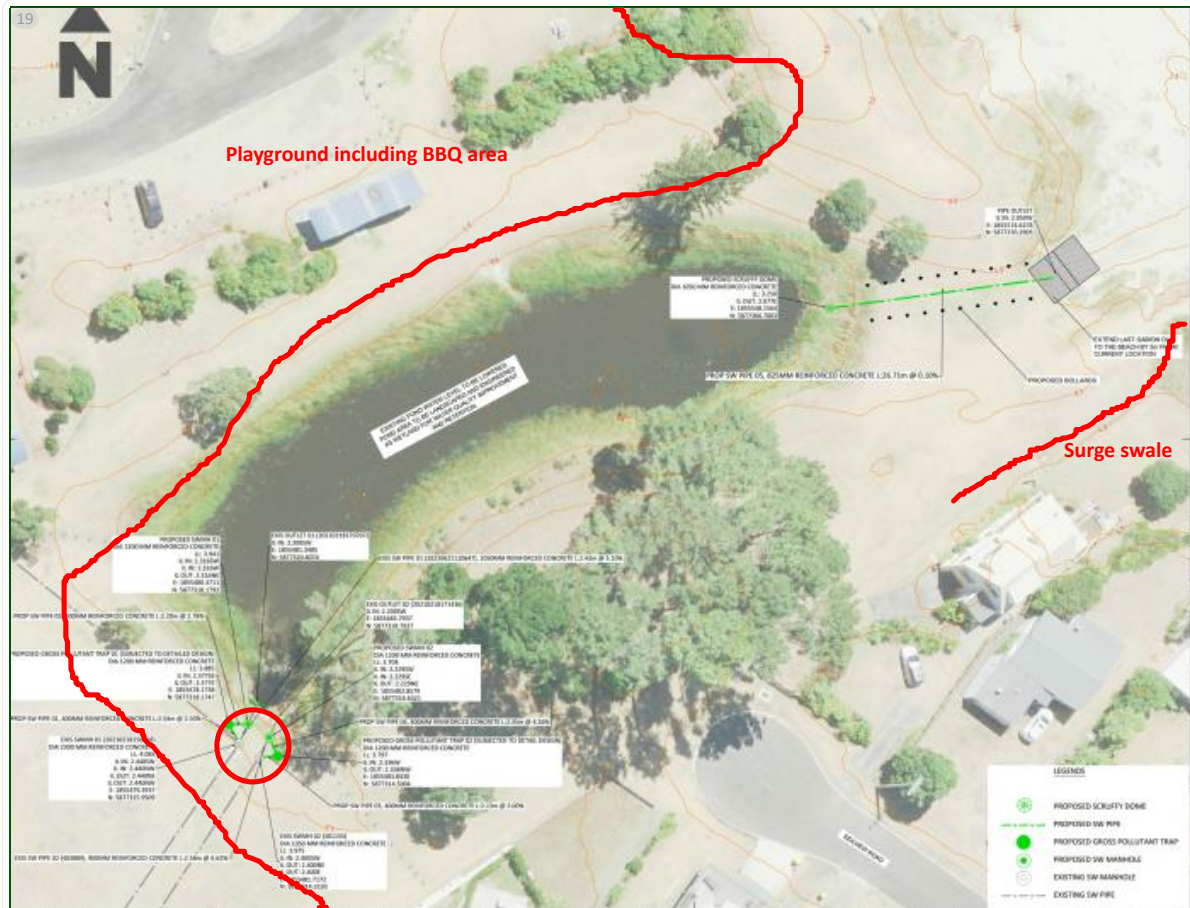
180 Metis proposal wetland 20231204_235241_SC_.jpg

Metis configuration

1. The circle represents a gross pollutant trap. It will need servicing so needs to be along Ocean Rd for truck access. Reminder the old sediment trap is along these lines
2. The weir must be raised to prevent surges breaching it
3. The weir must be moved toward the Ocean to change the Vee to stop/minimise surge funnelling
4. The green pipe does not need to be long
5. The pond being changed into wetland is totally unacceptable.
6. The discharge rate other than in storms is only road runoff which is zero in dry weather.
7. Cannot ever have a wetland (or pond) in close proximity to childrens playground.

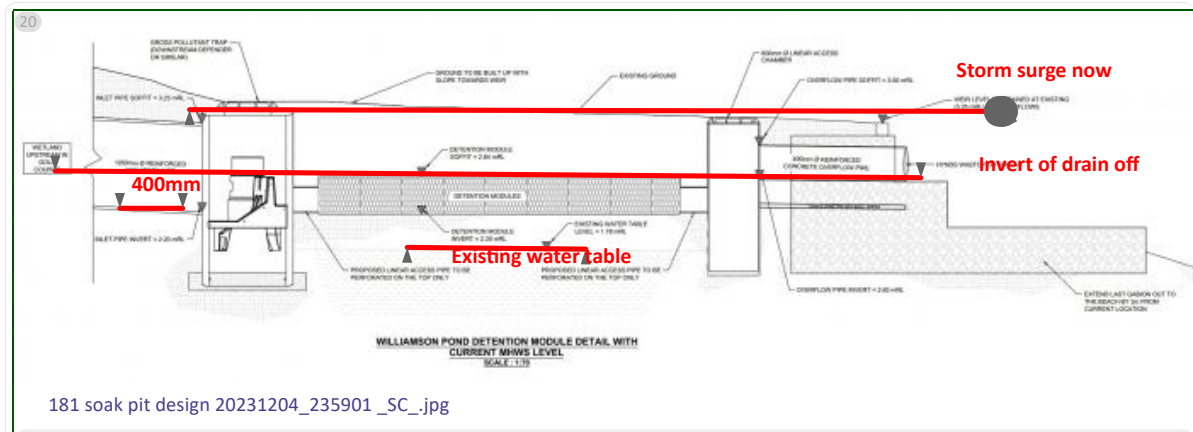
Drawings cannot be right as the drain off level is 2.6mRL and the discharge invert is 2.2mRL which leaves 400mm still water in the Williamson Rd pipe and the Cirtex submerged.

2. The 1050mm Williamson discharge is directed into an unsized perforated tube drawn to about 400mm so won't cope.
3. Overflow relies on the bubble up through the linear access chamber which relies on the perforated pipe flow rate through the Cirtex. This will be inadequate against gravity with the 1050mm discharge.

4. The drain off to the Ocean at 400mm dia is inadequate sizing. Currently the weir over tops to about 100mm across its width.
5. The Cirtex will be submerged and not function as the invert drain off is above this level.

12. How will maintenance be done whilst the weather is wild. No machine or operator will be safe during storms.
13. By filling in the basin we lose the storage capacity at high tide. Whilst sand does store water it takes time to absorb at the soakage rate which is a lot less than liquid water mobility. Won't work.
14. Drawing 4 includes lines for the 100year sea level rise - but this is 520mm above current existing water table levels at 1.78mRL which lifts everything up including storm tides and ability for Cirtex to contribute to soakage.
15. The Cirtex will become submerged and block the Williamson feeder just like it is now.
16. The proposal does not provide much benefit to community users of the reserve.

What should be done now is workshop this proposal into something more useful for the Master Plan.

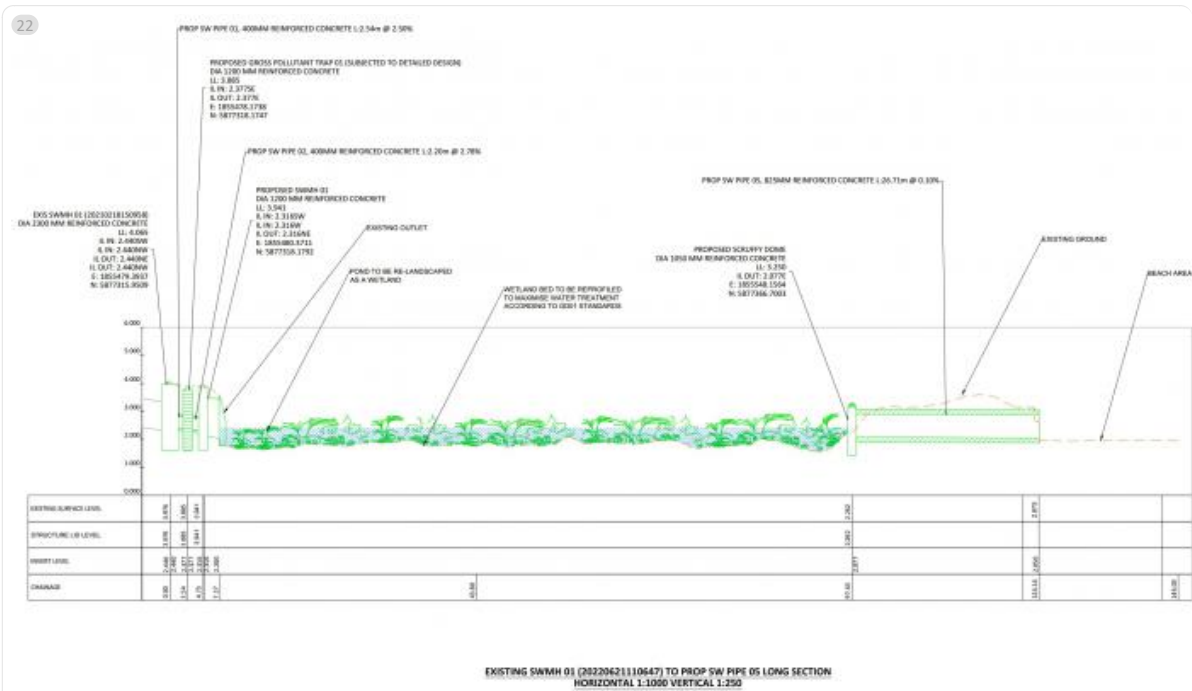
184 Wetland option Metis 20231205_000041_SC_.jpg

Wetland option:

1. Wetlands do not work on sandy soils. Vegetation requires a water table
2. Wetlands are unacceptable as a long term plan for a highly rated Beach. Visitors cannot see this.
3. Wetlands are notorious for maintenance. On sandy soils this will mean replanting after dry spells that we have between weather cycles.
