TECHNICAL REVIEW OF LOCAL ROADING
for
THAMES-COROMANDEL DISTRICT COUNCIL
Final Report

1. Executive Summary

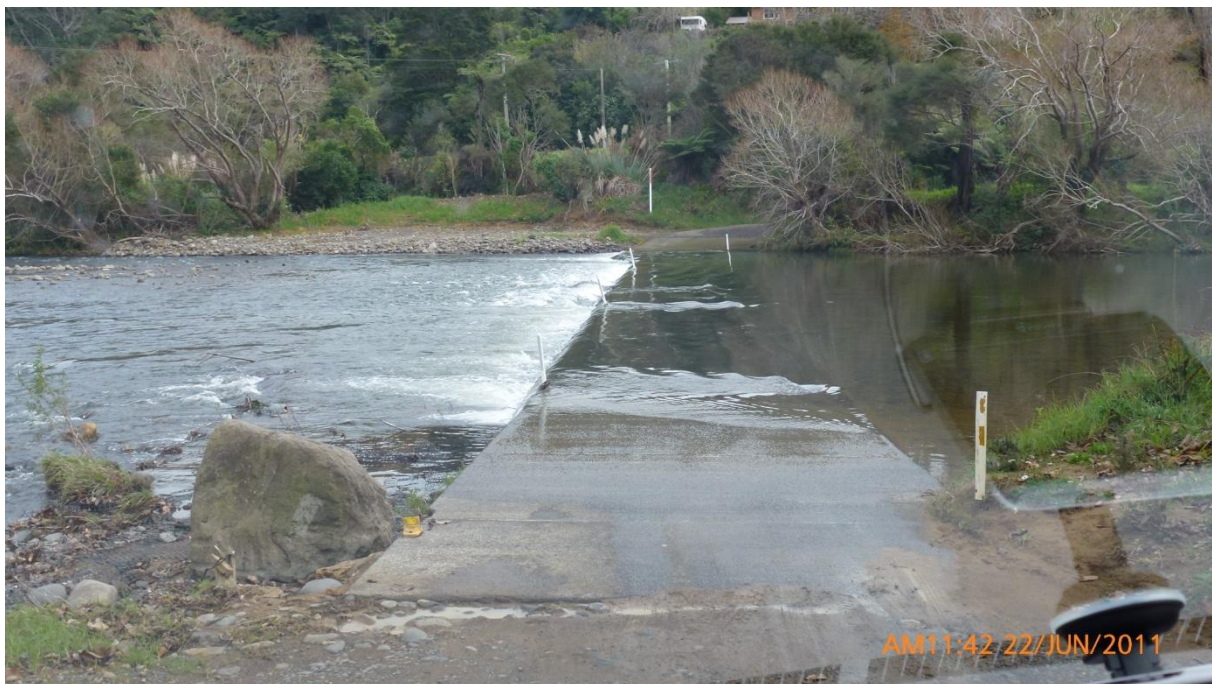
Figure 1 Kaureranga Valley Road ford

- Develop a strategy to manage the 29 fords for safe crossing risk. We were concerned at lack of information at fords to enable motorists to determine if a ford was safe to cross, e.g. Kaureranga Valley Road (see Figure 1 below). We saw little evidence of signage or depth and flow indicators to assist with the decision making process particularly when the river condition is difficult to judge. This issue was identified in the AMP 2009 and requires action.

Develop ford management strategy. Improved maintenance of ford delineation across the district was raised as a performance issue and area of focus for our maintenance contractor following this review. Painting depth bands on ford edge marker posts and installation of water depth guide signage at ford approaches has been tasked to our road maintenance contractor, to improve motorist awareness of the water depths when crossing fords.

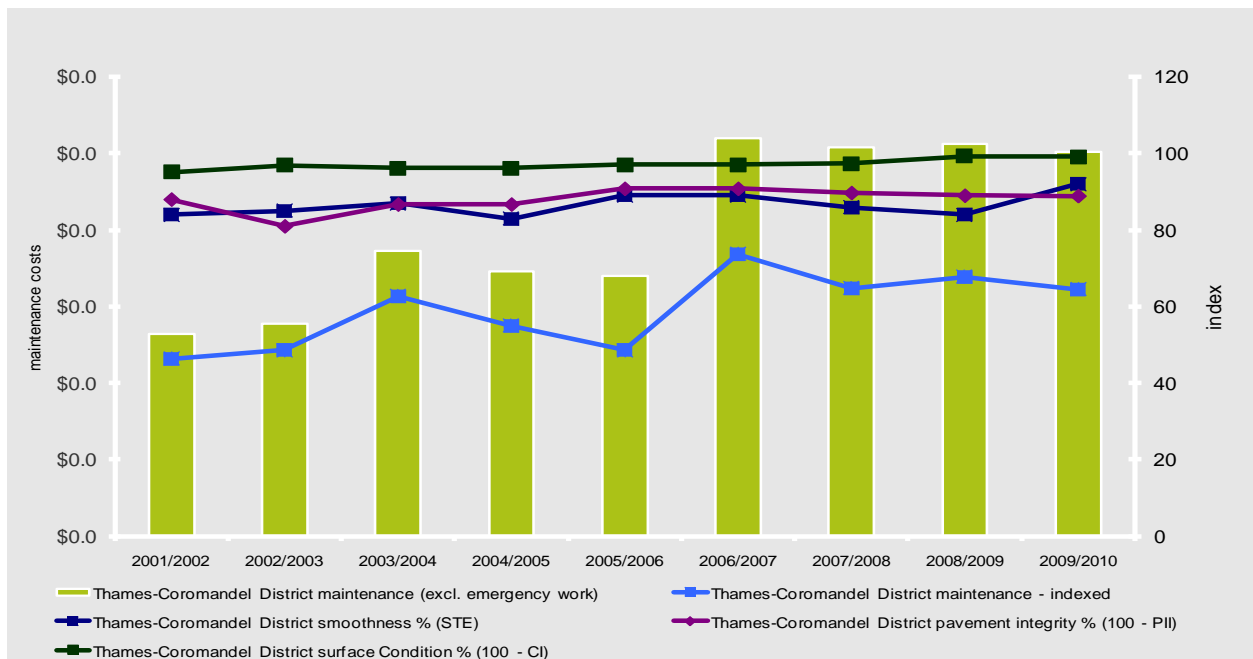
Graph 1 Sealed network condition vs. indexed network structural maintenance *

The condition of the sealed network has improved over the period as shown in graph 1 below. Of concern is the significant step change in expenditure for structural maintenance between 05/06 and 06/07 with no change in the condition indicators.

In summary the pavement condition (PII) has been stable but is still below NZ values. The surface condition has improved over the last 10 years and is now better than NZ values. Smooth Travel has been constant and while better than NZ values it is below its peer group. Roughness values are consistently greater than the region and all New Zealand values.

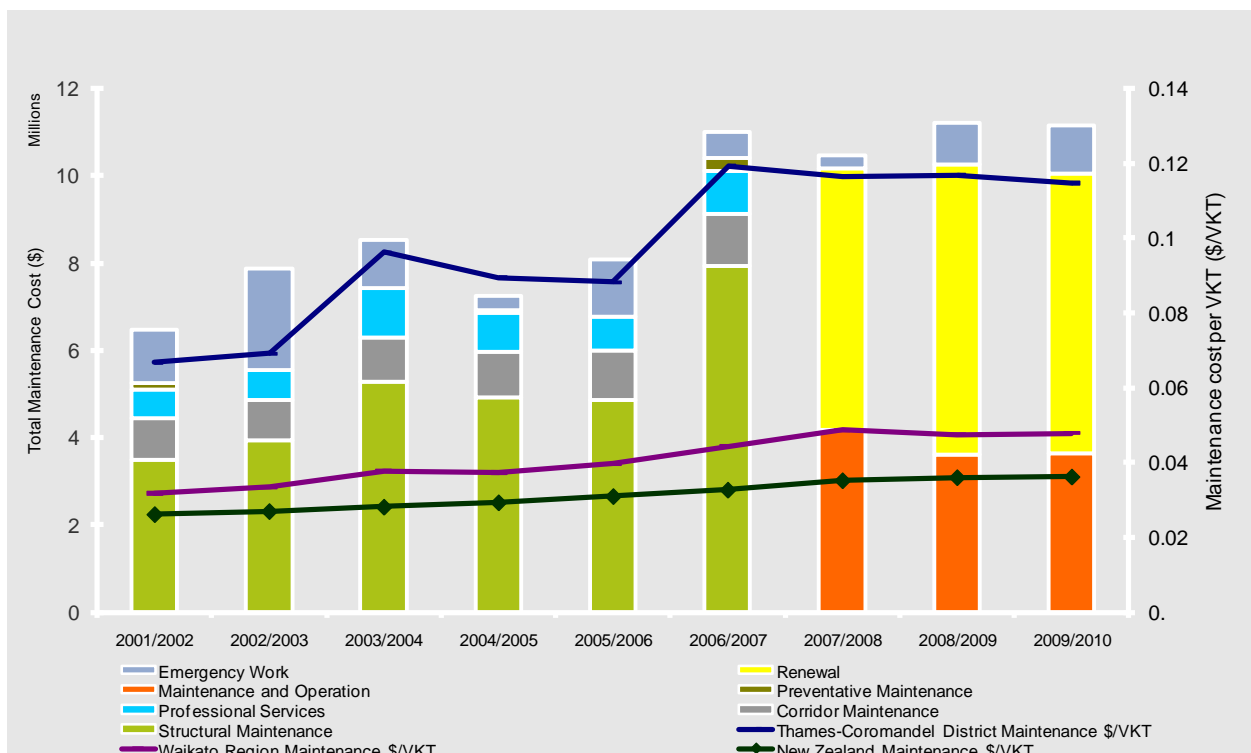
Graph 2: Total maintenance cost and cost per VKT (NZTA + local share)

Historically, Council's structural maintenance programme has been resurfacing an average of 46.0 km per annum for the period 2006/07 to 2009/10, which is greater than the 35.2km per annum indicated by long term database analysis. Analysis of the Resurfacing Achievement report in RAMM shows a noticeable increase in surface activity from 2006/07 of 12km per annum. This corresponds to the step change in funding indicated in Graph 1 above and Graph 2 below. At the same time there has been an average increase in first coat seals of 3.2km per annum from either new construction or rehabilitation works. The 2006 technical review recommended that Council address the backlog of reseals and Council has responded.

The increase in resurfacing has reduced the backlog of surfacing overdue and this is now reported at 10% of the sealed network length. This increase corresponds with a small improvement of the surface condition indicator, a measure of surface defects.

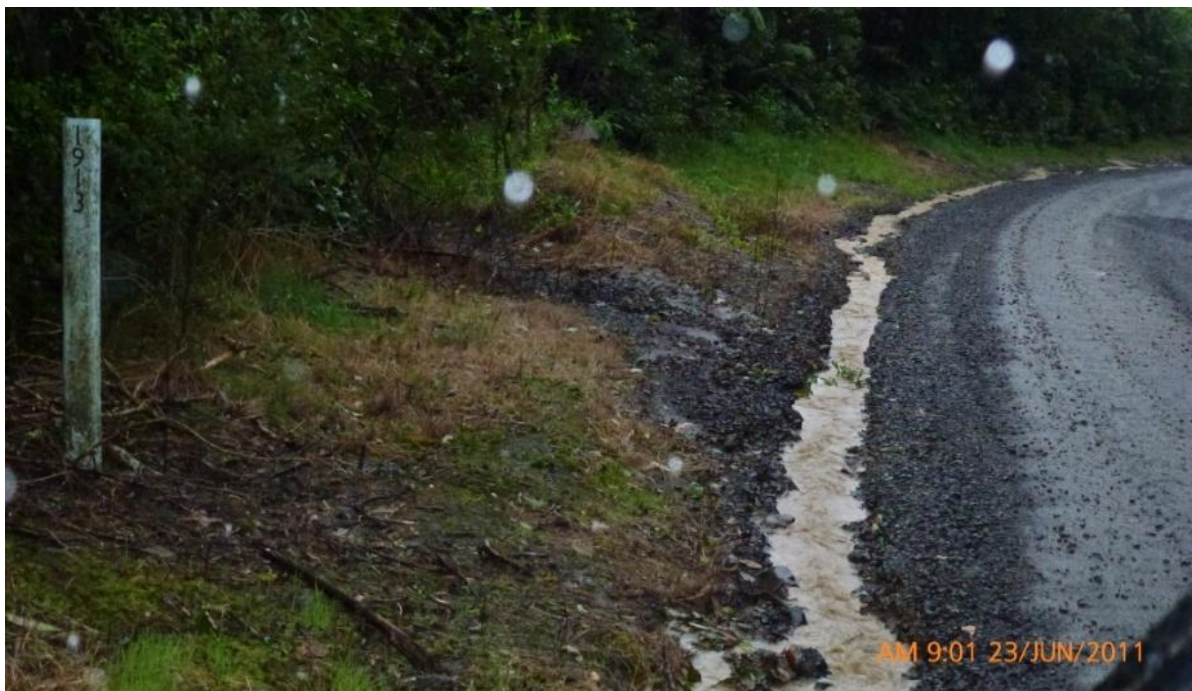
Figure 2: Storm water run-off missing cut out drain

Drainage maintenance is very important for Council with such a hilly topography and with frequent high rainfall events. We would remind Council of the need to regularly inspect surface drains to ensure they function correctly with the optimal time for inspection being during a rainfall event. We observed that some cut out drains did not function correctly due we believe to routine grading operations undercutting the wipe off drain (see Figure 2 below). By not re-establishing the wipe off Council faces excessive scour of the drainage channel and the possibility of drop outs that will lead to future emergency works.

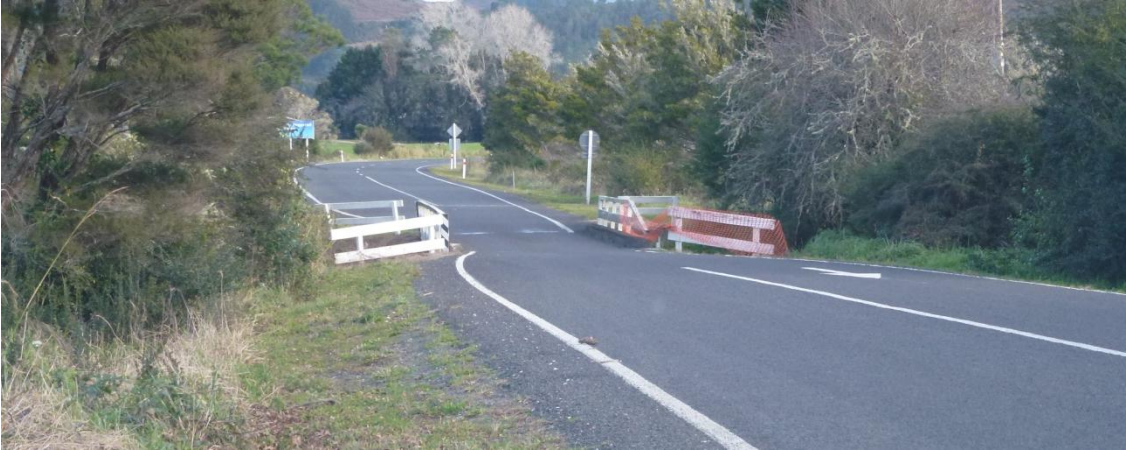
Figure 3: Bridge damage, Hot Water Beach Road

- Seek an Improvement in contractor performance - ensure the contractor meets the targets set in the maintenance contract. We encountered a bridge site (Figure 3, page 10) that had sustained damage and presented a safety risk. It was communicated by staff that the incident had occurred several weeks earlier and was now outside of the response times set in the

Of concern was the excessive time taken to repair damage to a bridge on Hot Water Beach Road (Figure 3 below). While aware of the damage the maintenance contractor had not progressed the repair in accordance with the time requirements set in the contract. Council was aware of the damage and the time overrun yet the site still poses a safety risk until the repairs are complete. Council need to ensure

that contractual requirements are met by contractors and those contractors are aware of the consequences of poor performance.

Seek contractor performance improvement. Changes to our road maintenance contractor's management staff in mid-July 2011 have resulted in performance improvements, through a more proactive approach to achieving specified levels of service.

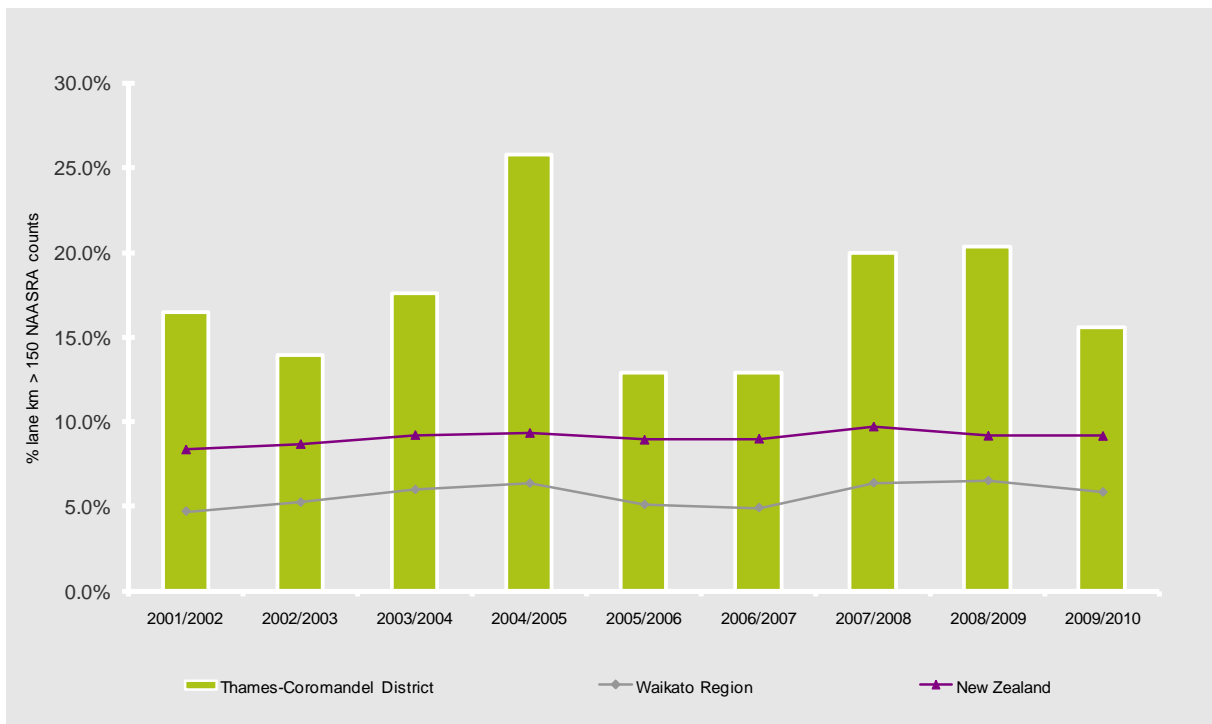
Graph 6: Road Roughness

The proportion of Council’s sealed roads exhibiting a roughness count of greater than 5.71 IRI (150 NAASRA) has been *generally rising* over the last 5 years. Overall, the Thames-Coromandel District Council network has a *greater* proportion of “rough” roads in comparison with the Waikato region authorities.
