Draft Whangamata Catchment Management Plan

Prepared by:
Julie Beaufill

For:
Environment Waikato
PO Box 4010
HAMILTON EAST

21 November 2006

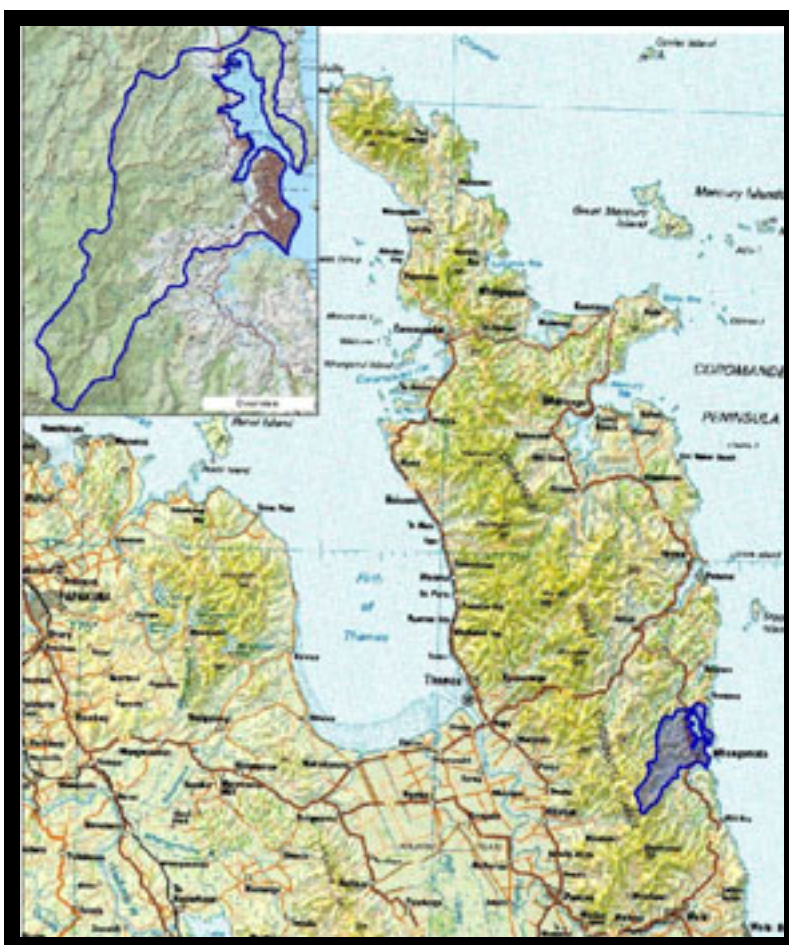
Figure 1. Location of Whangamata Catchment

The Whangamata Catchment is located on the east coast of the Coromandel Peninsula in the southern part of the Coromandel Zone (see Figure 1). The catchment contains 81 kilometres of stream. The main contributor to Whangamata's harbour is the Wentworth River. Streams flow from south-west to north-east.

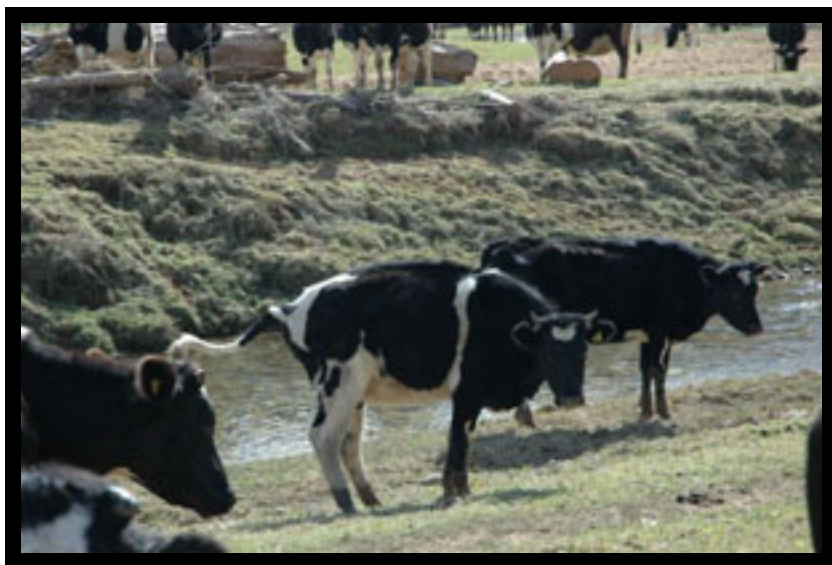
Approximately 70 per cent of the main Wentworth channel is fenced to stock class standard and prevents stock from accessing the stream bed. Of the seven tributaries in this catchment area only the Wairoa Stream has any significant riparian protection (90 per cent fenced, good riparian (stream bank or river bank) cover 90 per cent).

Figure 4. Cattle next to the Wentworth River

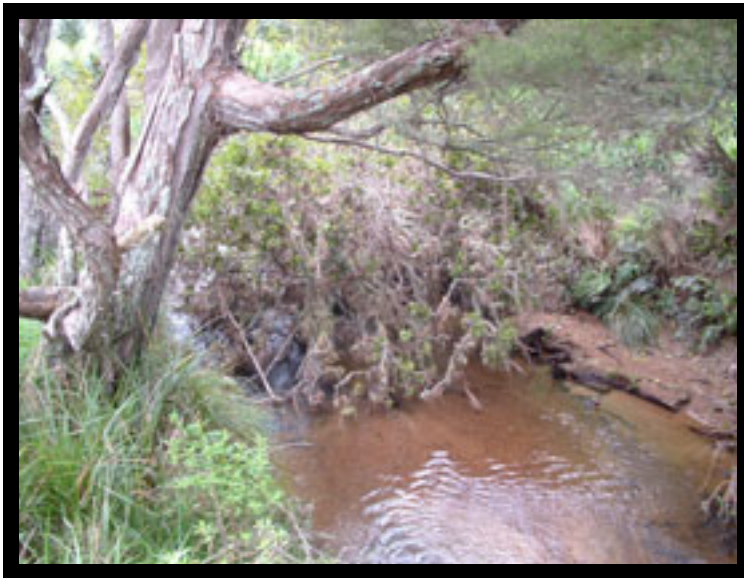
- Large possum numbers in the upper catchment degrading the forest.
- Pampas growth on stream margins (less than 10 per cent).
- Lack of riparian vegetation (present, but needs in-fill planting).
- Isolated blockages within the stream need to be removed.
- Silting up of the stream reducing channel capacity and increasing water temperature.
- Flooding between the causeway and the golf course (refer below for summary of assessment).
- Hetherington Road causeway causing a dam effect at the mouth of the river
- Increased sedimentation of the estuary.
- Unauthorised stopbank and infilling next to the upstream side of the bridge.

Figure 5. Blockage in Wentworth River channel

- Rock work or willow layering on badly eroding corners.
- Stream bank fencing.
- Clearance of pampas (spray or mechanical removal) to reduce seed source and spread.
- Willow and/or poplar pole planting in highly eroding areas.
- Planting of native riparian species.
- Removal of mangrove seedlings on an annual or as needed basis.
- Initiation of channel surveys with consequent adaptive management practices.

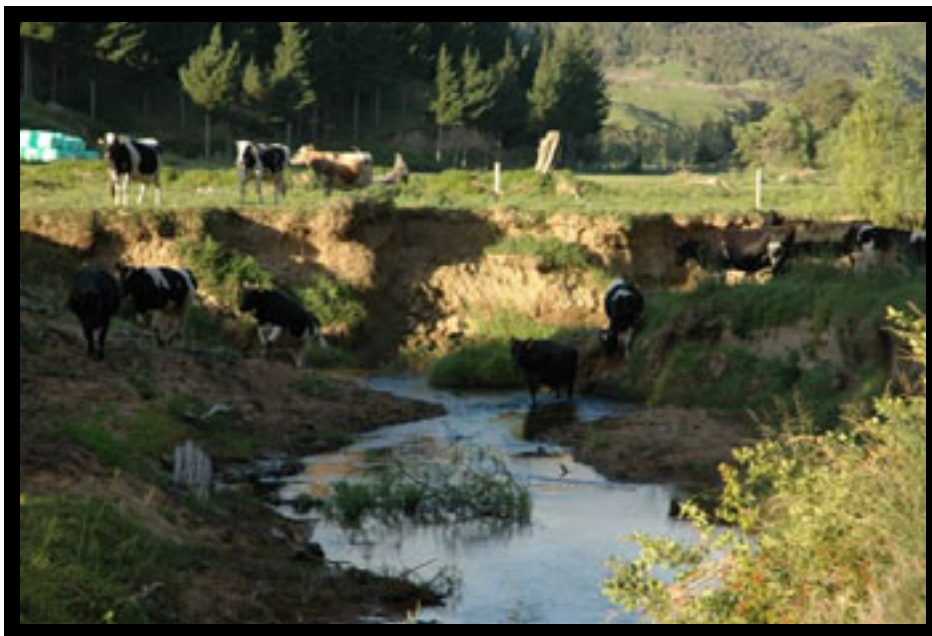
This section is the most degraded in the catchment area and probably the greatest contributor of sediment within the Whangamata catchment.

Figure 6. Slumping of the riverbank and stock access

- Possible digger work to carry out minor repairs and to remove some in stream vegetation.
- Upgrade fencing to cattle class standard.
- Undertake plant pest control (pampas and wattle).
- Undertake possum and goat control in the upper catchment.

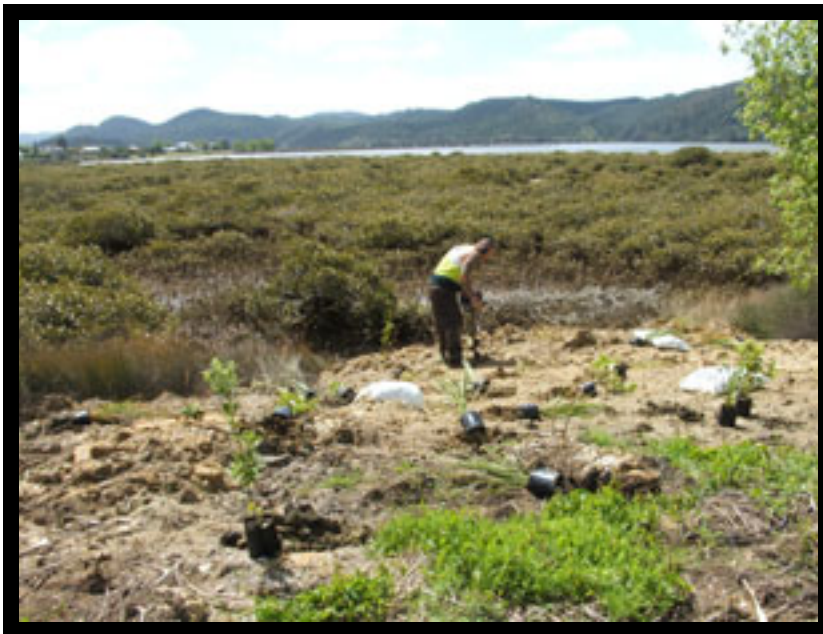
Figure 7. Planting on coastal margin of Te Weiti Stream

- Regular maintenance of the stream channel through the mangroves into the harbour.
- Upgrade the stream fence and plant with appropriate natives.
- Maintain existing silt traps.
- Investigate potential in this area to carry out coastal wetland enhancement for biodiversity purposes.

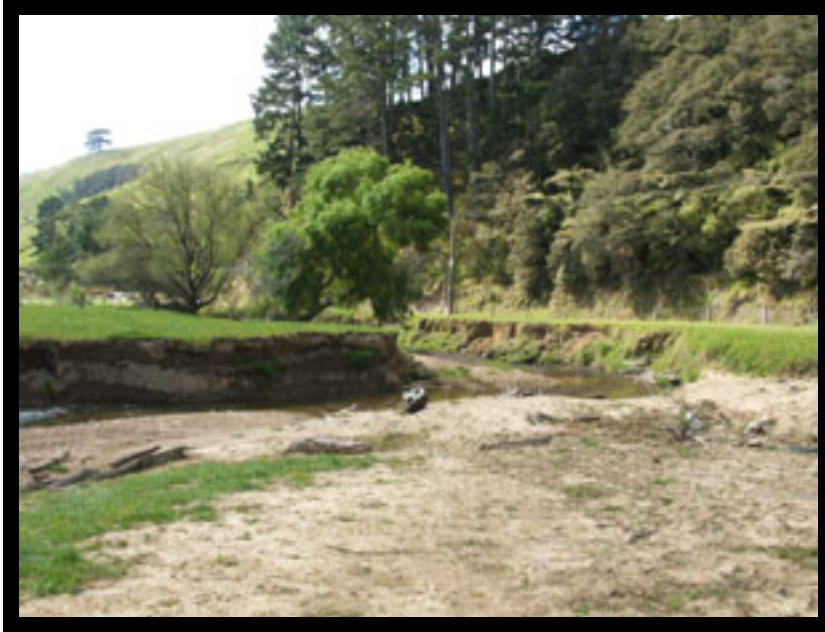
Figure 9. Stream bank erosion in the Wentworth River
