**Folder [Details of spillway construction Williamson Weir]**

Folder [Williamson Park Pond Weir]

4 April 2024

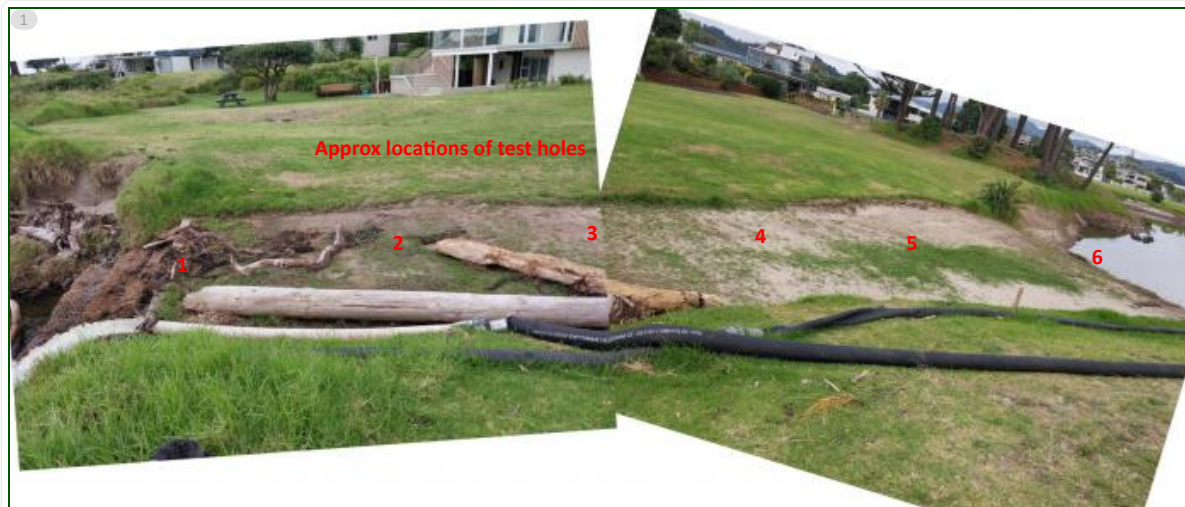
001 weir spillway 20240404\_172911\_SC\_.jpg

6 test samples at 5m spacing from the weir (test 1) to the edge of the basin (test 6)

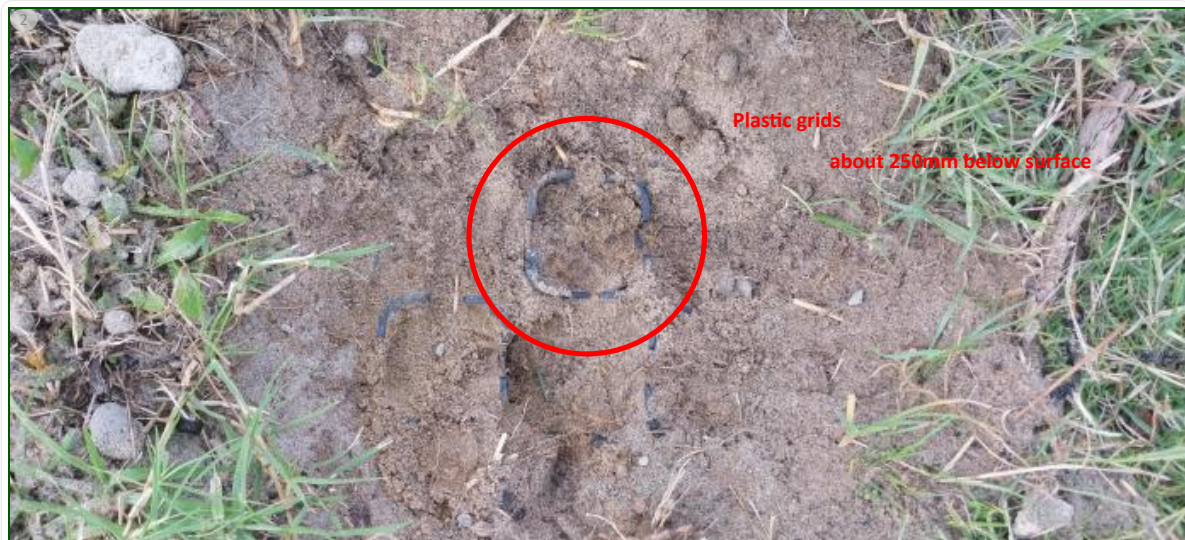
Test 1 by weir is plastic gravel grids filled with sand - although the sand is not well compacted underneath or is eroding away through the weir.

010 Hole 1 plastic grid 20240404\_161021.jpg

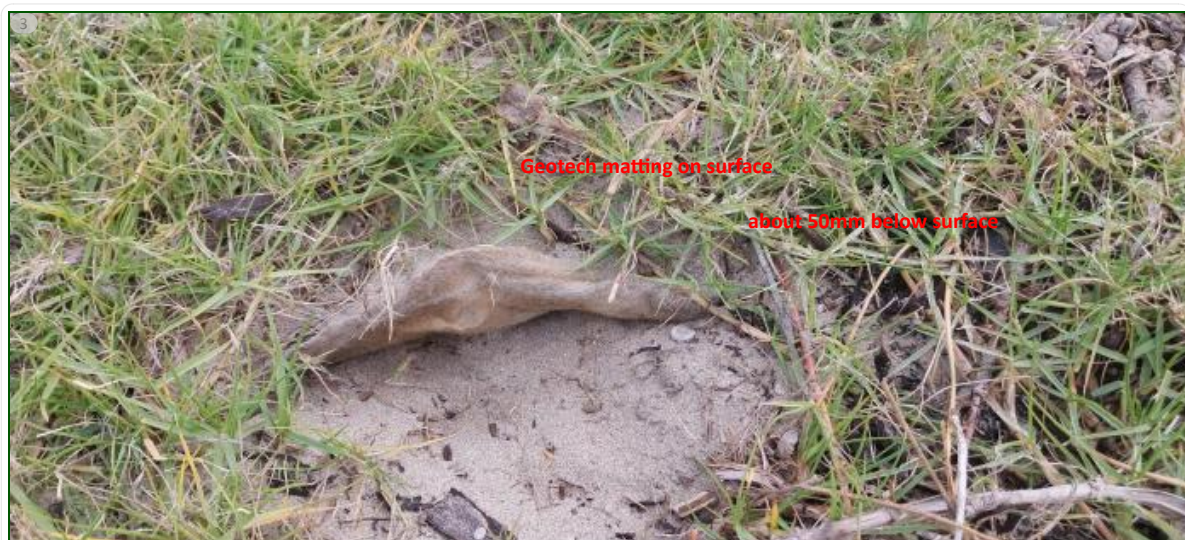
Test 2 has a Geotech material quite close to the surface but cannot determine what's underneath without cutting.

020 Geotech matting 20240404\_161140.jpg

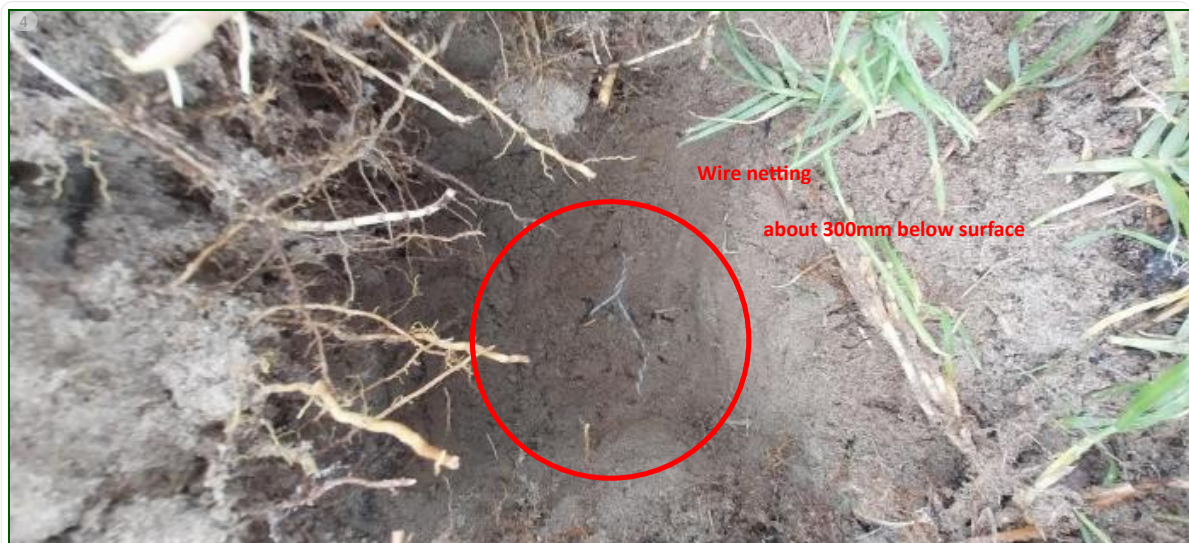
The remainder tests 3-6 have wire netting which has sand underneath but is probably rocks with sand filling spaces.

030 Wire netting about 300mm below surface 20240404\_161314.jpg

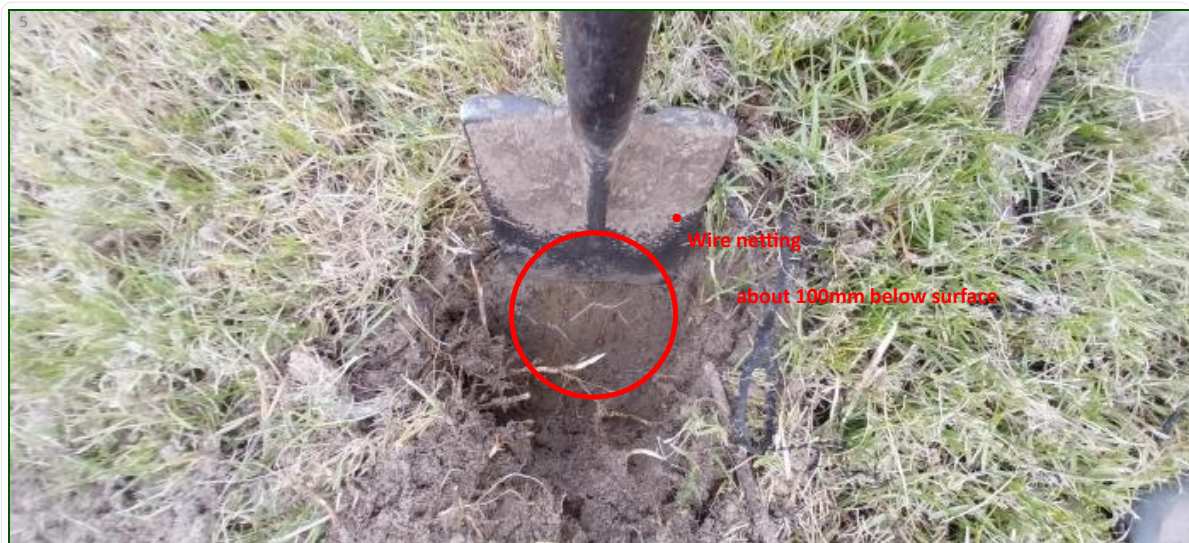
040 Wire netting 20240404\_161439.jpg

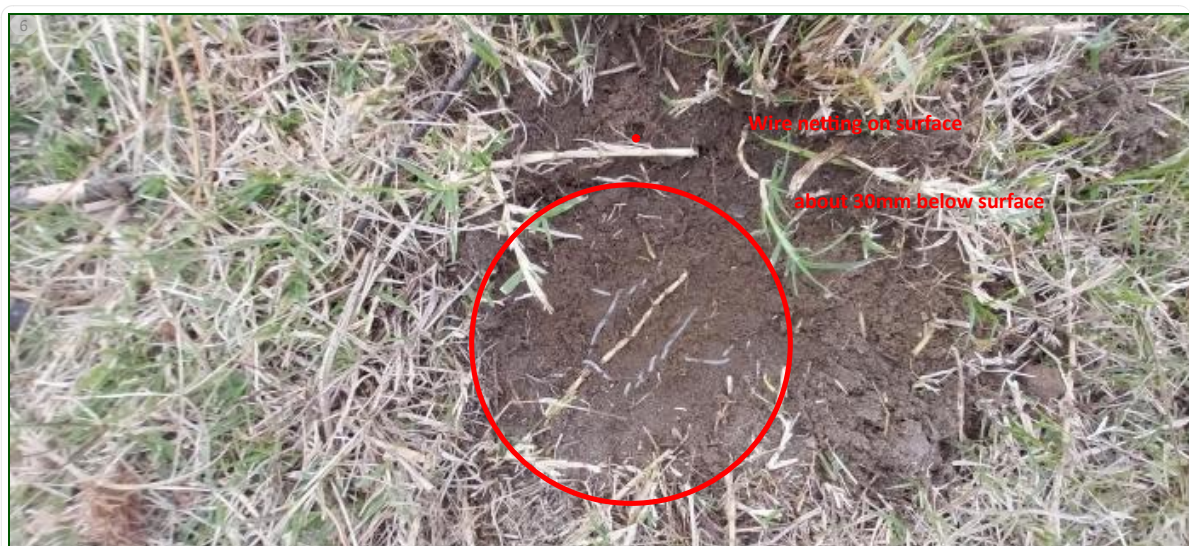
050 Wire Netting 20240404\_161541.jpg

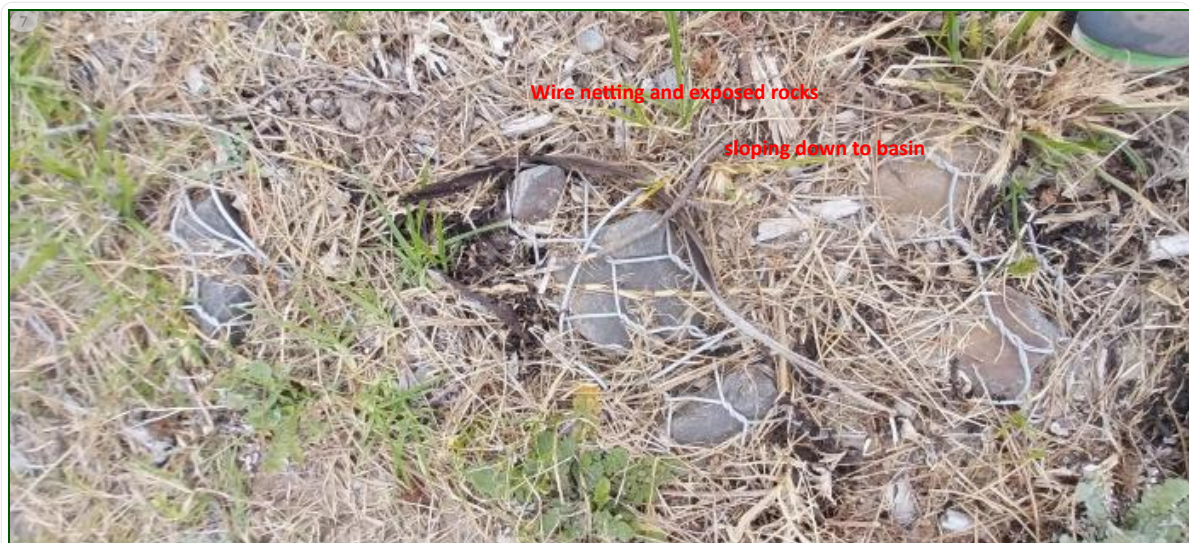
At 6 the wire netting and rocks form the batter to the pond basin

060 Wire netting and rocks 20240404\_161606.jpg
