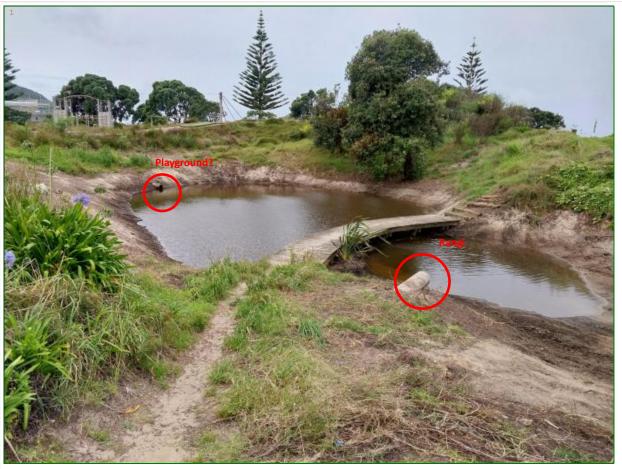
010 Island View Reserve20230211_174026.jpg

Just been cleaned 11 February 2023

This was between Hale (10 January 2023) and Gabrielle (20 February 2023)

Before the clean out the bracken was so thick it was difficult to push through the walkway.

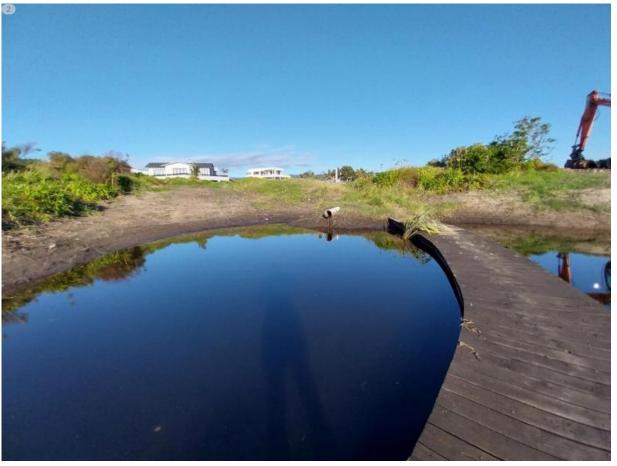
030 20230307_084459.jpg

Showing depth of lake 2 weeks after Gabrielle

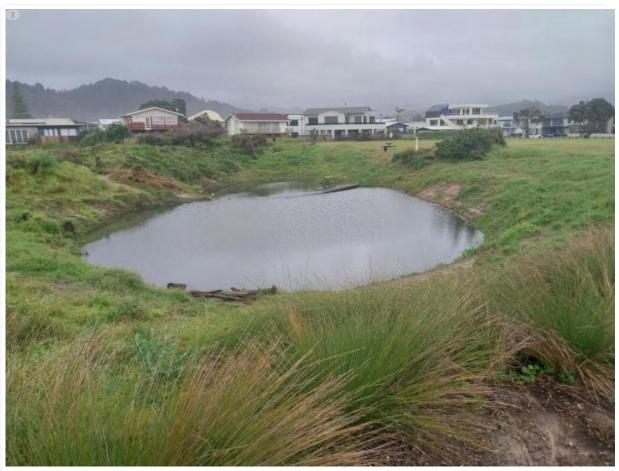
060 20230624_103419.jpg

Depth of lake 24 June 2023 - had a major event during the night. Level about 400mm below far pipe invert

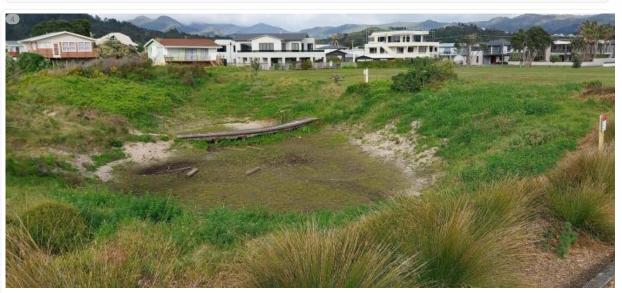
100 20231010_085711.jpg

No water 10 October 2023

Nothing exiting the pipes

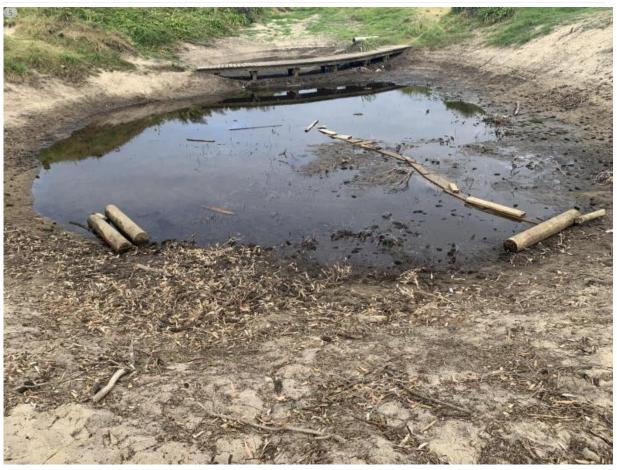
170 002B4B07-8FB6-4156-9554-E6D29E7878CD.jpeg

Undated image

Likely around May as grass is returning around the edges.

Kids have carried timber to create a walkway.

No-one can police safety - even parents won't have realised kids have done this.

Accept the lake must go.

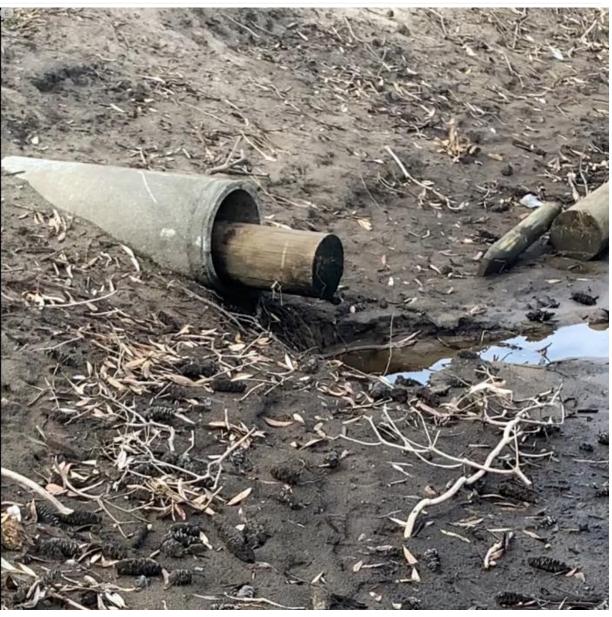
172 20231029_140544 _SC_.jpg

Pipe x playground - unknown connection

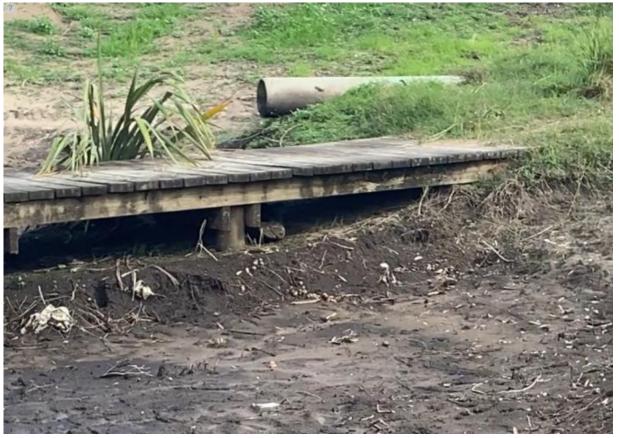
173 20231029_140621 _SC_.jpg

Pipe Rangi. Unknown invert LVL

Appears to b approximately 1m below ground level which is likely 1m below Rangi crown.

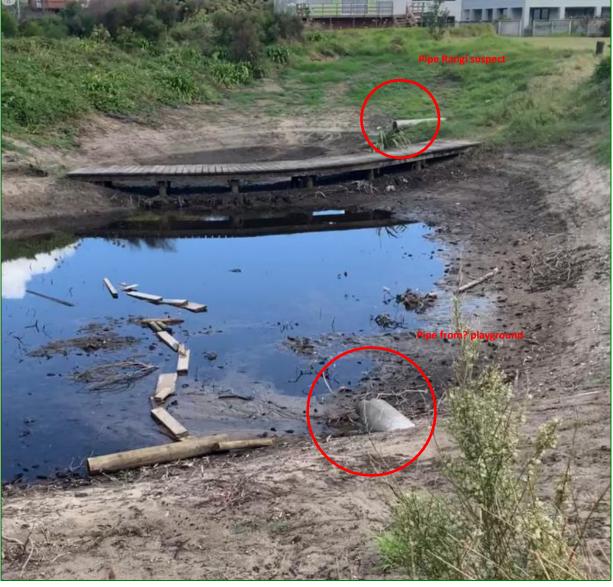
174 mp4 showing both pipes.jpg

No water exiting either pipe.

More likely residual rainwater from earlier rain.

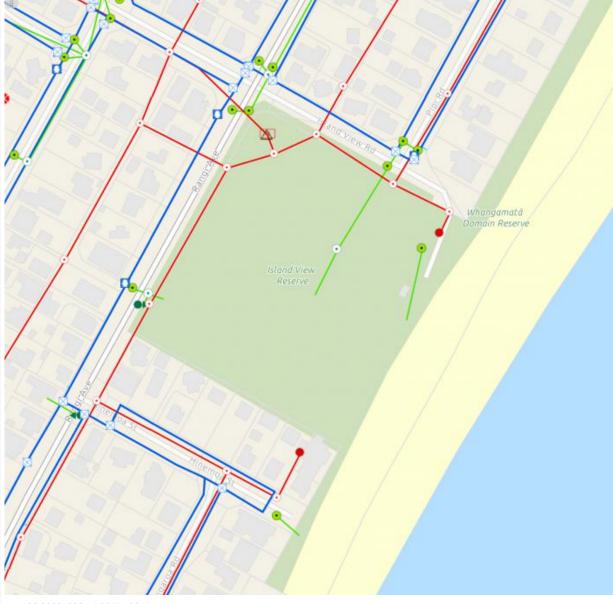
199 20231029_150257 _SC_.jpg

From 3 Waters Smart Maps looks like the playground entry is Pipi Rd and the other is an unmarked extension from Rangi Rd.

By useful to check that the Pipi one is clear as the carpark often gets flooded from Pipi and Island View Rd.

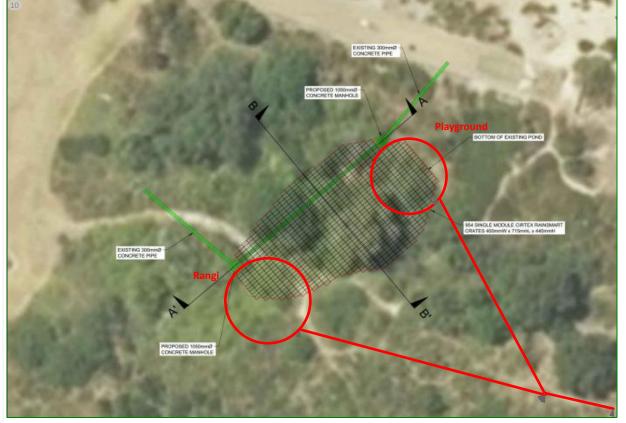
200 TCDC plan view Cirtex.jpg

I don't accept that the entire basin needs to be Cirtex. I agree with the manholes as the catchpit for solid particulates.

The Cirtex can be minor because soakage devices are NOT part of a 10%AEP. The soakage devices can be small to cater for minor rainfall events and then overflow into the basis as a short term holding pond and piped out once the depth got over say 100mm. The circles represent the pond sizes and the red lines pipes into the Ocean.

NOTE: I do not want pipes discharging into the Ocean BUT we have no choice because we cannot get all pipes to Otahu river. If we could that would be great BUT it still means discharge somewhere.

There can be no objection to 10%AEP being discharged directly into the Ocean or river especially in a small township like Whangamata and especially a road as little used by trucks as Rangi

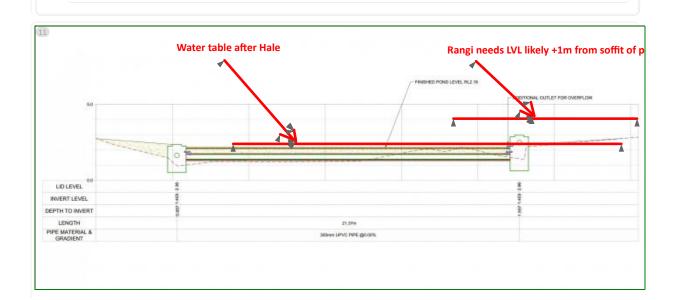
201 TCDC cross section showing drainage.jpg

Photos show watertable in February after Hale to be about invert. Having Cirtex below this (the red line) is not useful for storm-water management as they will be flooded and working in reverse. They will provide NO soaking away so the purpose for having them is incorrect.

Soakaway is only possible once the water table has fallen and by then surface flooding has gone away.
