**Folder [Beach scour and algae bloom]**

Folder [Williamson Park Pond Weir]

**Williamson Pond History:**

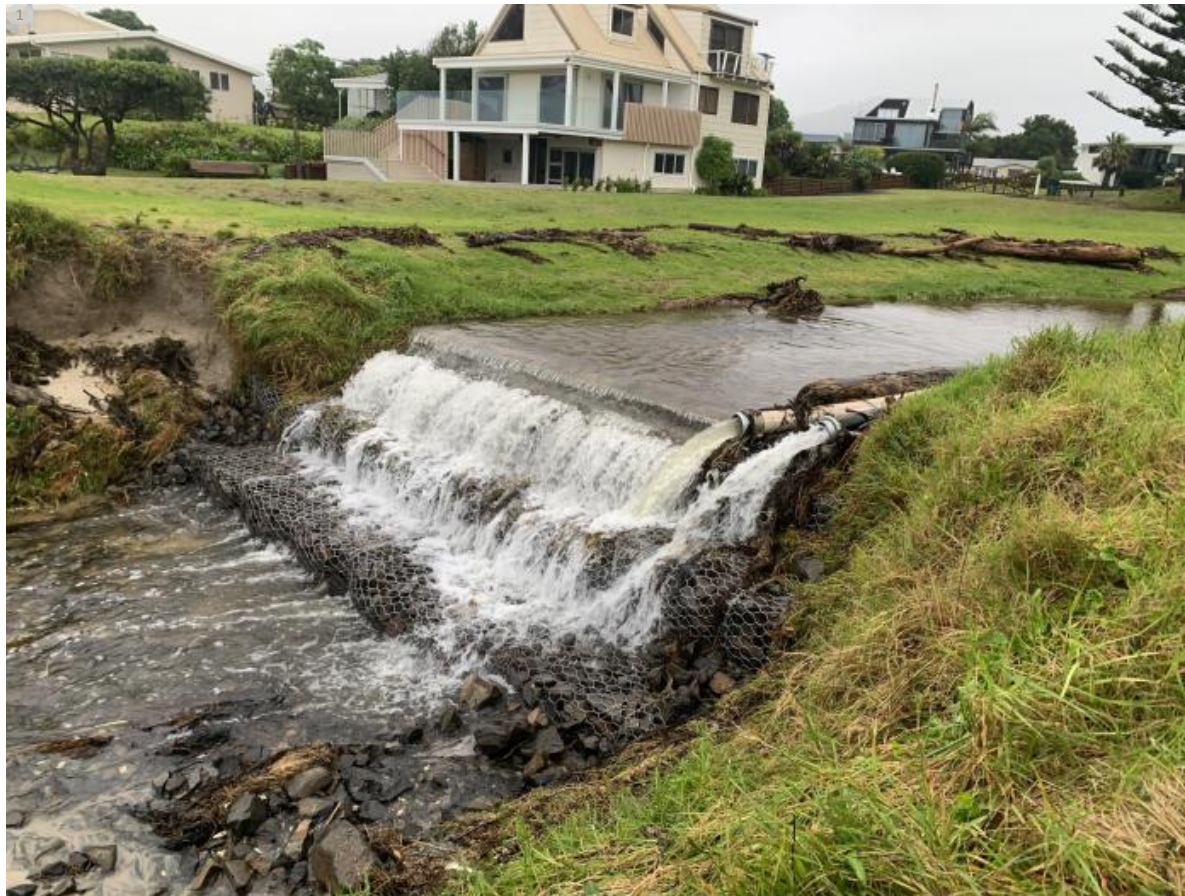
105 Weir at 13 March with pumps running.jpeg

This was about 4 weeks after Gabrielle when the pumps were working and weir was still overflowing.

See the water level in storm surges

One decent log is washed up

Flutter valves will need to be sturdy

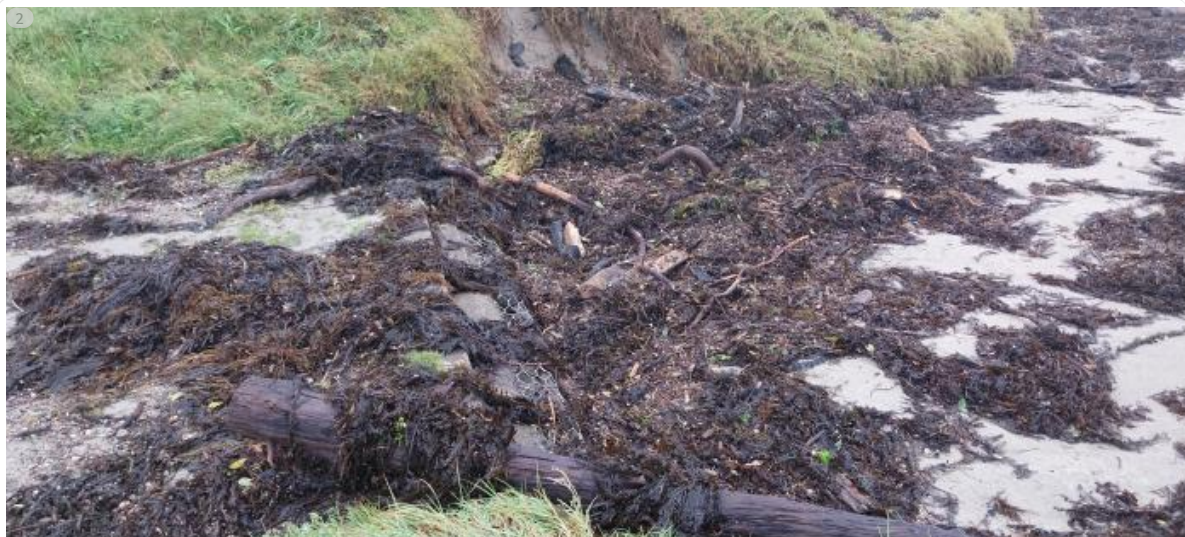
110 Weir after King Tides 1 November.jpg

Weir buried in sand up to last gabeon with driftwood topping.

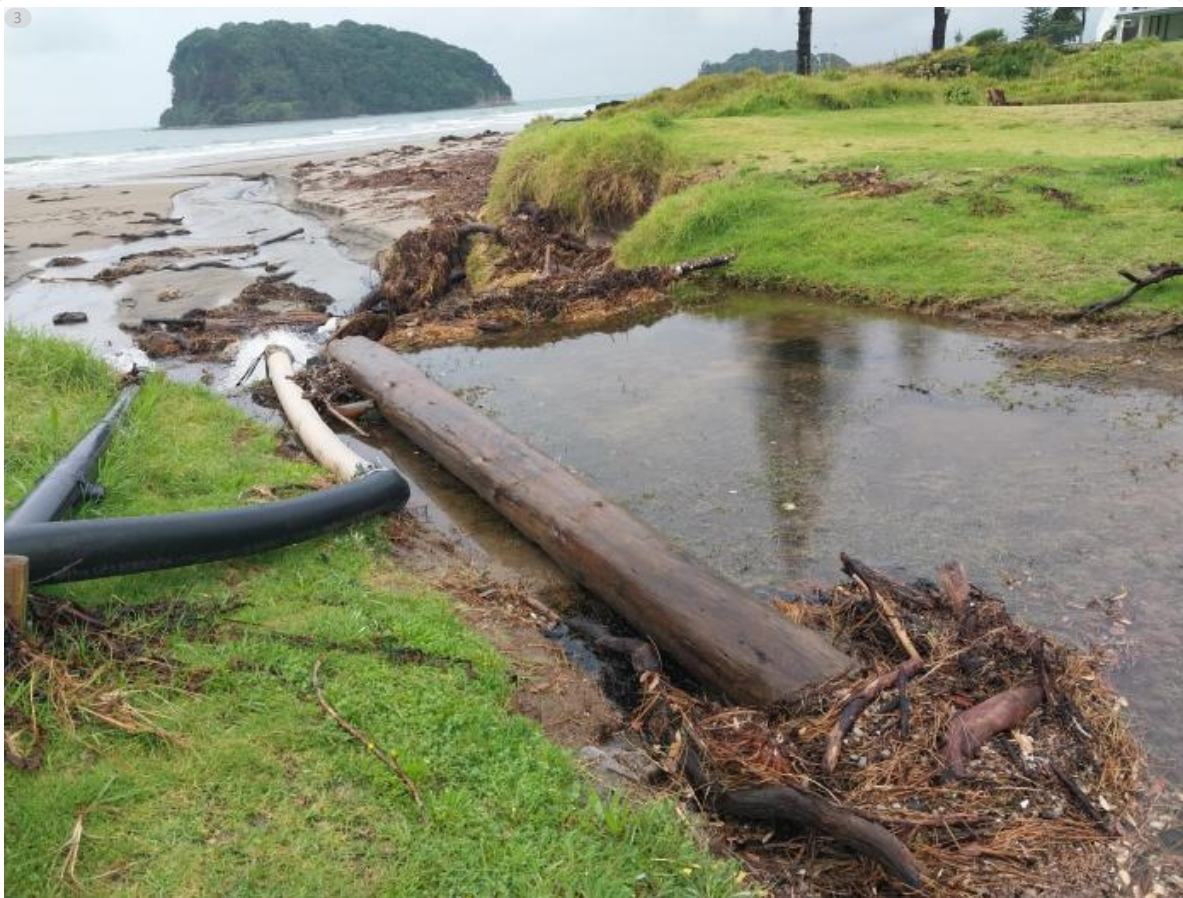
124 King Tides breach weir 20230227\_105746.jpg

Level of breach is significant

Weir MUST be raised

If sea levels do rise the level needs to take account of this.

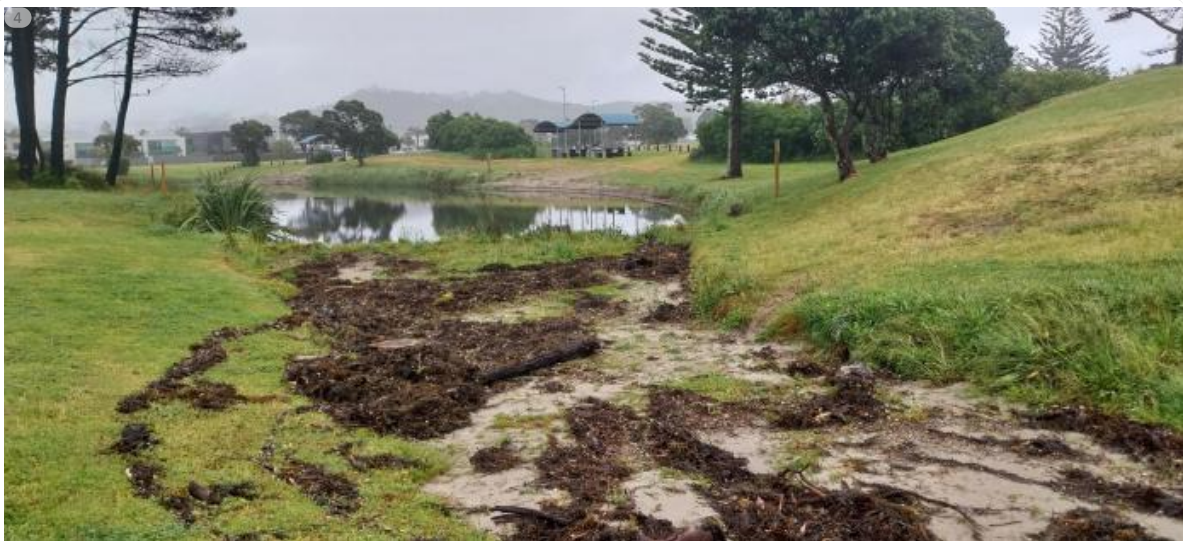
130 King Tides breached weir 1 November 2023.jpg

Storm tides breached the weir on 1 November.

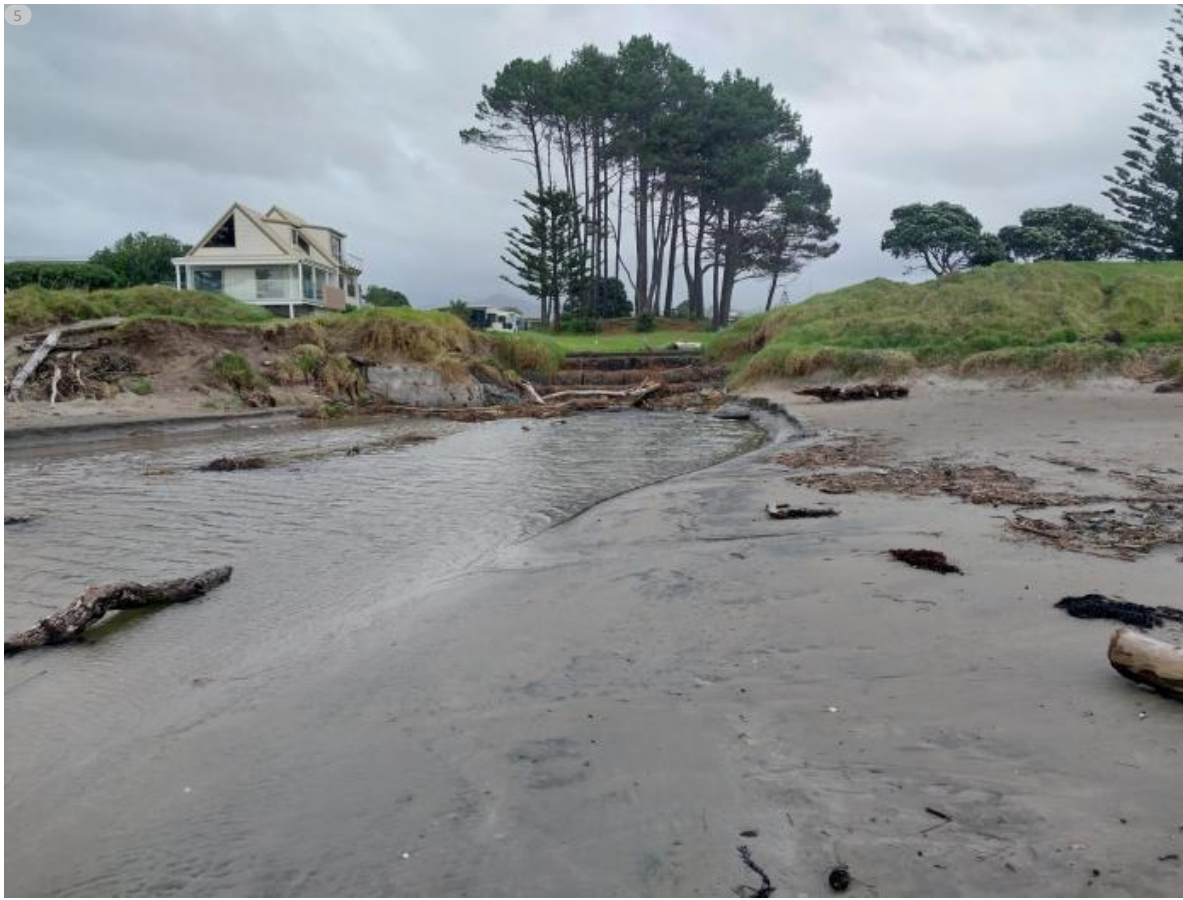
140 20230418\_081644.jpg

Lake forming on the Beach in front of the weir as 18 April 2023

Note erosion

The shape of the Vee to the weir location is poorly designed as it forms the surge and magnifies the surges velocity and momentum so makes it worse.

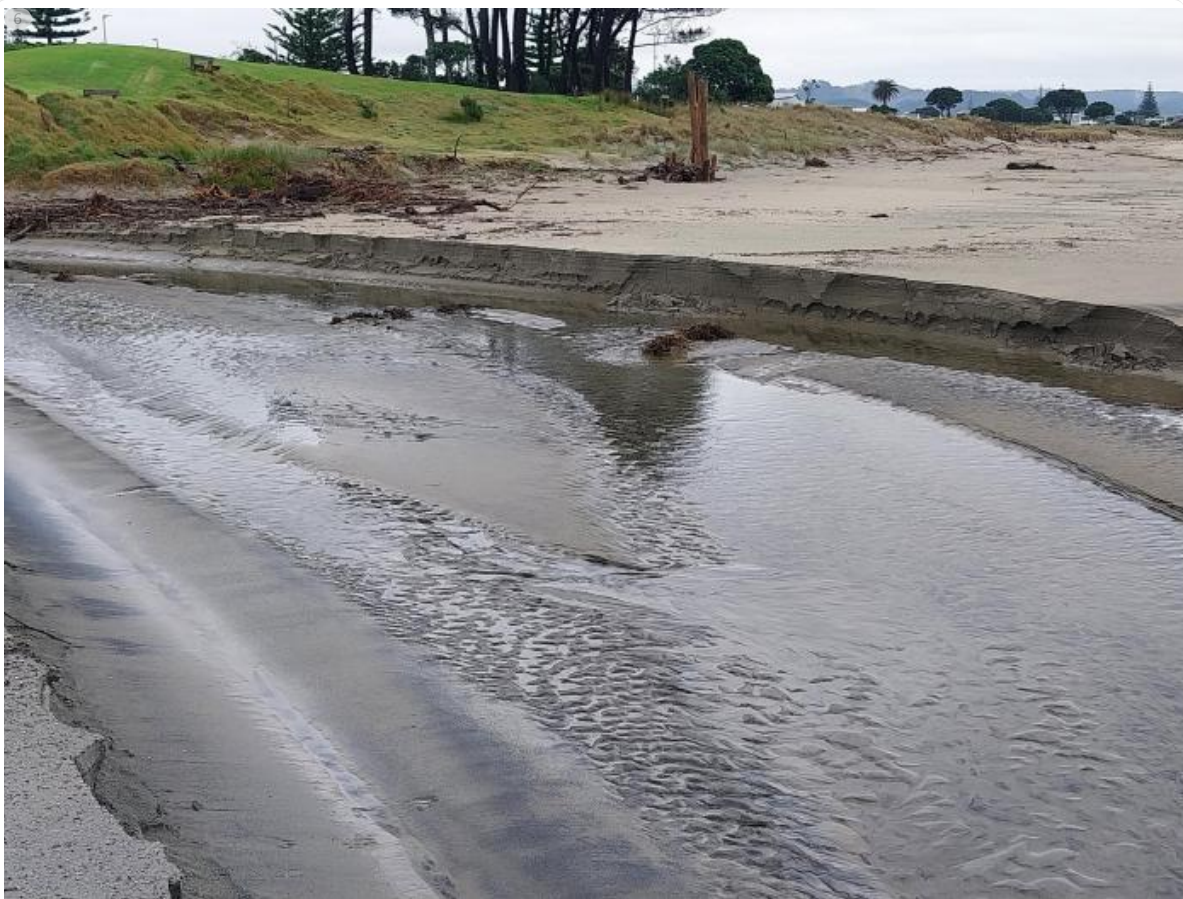
141 erosion of beach into channel 20230618\_090914.jpg

Whilst the water tops the weir we get erosion as water makes its way to the Ocean.

Normally the sand recovers quite quickly but it is not desirable

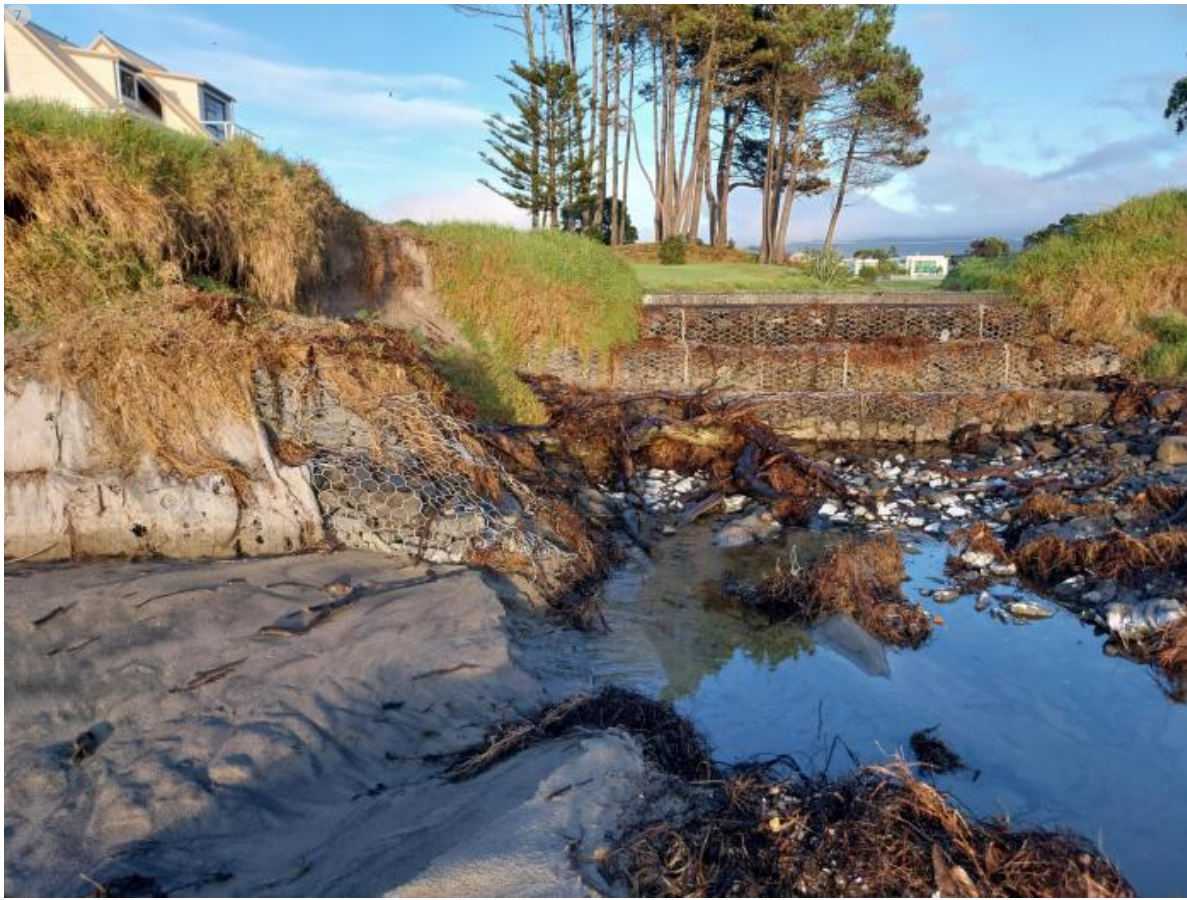
150 20230620\_082053.jpg

Weir on 20 June 2023

Note depth of erosion

Old weir is the wire cages in the foreground.

It is unknown if this was pulverized by the Ocean or broken through to create the new weir behind

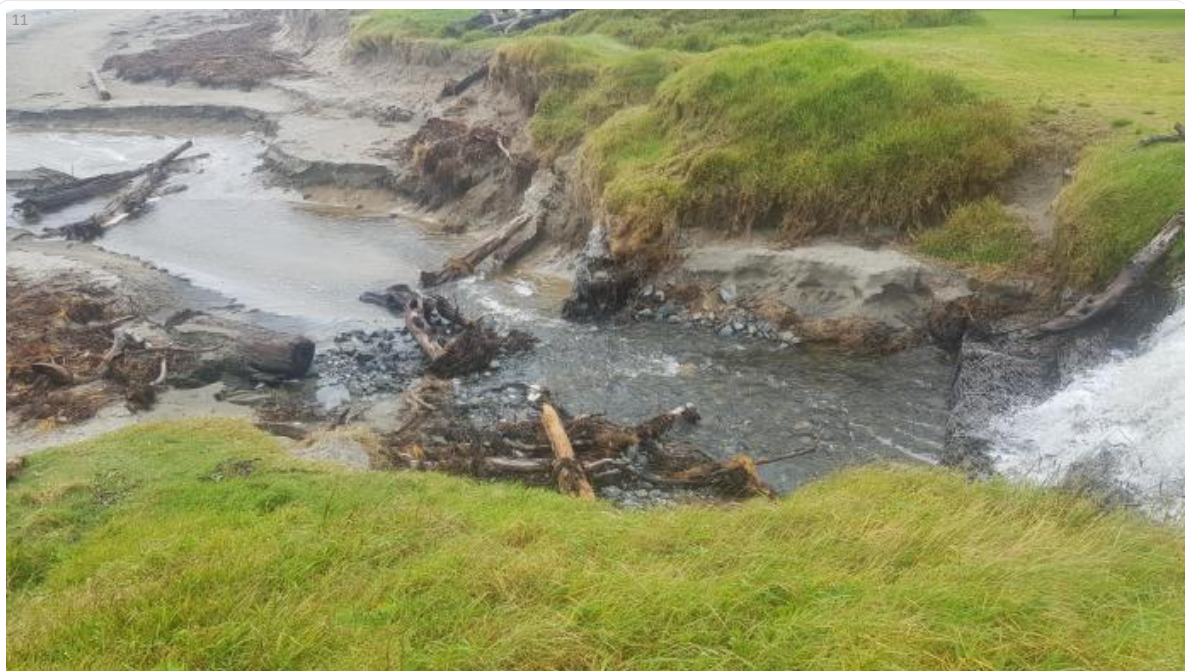
20230129\_123751.jpg

29 January 2023 early Beach scour

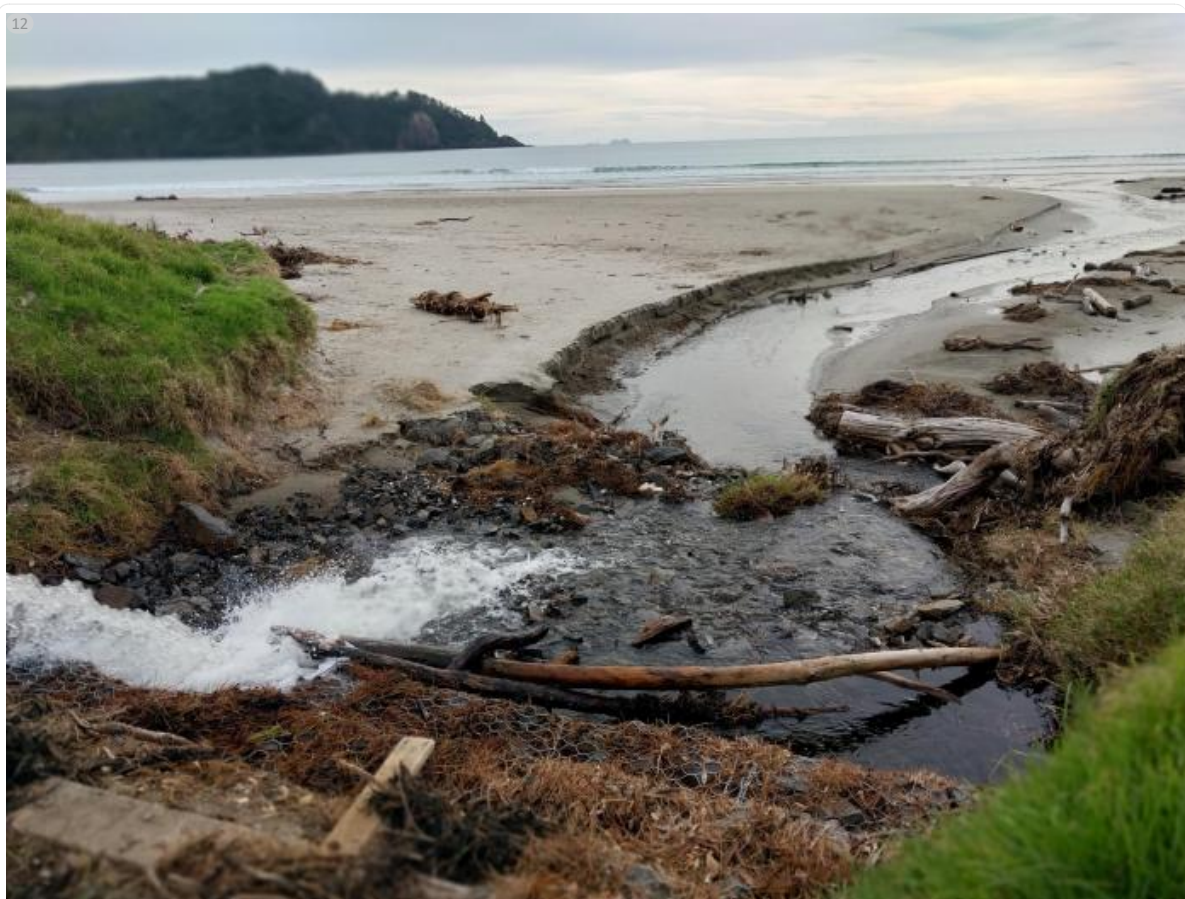
20230313\_092808.jpg

13 March 2023 beach scour

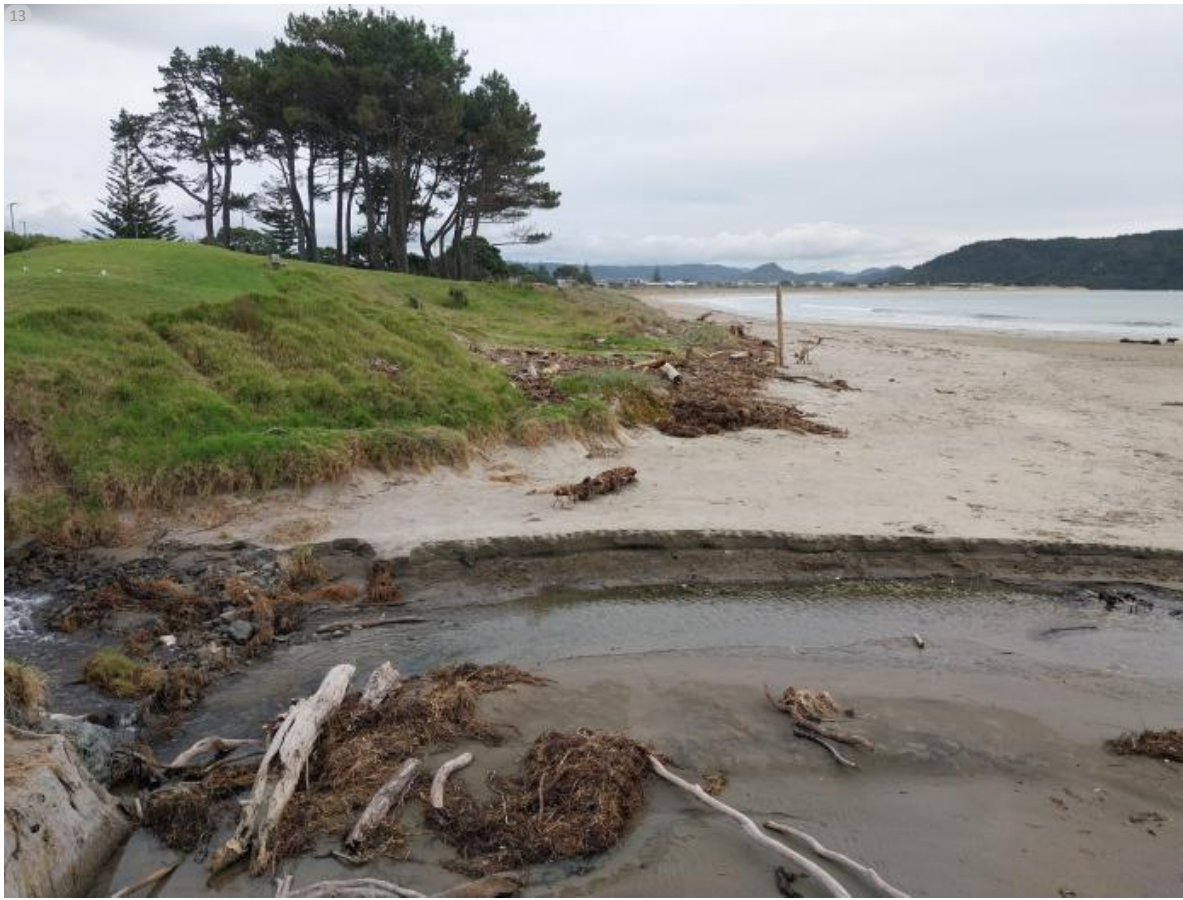
20230313\_092914.jpg

Showing erosion of sand at discharge from weir.

This is after pumping.

At the beginning of the pumping water was flowing over the weir - then the pumps added to the water fall.

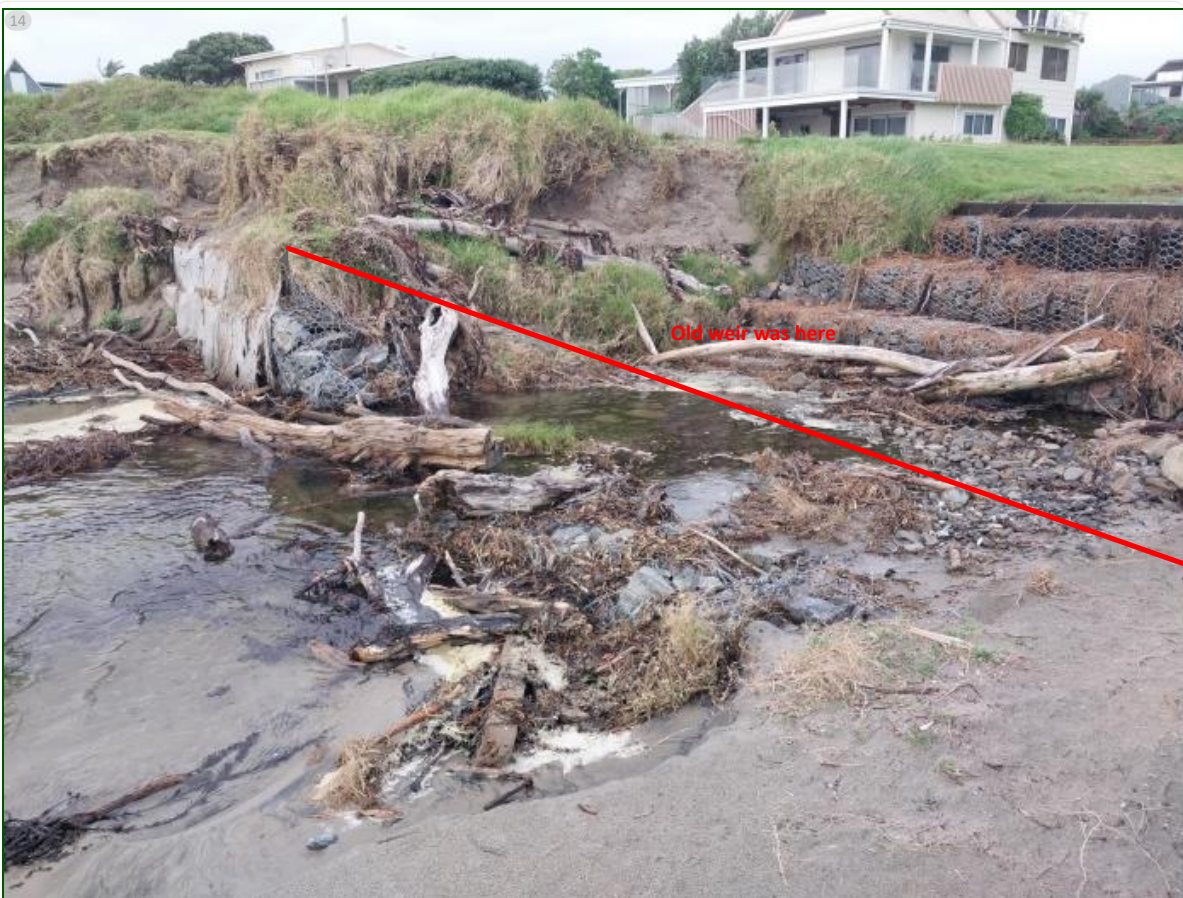
20230418\_081718.jpg

Can see the remnants of the old weir

When its raining the water runs over the weir and is deep along the Beach so people walking in sand shoes get their feet wet.

Not a big issue but people try and jump across and walk over the rocks and logs so is a accident

waiting to happen

This could be rebuilt with flutter valve pipes and a walkway along the top with a hand rail

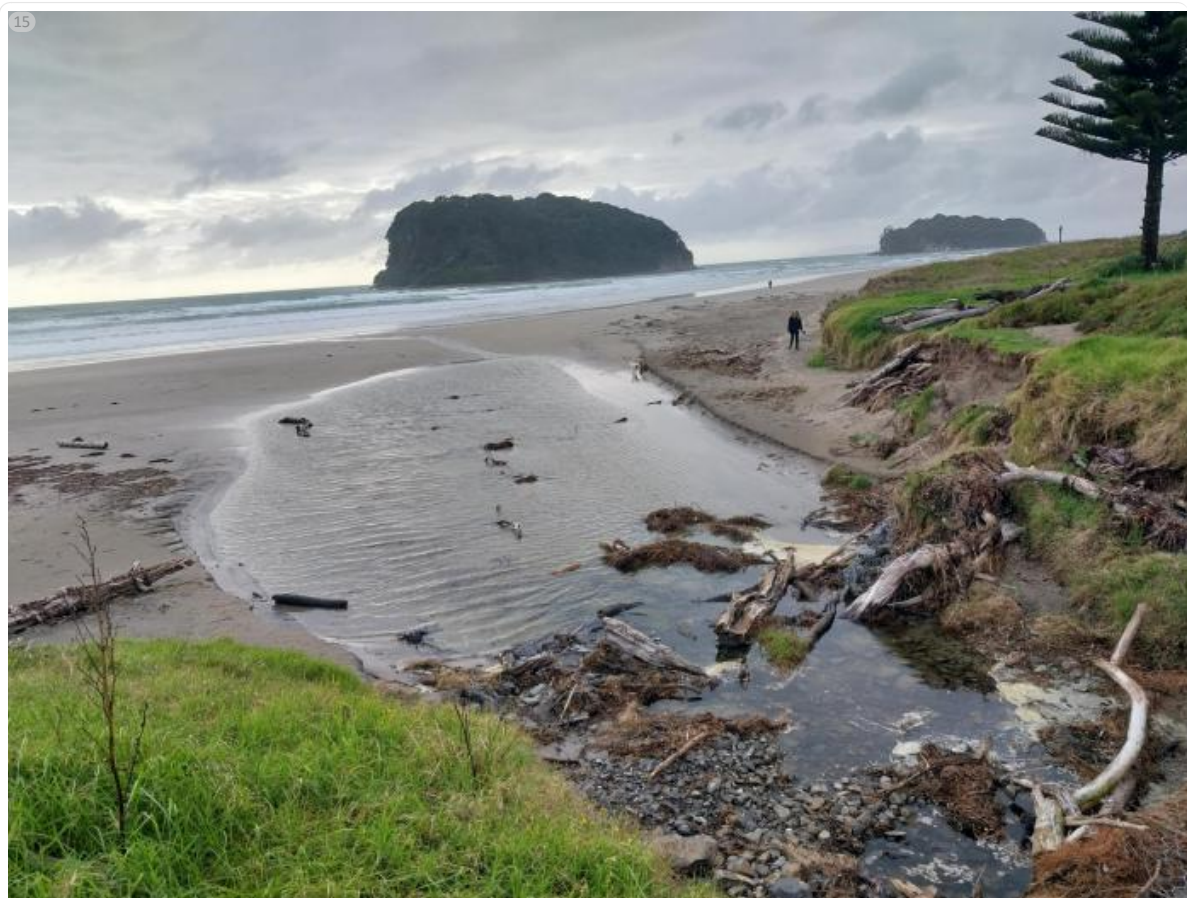
20230418\_081806.jpg

Current state of weir(s) and lake forming with logs and debris lying around.  
This is right next to the surf club and often the flag Marshall area is right here.  
This is the carriage way discharge and the Golf Course water

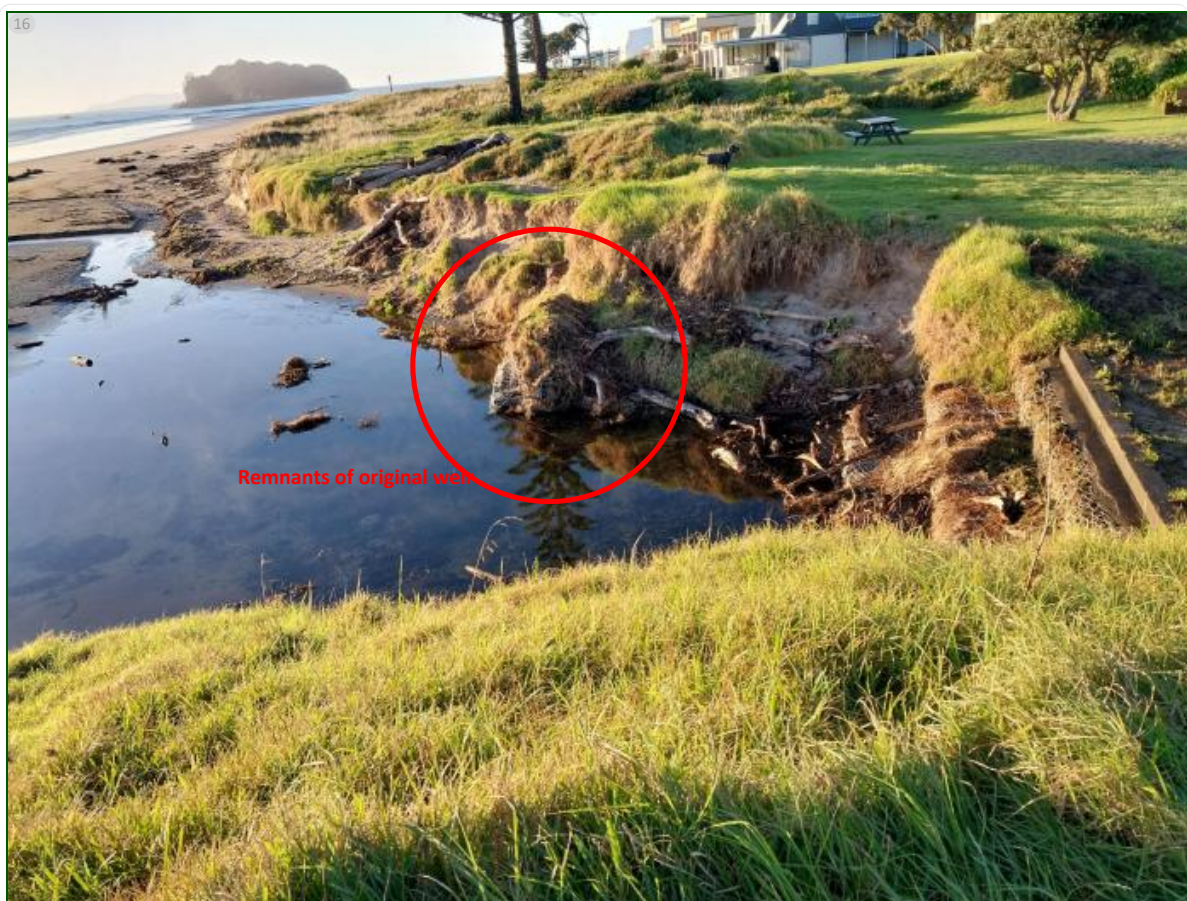
20230513\_074420.jpg

13 May 2023 condition of sand dunes beside the spillway.

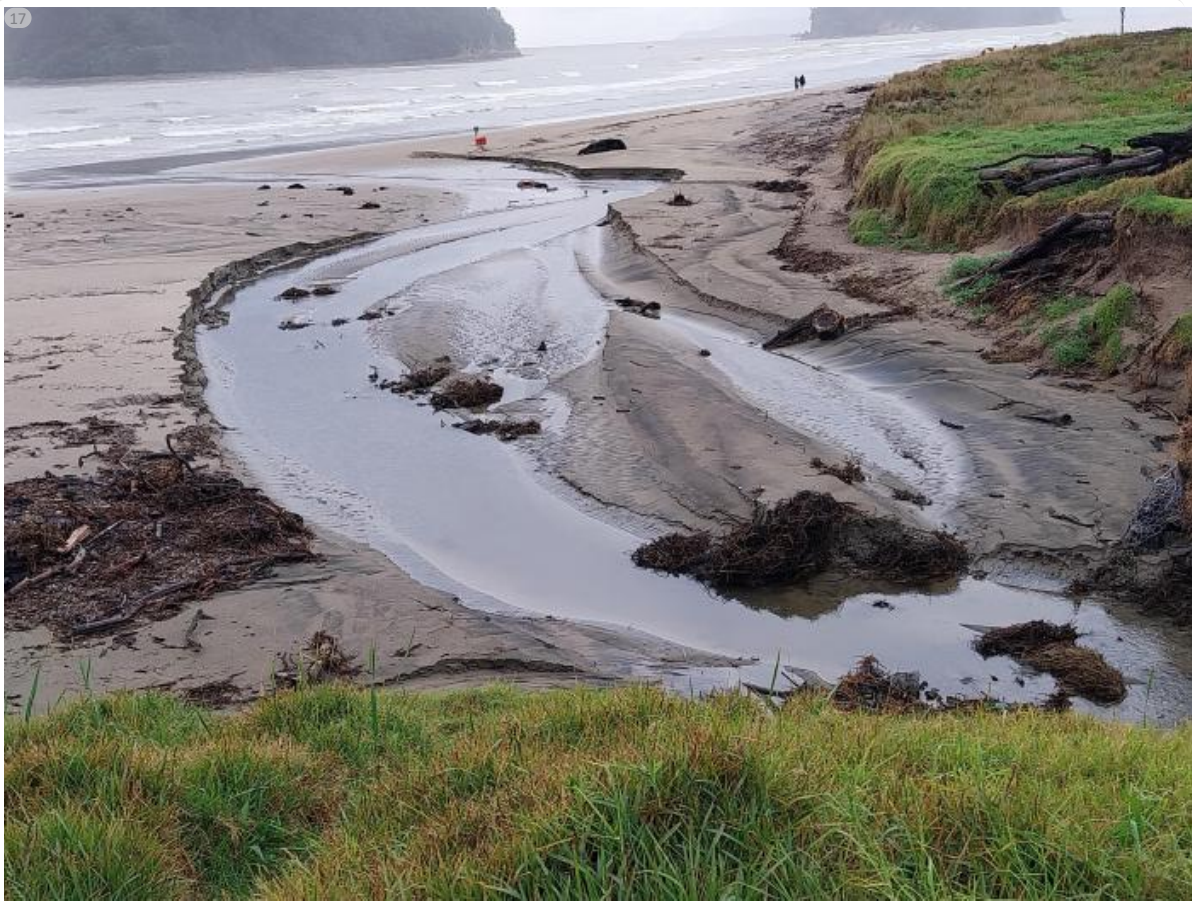
20230618\_090508.jpg

18 June 2023 Beach scour

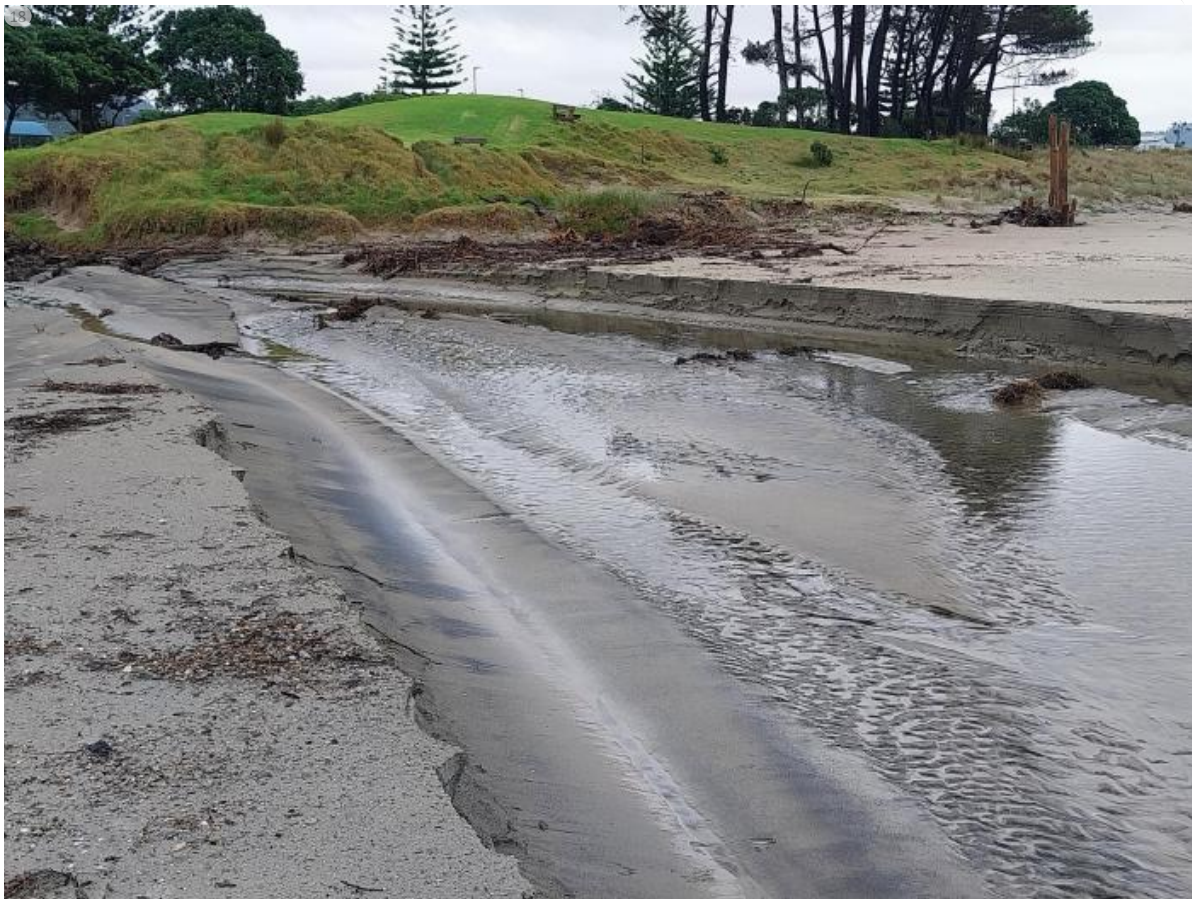
20230618\_090915.jpg

18 June 2023 angle of beach scour looking back to weir

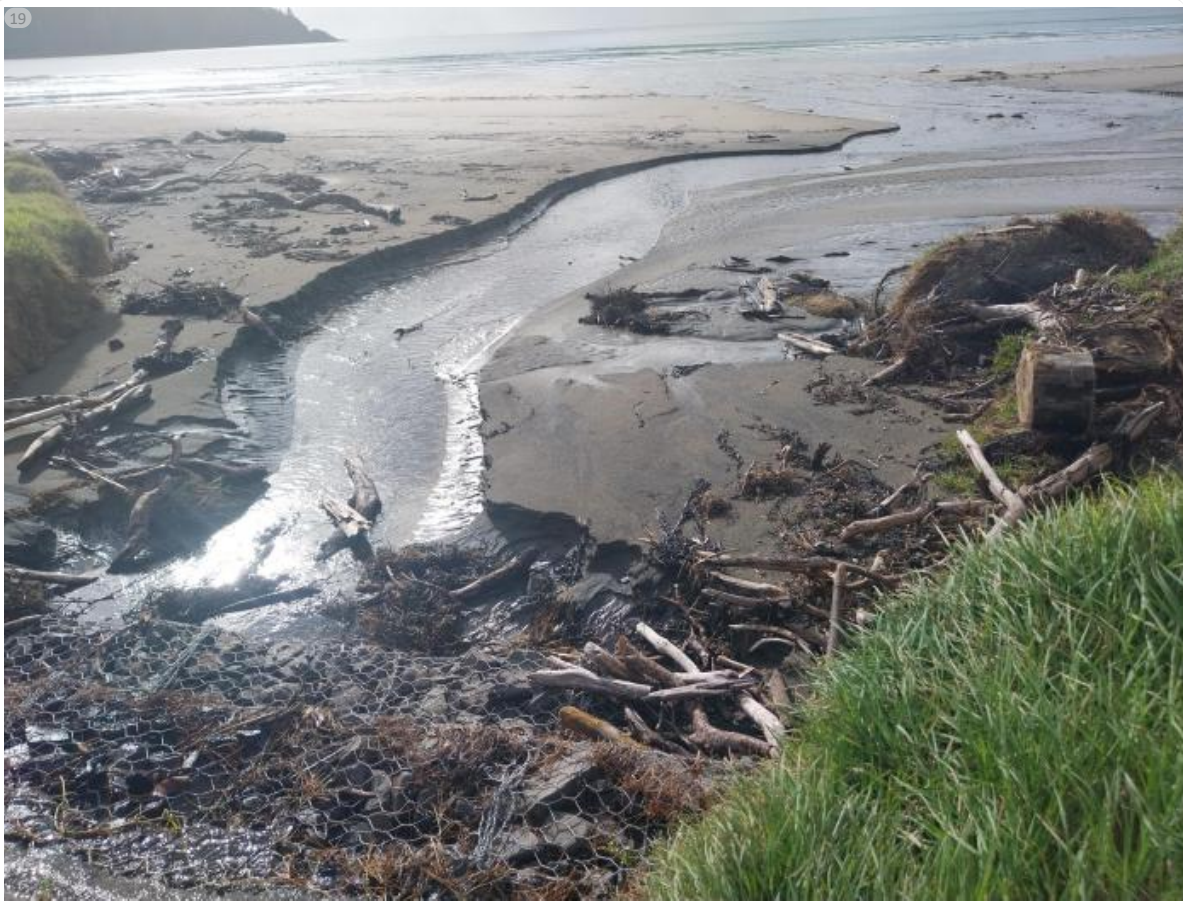
20230702\_111655.jpg

2 July 2023 scour shifted towards surf club

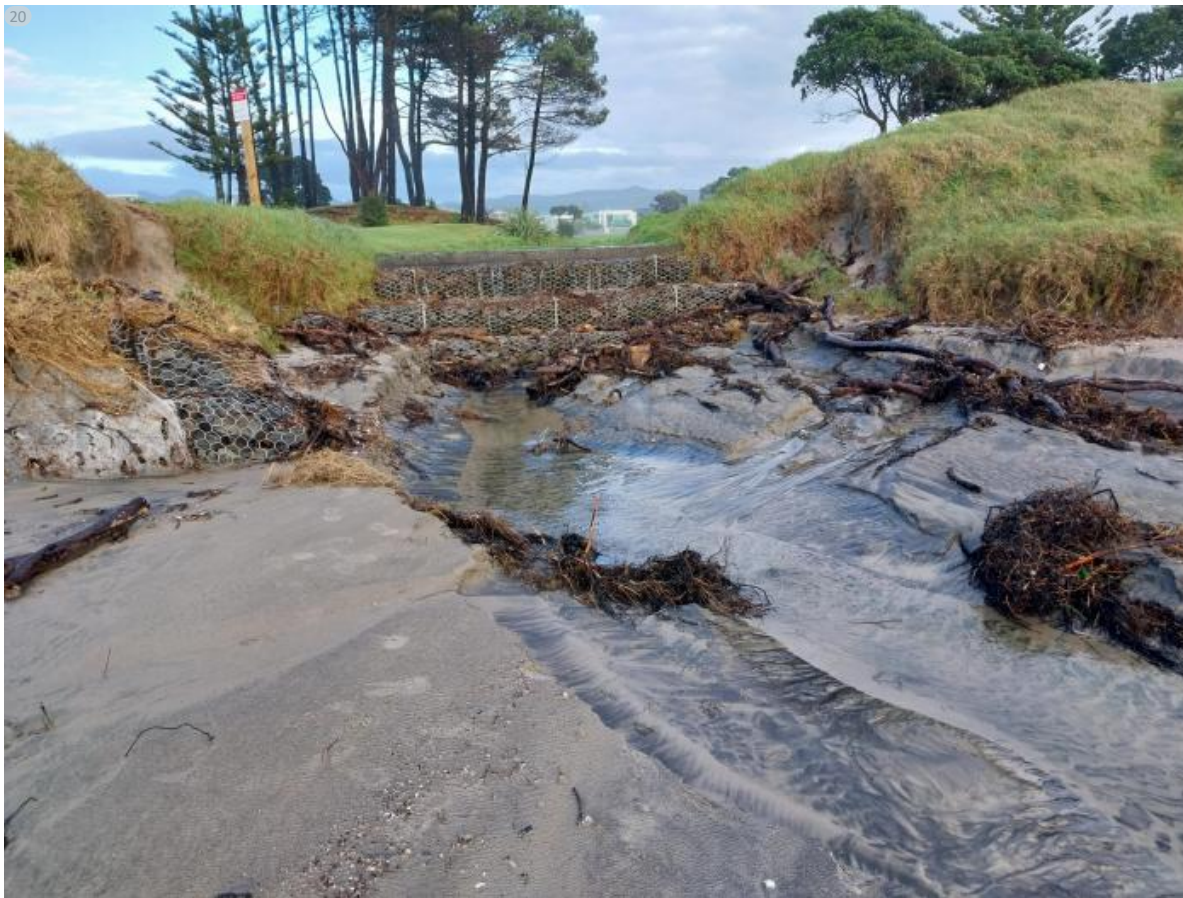
20230708\_084216.jpg

8 July 2023 scour now undermining weir - exposed bottom Gabion wire baskets. Note old weir now exposed. Scour now deep in comparison to remainder of beach

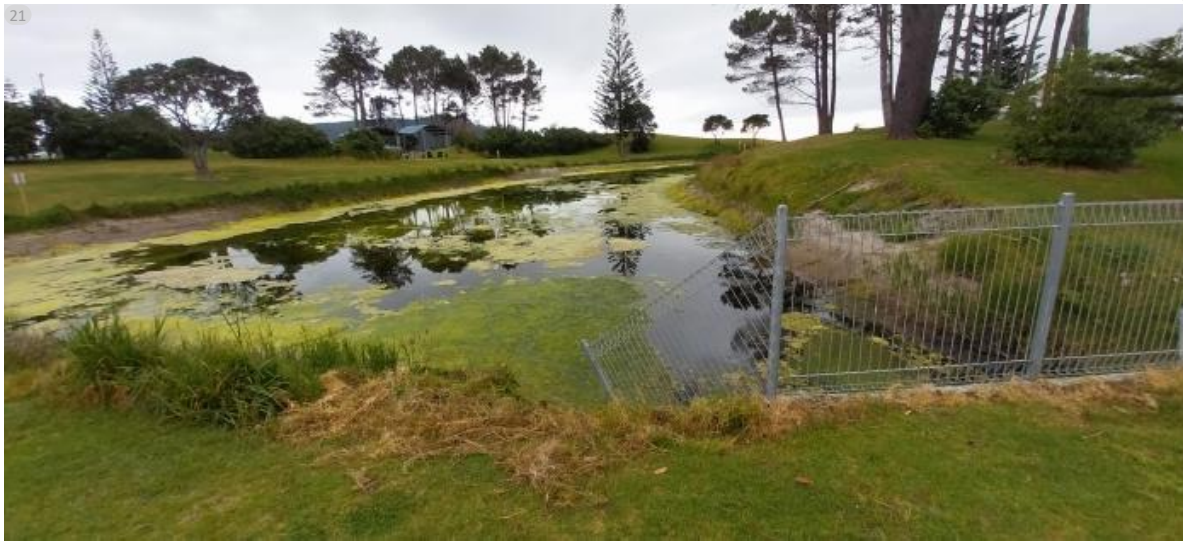
20231020\_080019.jpg

20 October algae bloom now almost fully covering pond - it stretches up the pond banks about 500mm and is very slippery. It has settled onto and smothering all the grasses and rocks.

This is called HAB harmful algae bloom

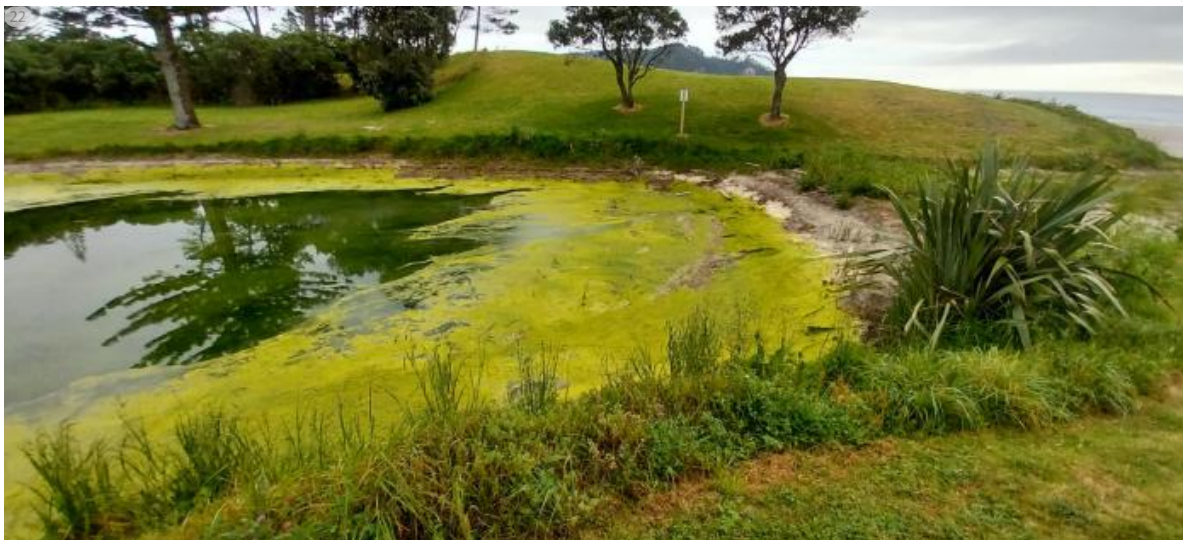
20231020\_080157.jpg

20 October 2023 seaward side of pond algae bloom.

NB: was cleaned out in February 2023.

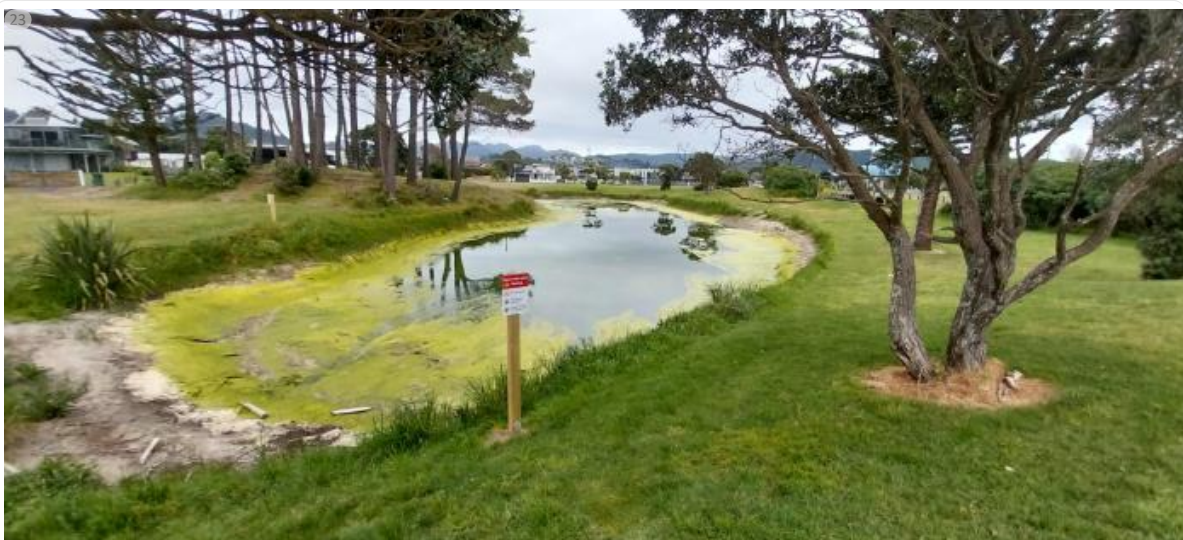
20231020\_080233.jpg

20 October 2023 algae bloom looking back from sand dunes.

NB: Council erected these warning signs after I complained of safety hazard.

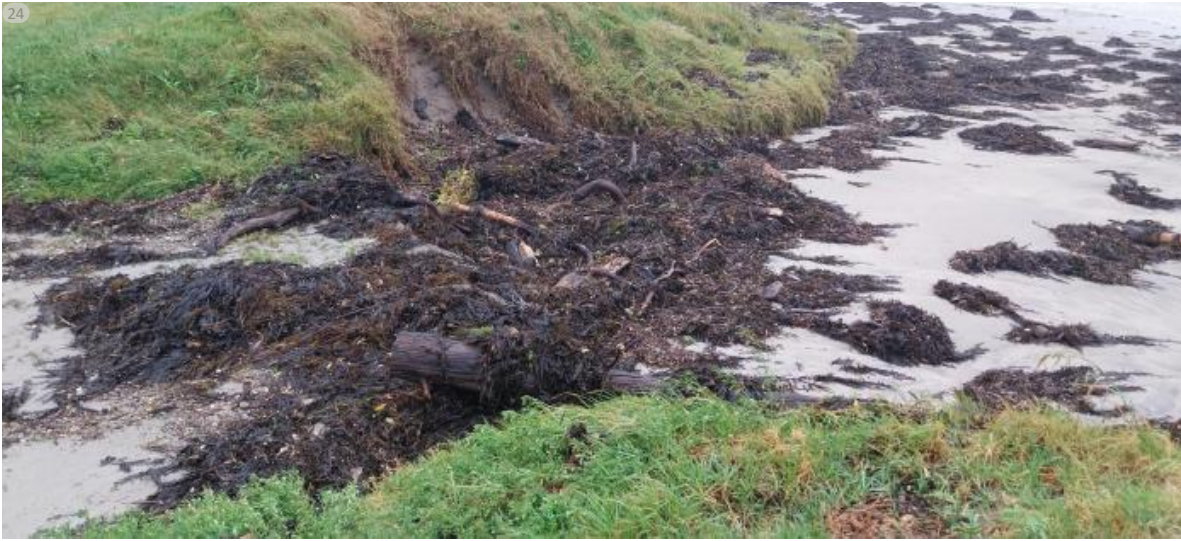
20231031\_074519.jpg

31 October 2023 sands now shifted - no more weir over topping so no new scouring so beach has recovered sand wise and blown - washed sand right up to the weir almost flush with the top of the weir.

If pipes were installed to release the water in the pond the scouring would continue or have blocked the pipes.

Maintenance would be needed - however when the weir over tops that does not cause flooding - it just means the pond is full and the discharge pipes are full and not working efficiently ie ponding water entering the pipe system catchment areas is not drained away.

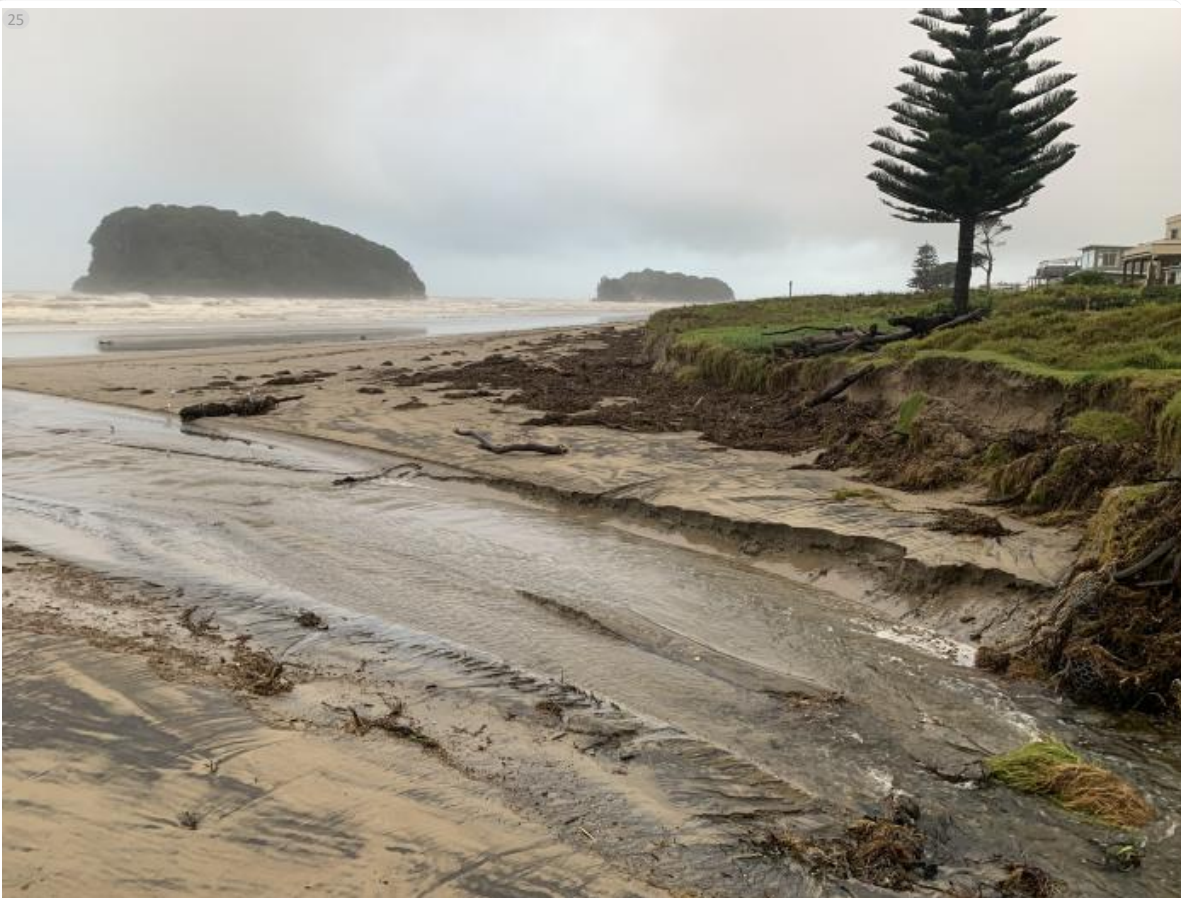
CF58FF2B-3F8A-4130-B221-6F96F7A834A2.jpeg

About 4 weeks after Gabrielle this is like a river.

Can see debris up to the Norfolk Pine

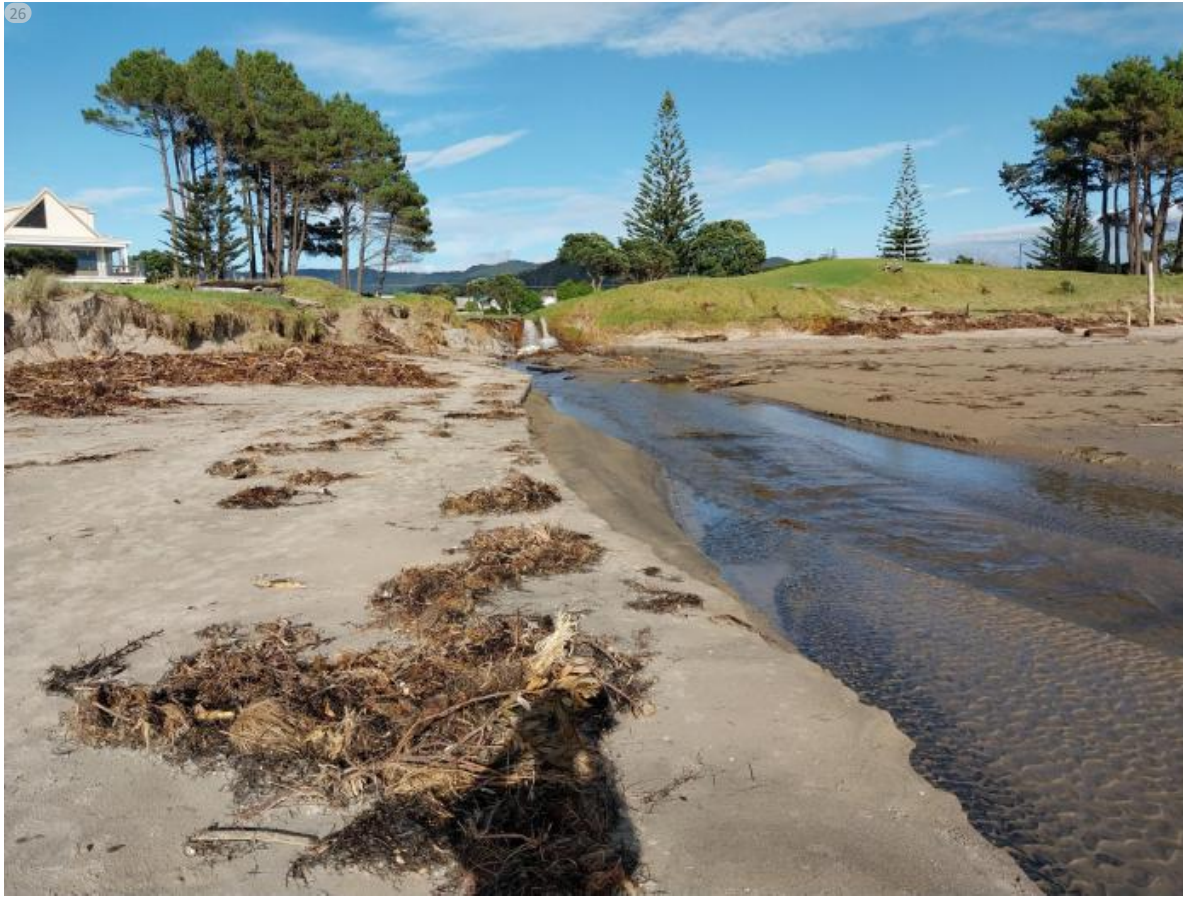
Williamson Lake Weir 20230228\_090217.jpg

28 February 2023 showing scouring when the pumps were operating to empty the pond and remove the sludge.

Hard to see in the photos but the water is murky.

I am concerned the dumping of the contaminated pond water onto the beach has caused the loss of the Oyster catchers - ie polluted the sand and killed off the shellfish they feed on.
