### Folder [Flooding 20240222 Photos collected]

WRA Whangamata Rate Payers Association > Folder [Library: Stormwater Working Group 2023]

## 20240222 Flood Event

Overnight 29249221 and into the morning of 20240222 its reported we received 40mm of rain.

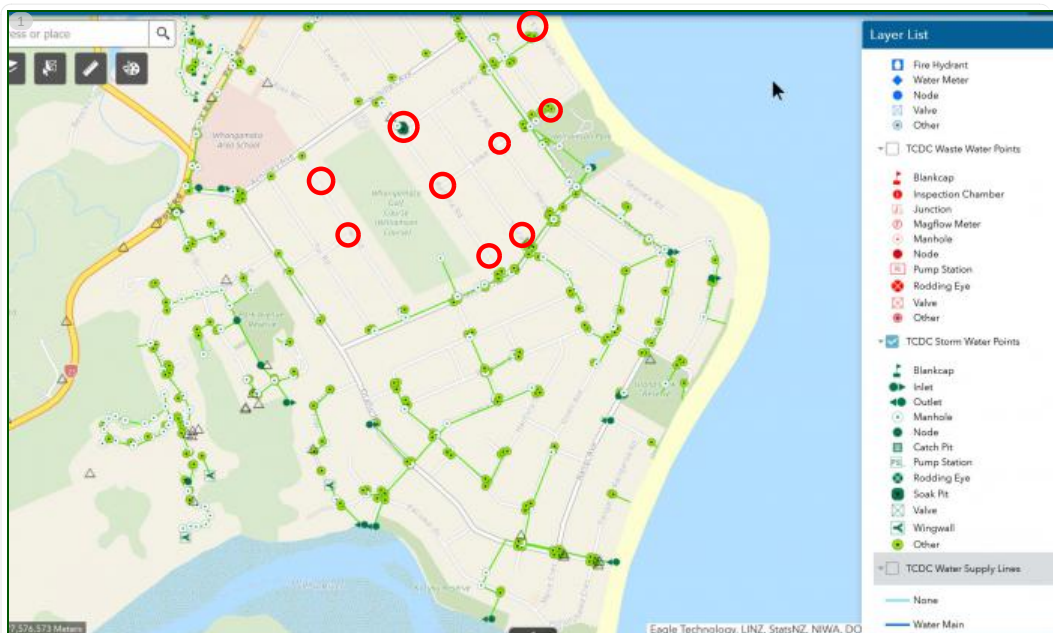
20200000A Smart Maps Stormwater Infrastructure South.jpg

Circles of locations of images shown

These are not all the hotspots - chosen after 20240222 rain event

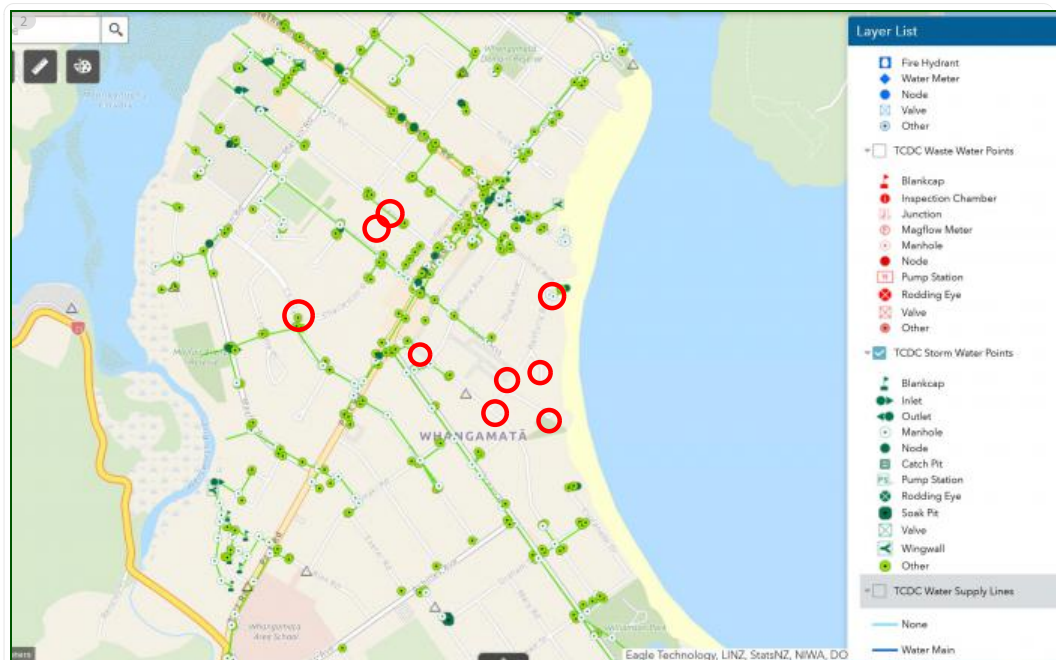
20200008 Smart Maps Stormwater Infrastructure North.jpg

Circles of locations of images shown

These are not all the hotspots - chosen after 20240222 rain event
